RENNIE'S RIVER WATERSHED

RIPARIAN ASSESSMENT

INTRODUCTION

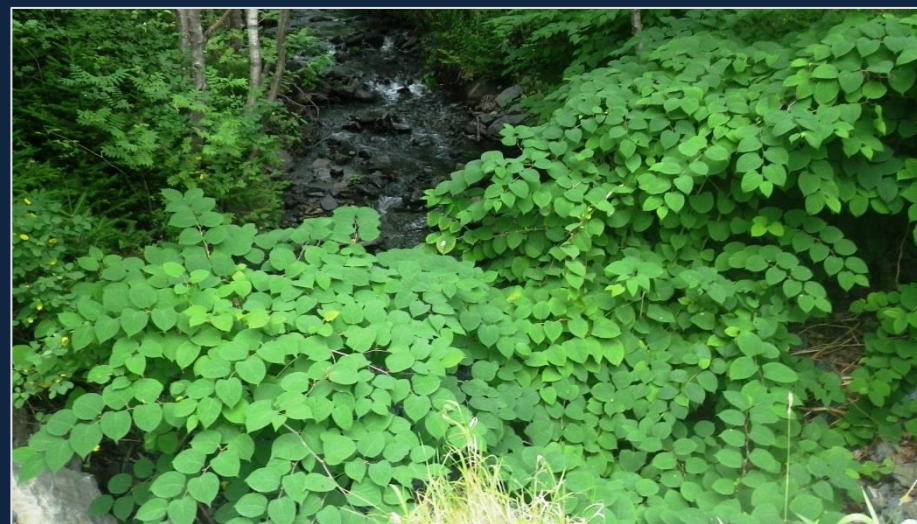
Figure 3a. Japanese knotweed, in the foreground, has covered the entire stream channel at Nagels Brook

Removal of invasive plants. One aspect of the riparian zone that could benefit from future attention is the vegetation assemblage. Non-native invasive plants were found throughout the watershed, with a heavier presence in some areas than others. Remediation is possible with further research on proper techniques for their removal. Native species could then be planted in place of the non-native species.

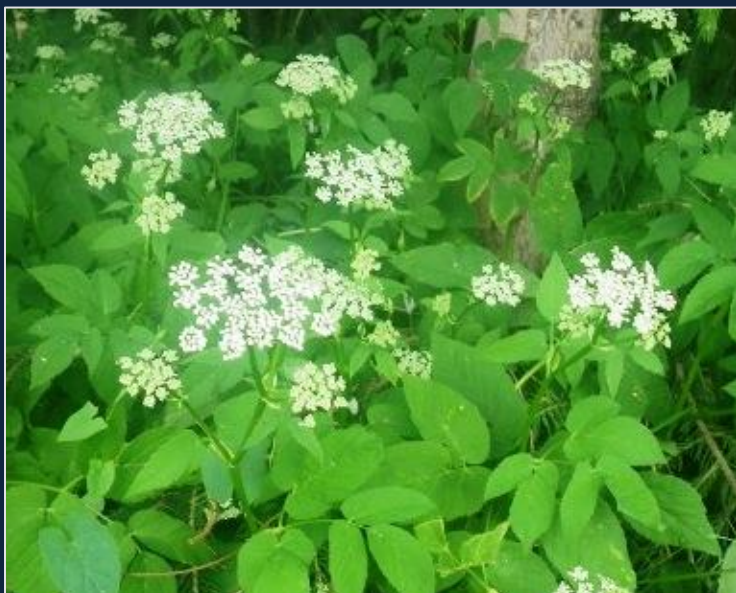
Figure 4. Goutweed was found throughout the watershed.

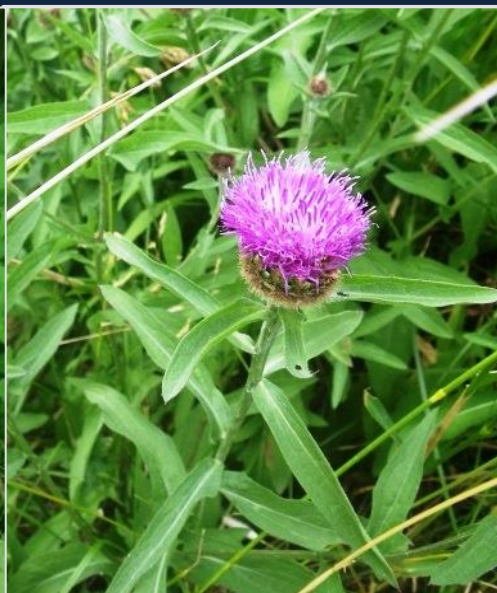
Figure 5. Black knapweed (above) was found throughout the watershed

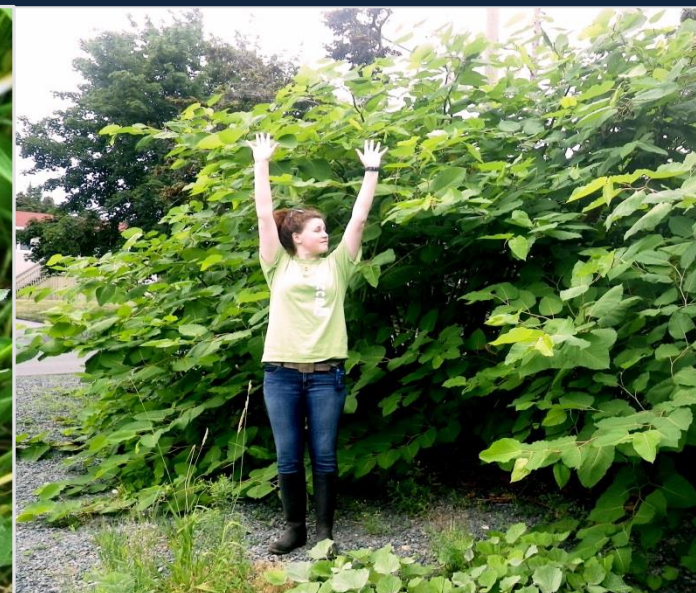
Figure 3b. Japanese knotweed growing adjacent to Leary's Brook, with a Green Team member adjacent to it for scale

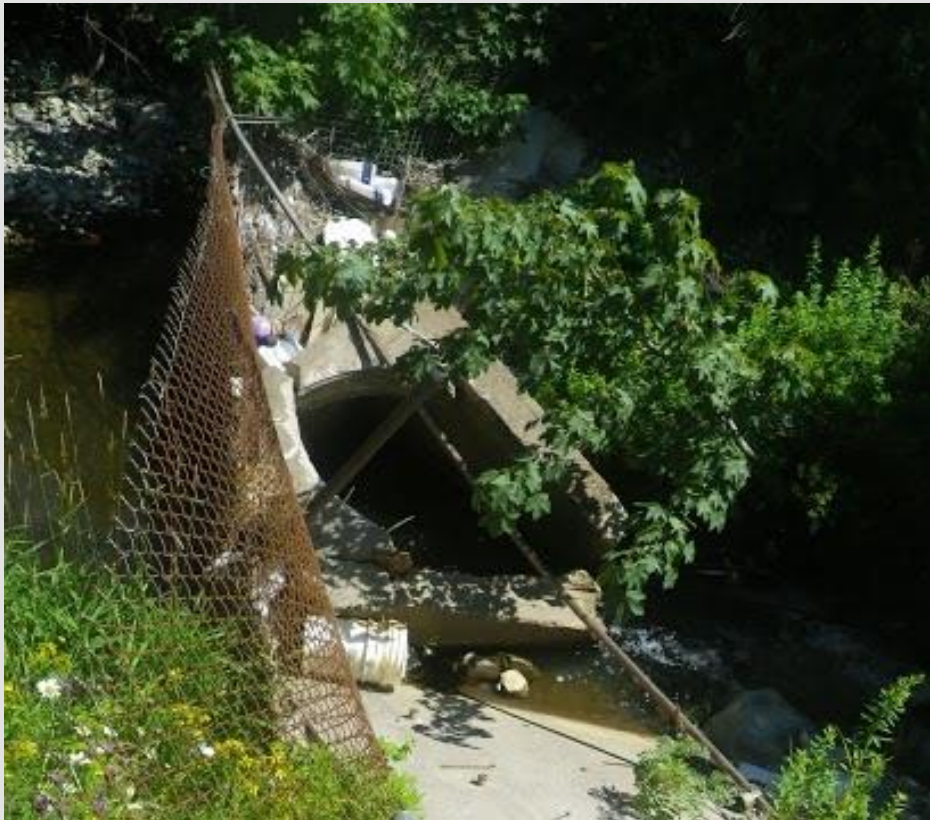
Figure 6. Along Kenmount Brook, the cement casing for the culvert and a section of chain link fence has fallen into the river and has accumulated debris, and could be a barrier to fish passage.

Garbage and debris buildup were repeatedly noted as a potential source of barrier to fish passage. Grates that cover culverts and fallen trees collect garbage which has the potential to block passage. The condition or installation of stream crossing infrastructure was also often viewed as a potential source of barriers to fish passage. The drop height on the downstream end of culverts is commonly a barrier to fish passage, and was noted at numerous locations throughout the watershed. However, as no detailed measurements of the extent of the drop were collected, it is not possible at this time to conclude if they were barriers to specific fish species or life stages. Deteriorating stream crossings were also found throughout the watershed that could act as possible barriers to fish passage. There were some private driveway crossings that were found to be in disrepair and falling into the river channel. One such case was along Kenmount Brook, at the downstream end of the crossing for the business located at 350 Kenmount Road, where the cement casing surrounding the culvert and a section of chain linked fence have collapsed into the river. These structures are not only themselves blocking the flow, but are allowing garbage and debris to build there as well (Figure 6), enhancing the potential for blockage.

Regular debris removal at grated culverts and maintenance, and regular monitoring of stream crossing infrastructure.

The condition of various stream-crossing infrastructure throughout the watershed is something that can also be improved. This is not only important from the perspective of fish passage, but is also important for ensuring that proper flow is maintained. Private stream crossings should be monitored to ensure that they are not in disrepair. The *Rennies River Catchment Stormwater Management Plan* has stream crossing evaluations contained in an Appendix, and could be a valuable start point for identifying infrastructure needing repair. The fallen culvert casing and chain link fence at 350 Kenmount Road should be cleaned up as it is an obvious problem which was identified in the *Rennies River Catchment Stormwater Management Plan* and during this project. Further fish passage studies on stream crossings are necessary to determine if they are barriers to the species specifically found in the watershed.

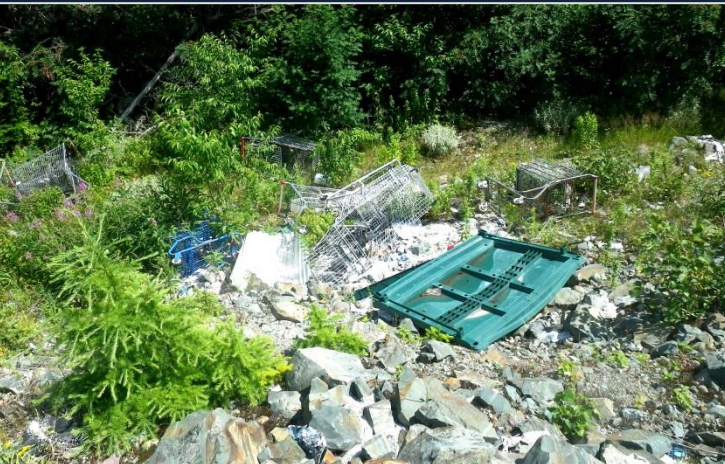
Shopping carts were a type of debris commonly found throughout the watershed, notably in areas near commercial development including the Avalon Mall and Kelsey Drive (Figure 7), but also further downstream towards the Health Sciences Centre. Car parts and various

Figure 7. Large debris, including numerous shopping carts, found along the riverbank of Kenmount Brook behind Marks Work Wearhouse and Canadian Tire on Kelsey Drive (Reach 17).

Removal of large debris. The removal of larger debris can be slightly more difficult than the removal of garbage, because of the size of the debris, and because it was often located in the water, requiring greater attention to safety during the removal. One area with a large number of shopping carts was behind Marks Work Wearhouse, where the carts were found mainly along the side of the river, but over a steep bank from the parking lot, making access more difficult. The area behind the Avalon Mall where shopping carts were also found has steep banks and will have to be accessed with caution.

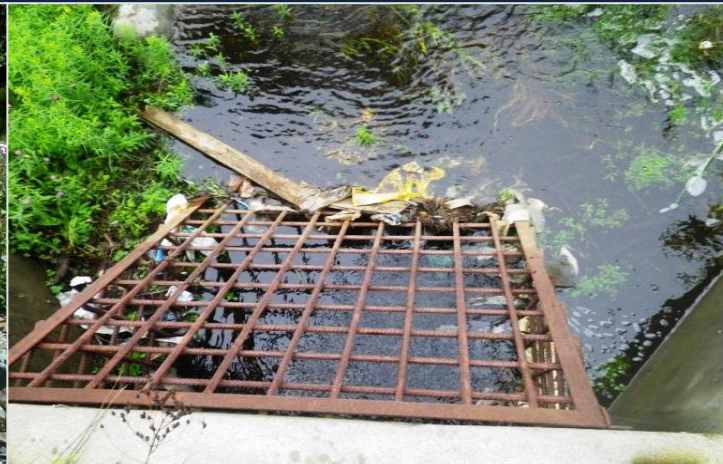
Although not documented in Figure 9 and Table 3, litter was found throughout the watershed. There were some areas where litter and garbage accumulated, such as in vegetation. Grates across culverts also often accumulated garbage (Figure 8 and Figure 9).

Figure 8. Garbage accumulated on a grate covering the culvert at the Thorburn Road crossing of the Oxen Pond tributary (Reach 22).

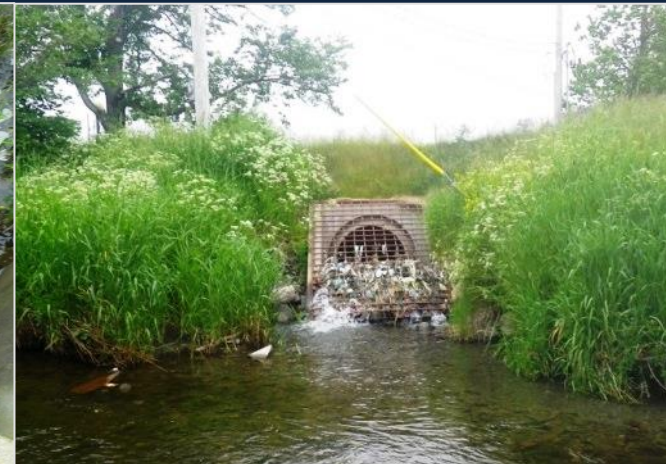
Figure 9. Garbage accumulated on a grate covering a culverted inflow to Rennie's River found in Reach 1, downstream of Kings Bridge Road.

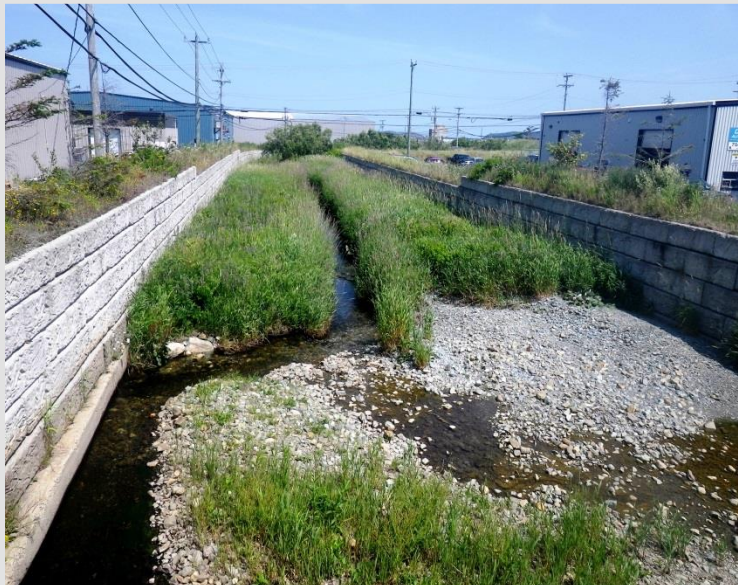
Figure 14 (right).

Another issue found throughout the watershed is channelization. This is linked to bank erosion and stability as bank stability measures often have the disadvantage of channelizing, not only altering the shape of the channel and the flow dynamic, but also removing riparian vegetation. While stabilizing one area, stabilizing structures can sometimes create an erosional problem downstream, when accelerated flow velocities as a result of the hardening of the riverbanks erode areas downstream. In some areas channelization consisted of stream straightening, but with riparian vegetation present (Figure 13) while in others natural vegetation was mainly replaced by a hard surface (Figure 14).

The section of Yellow Marsh Stream downstream of Pippy Place has been straightened and channelized, and is now subject to stream hardening.

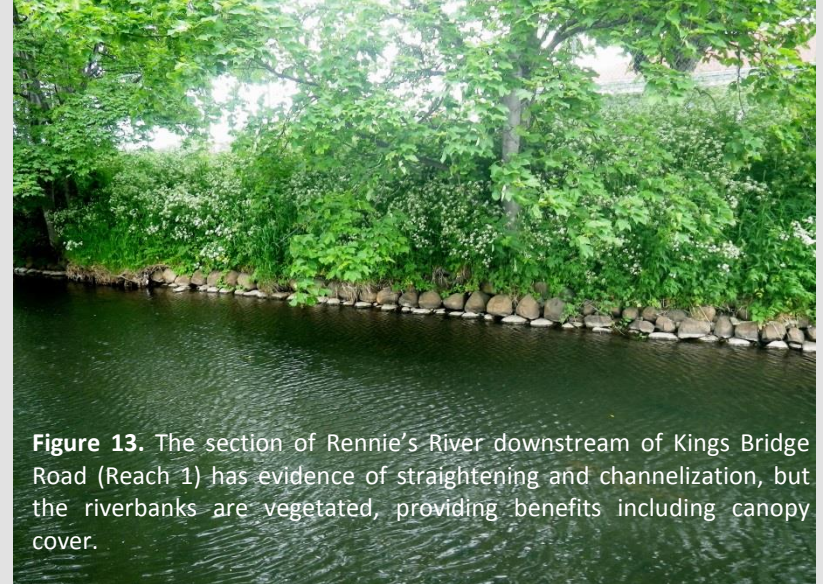
Figure 13. The section of Rennie's River downstream of Kings Bridge Road (Reach 1) has evidence of straightening and channelization, but the riverbanks are vegetated, providing benefits including canopy cover.

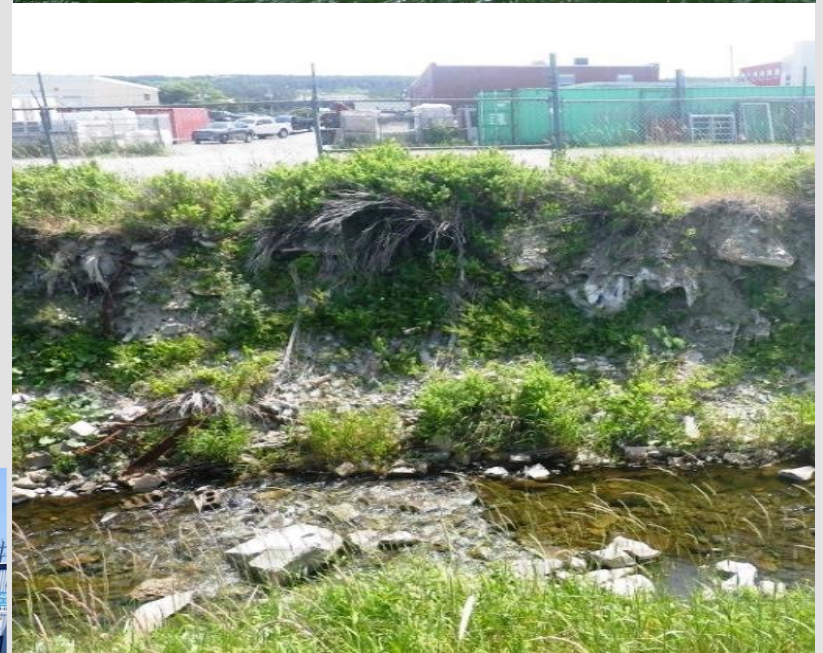
Erosion is a natural process, but can often be increased in urban settings due to the removal of riparian vegetation and increased volume and velocity of surface runoff from hard surfaces. In many cases during this assessment, steep slopes were experiencing erosion, likely exasperated by overland runoff from developed areas. In some cases bank erosion was decreasing the distance between the river channel and anthropogenic areas. One such case was along Yellow Marsh Stream downstream of Pippy Place, where the bank has eroded and exposed garbage that was buried in the past (Figure 12). Near this area, the opposite bank also showed instability; large rocks that were likely placed to stabilize the riverbank had fallen into the river.

Figure 12 (above). Extensive bank erosion along Yellow Marsh Stream, upstream of where it meets with Learys Brook (Reach 13).

Develop and implement engineering solutions for erosion. Some areas experiencing bank erosion or instability are unsuited for planting as the sole remediation strategy. Steep slopes and those that showed extensive erosion will need further observation and engineering solutions. These solutions may involve the use of heavy equipment in some cases. It is important to be mindful of impacts on surroundings while installing bank stability structures, such as sediment control during installation; any changes to water flow velocity that may then increase erosion downstream; and incorporating vegetation into the design to recreate a natural riparian zone with adequate canopy cover. Ideally, options with minimum effects of stream hardening are preferred, such that streamflow velocity is not increased and ultimately increase erosion in downstream areas. The permeability of the material used in the stability control structure may be one factor that can help ensure this. One area requiring future bank stability measures is Yellow Marsh Stream downstream of Pippy Place, where one bank has eroded into the river (Figure 12), while on the opposite bank large rocks that were placed for stability have fallen into the water. Another area of extreme bank erosion is along Nagels Brook, in the vicinity of the white building which once housed Easter Seals. The section of Learys Brook between the Avalon Mall and Toys R Us is also experiencing bank erosion, with a narrow buffer remaining between the water and the parking lots.
