Regional Watershed Survey:
Nut Brook Drainage Basin, St. John's
Stream analysis of a river system in a local industrial
zone

Prepared by:
Dan Ficken (B. Sc., ADWQ)

Prepared for:
Northeast Avalon Atlantic Coastal Action Program
(NAACAP)

June 2006

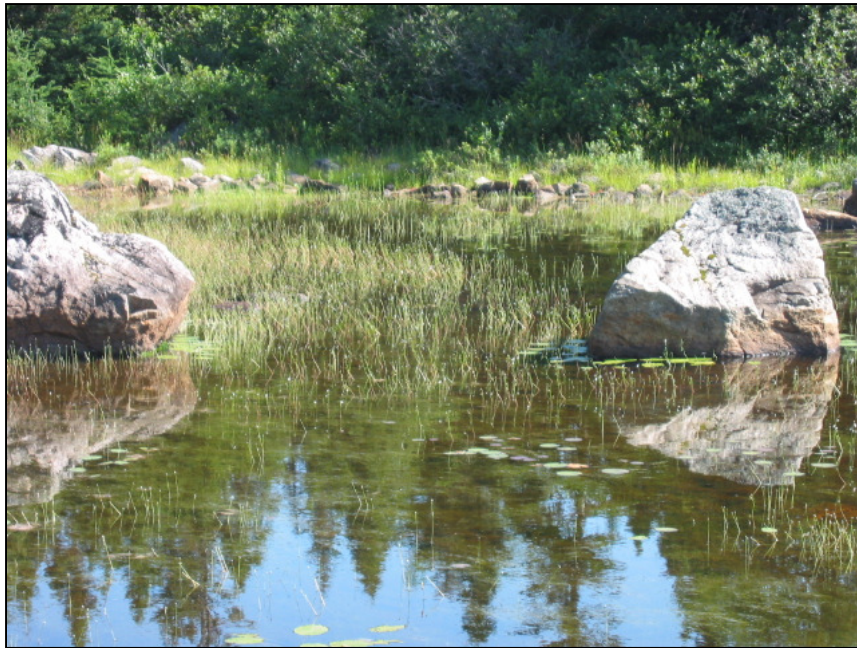
Photo 1: *View of Site 1, the reference site, at the headwaters of the Nut Brook and Kelligrews River watershed. Downstream begins to the left.*

The first site selected was in the seemingly pristine headwaters in the southernmost section of the watershed. This site was selected because it was upstream from all industrial activity, including the TCH, and was, therefore, the least likely spot to be contaminated in the drainage basin. Located in a pond surrounded by trees, it drained into a wetland, forming the beginnings of Nut Brook. Since it represented the natural conditions of the system, it was an ideal location for a reference site. This would be an important tool for determining the extent of anthropogenic impact on the system by comparing and contrasting it with other parts of the brook downstream.

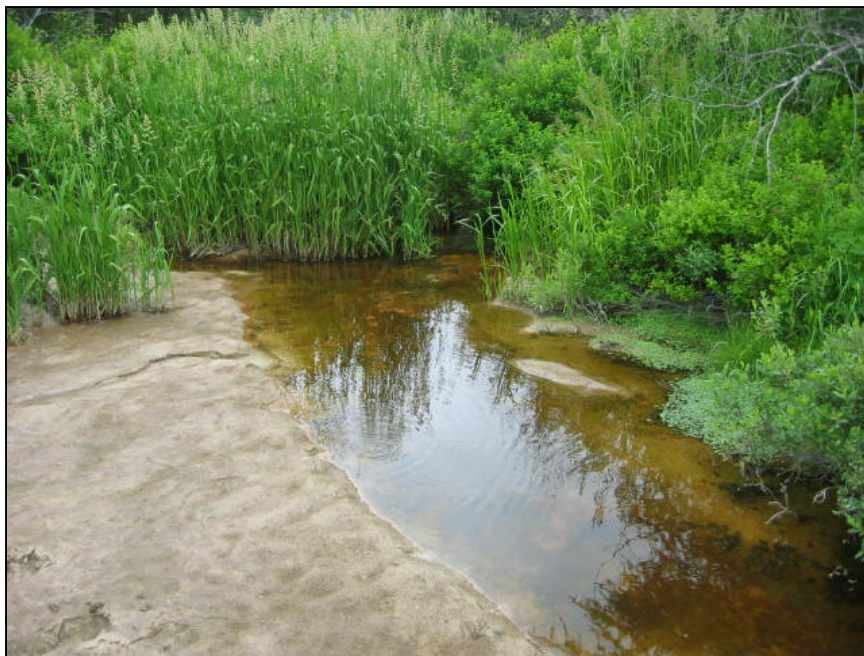
Photo 2: *View of Site 2, where Nut Brook combines with the adjacent tributary. Facing downstream.*

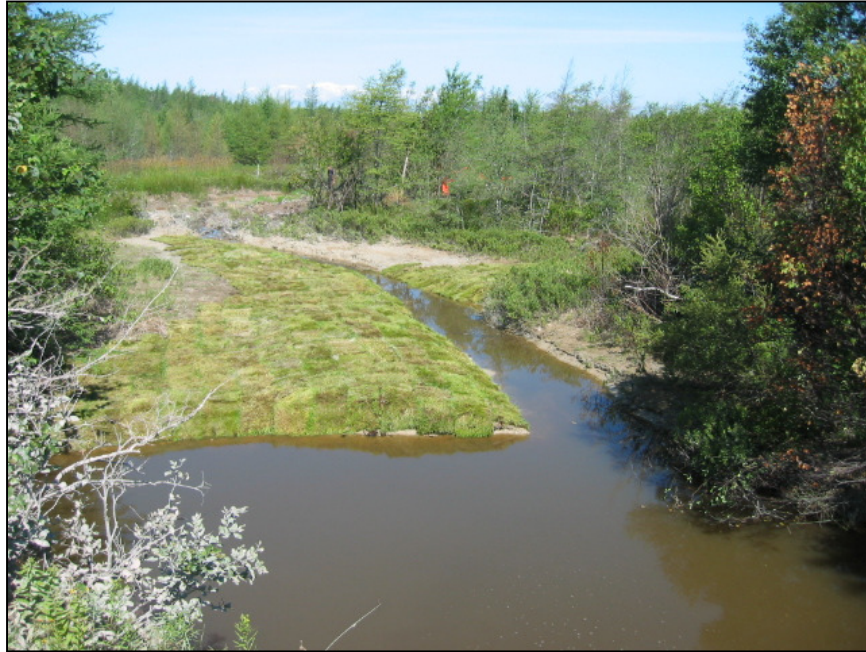
Photo 3: *View of Site 3 in adjacent tributary after sods had been applied to the sediment. Facing downstream*

Site 3 was selected in the tributary adjacent to the main branch of Nut Brook, which drained from the pool next to the north side of Incinerator Road across from the incinerator. The site was heavily sedimented and the odour from the visible rendering plant was very strong. The sediment had many red streaks and stains, and oily patches were present as well. The water was also very murky and red and smelled very bad. This site was probably very influenced by leachate from the landfill, as indicated by its colour. It was noted also that at some point hay had been spread over a part of the sediment for reasons unknown. It was speculated that it was a cover for a possible but indefinite spill. Later on during the sampling period (*sweep 3*), sods were planted over the sedimented banks, but a large hole was dug with an excavator and much of the unearthed material was piled in the stream, nearly blocking the flow completely. Much gas was noted saturated in the sediment and if stirred, it would flow into the stream. This site was one of the worst affected locations.

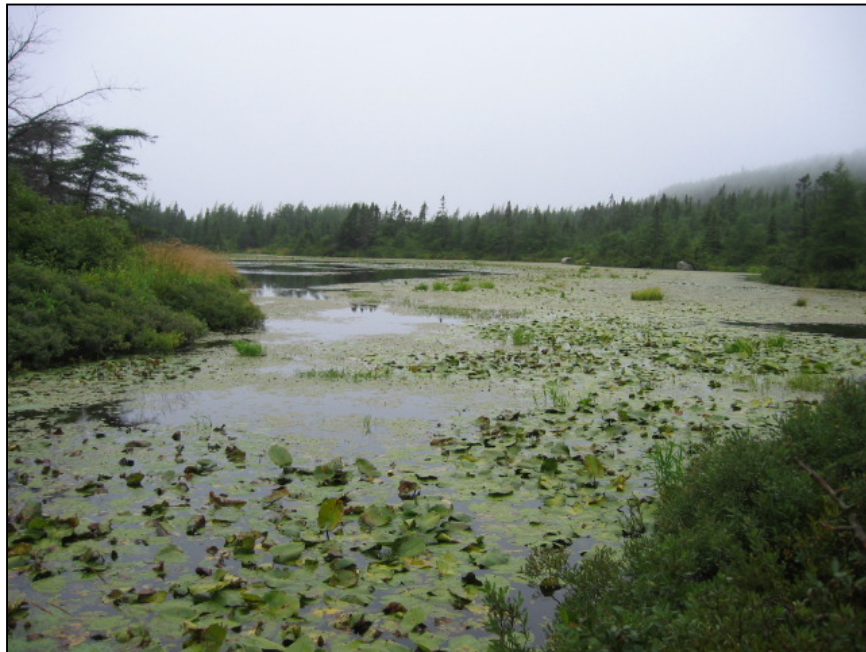
Photo 4: *View of Site 4, a pond on Nut Brook. Note the abundance of lilies competing at the surface. Facing downstream.*

Site 4 was located at the south end of Nut Brook Pond, and since there were so many lily pads and aquatic plants, it was thought that this site was undergoing eutrophication. If too many nutrients enter the system the plant life can boom, causing the water to become stagnant and the dissolved oxygen levels to be lowered (CCME, 2003). This can cause certain undesirable bacteria species to flourish. The site was an intermediate stage located between the locations where site 5 discharged and where Nut Brook met the abovementioned tributary. It should be noted that the east side of the rendering plant was visible here.

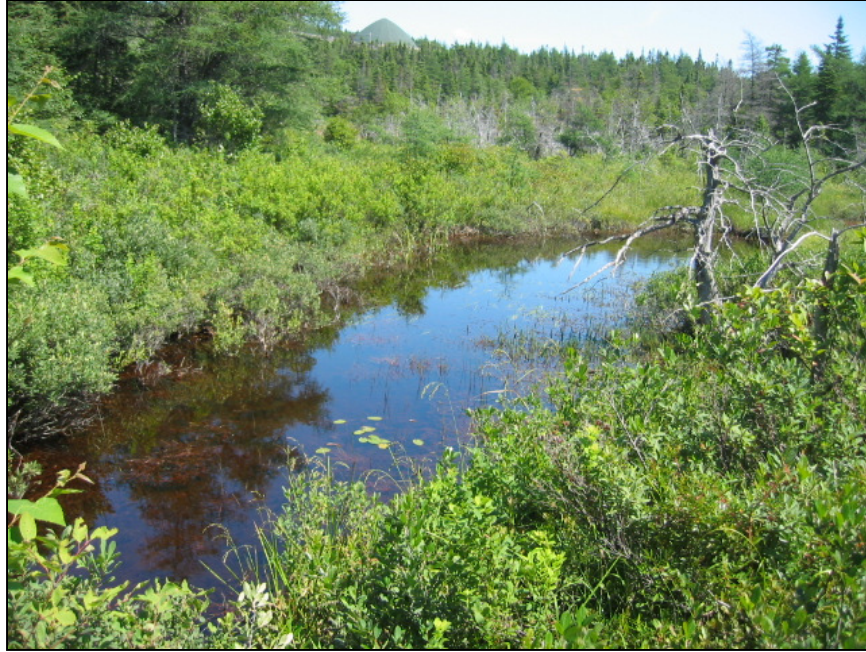
Photo 5: *View of Site 5 standing on the dam. Note the salt storage dome in background. Facing upstream.*

Site 5 was chosen for the fact that it was a pool created by a man-made dam on Nut Brook. It was just downstream from the septic waste handling facility and a quarry. The water was quite murky and had an oily sheen on the surface. For a comment on dams, they tend to cause substances to accumulate in the reservoir created behind them. Due to the flooding caused by dams, submerged vegetation will also tend to rot under water giving certain bacteria an opportunity to release mercury from the soil. Thus sometimes mercury is expected to show up in dam pools (Barlow and Clarke, 2003).

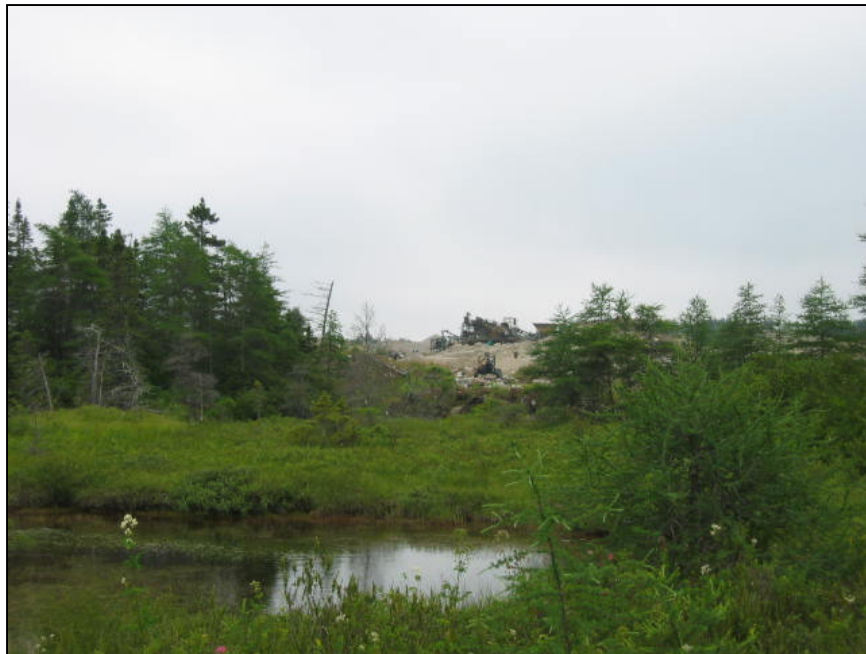
Photo 6: *View of Site 6 showing a quarry in background. Downstream is towards the right.*

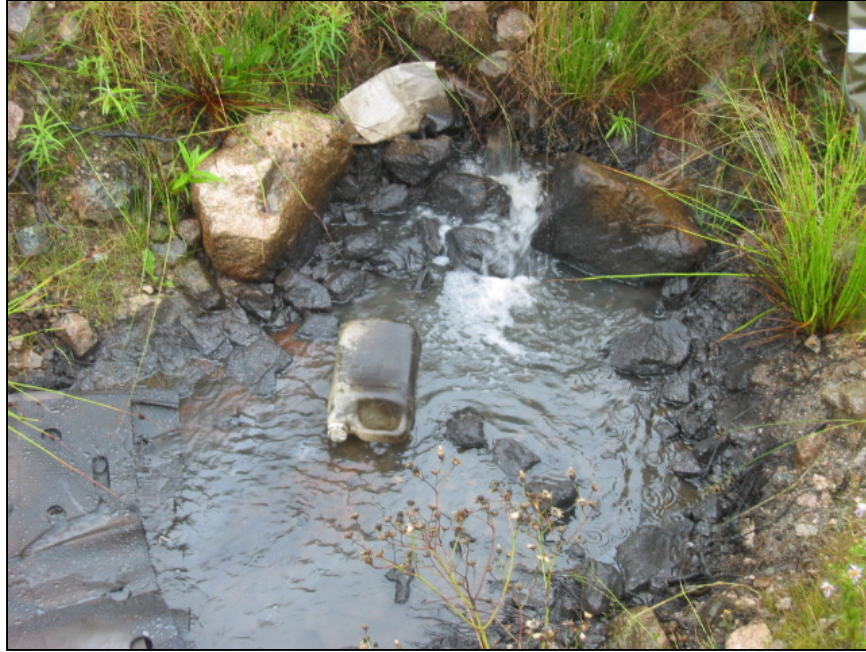
Photo 7: *View of oily discharge flowing from the outfall at Site 6b. Flow is towards the left.*

On the last sampling sweep of Nut Brook, it should be noted that site 6 was moved to a different location, due to significant circumstances when a small drainage ditch was noticed just downstream on the immediate south side of Incinerator Road. The ditch was discharging very oily and smelly water that was black grey in colour into Nut Brook. Its origin was a pipe jutting out of a small embankment on the edge of the septic waste handling facility. The flow rate was very high indicating the water was being pumped from the pipe. The sheer volume of oil that was estimated to be in the water would explain the oily sheen on the surface of the water at site 5 a short distance downstream. The rocks in the ditch all had a black coating of oil on them. Visually appalling, it was obvious that site 6 needed to be changed to give this new finding priority. The new site will hereafter be known as site 6b. At the time it was unknown as to why there was oil being pumped into the ditch, but it was seen as major grounds to test this water. It was later found to be the result of a faulty oil-water separator used on site.

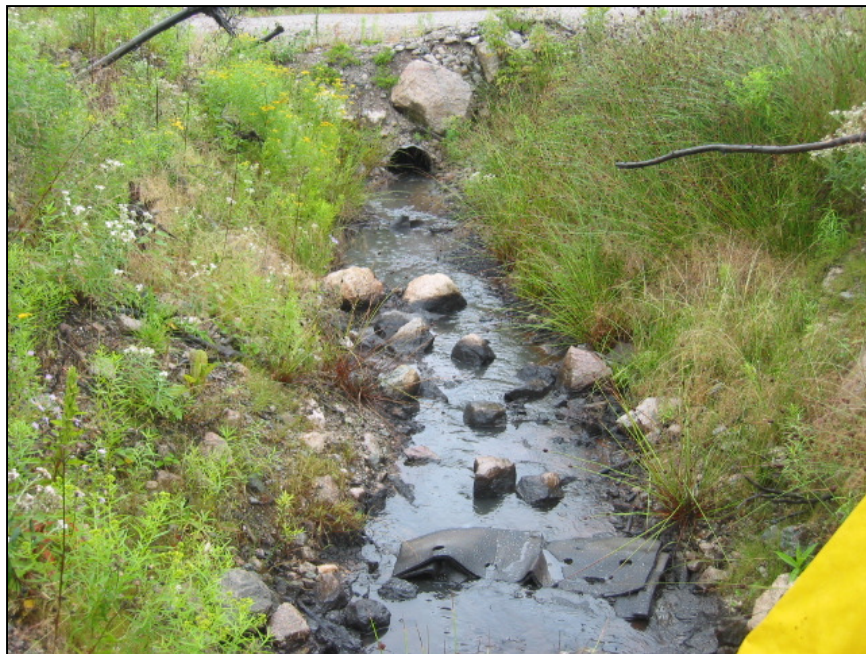
Photo 8: *Oily discharge flowing from Site 6b towards Nut Brook just beyond culvert (ahead). Facing downstream.*

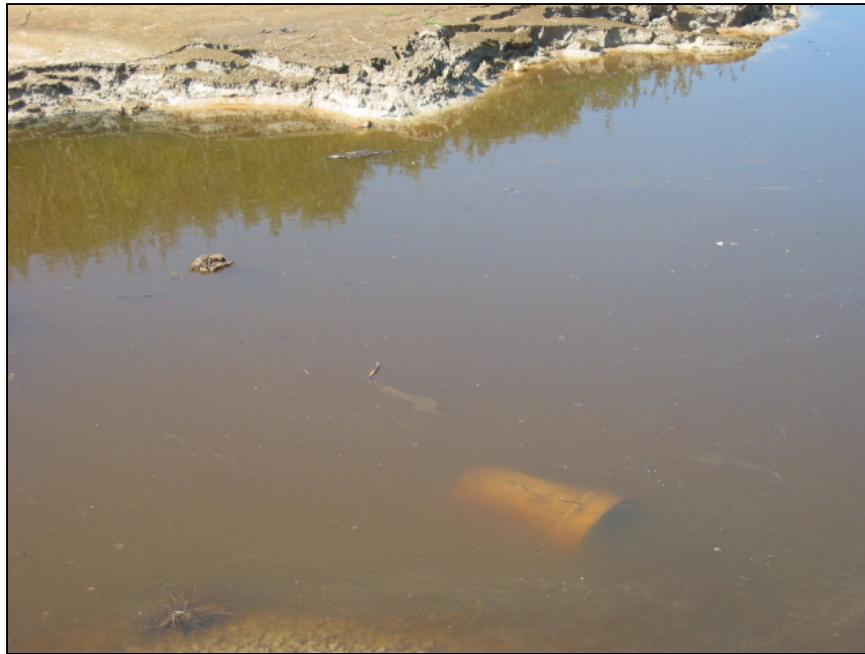
Photo 9: *Leachate from the landfill in the tributary adjacent to Nut Brook. Facing upstream. Note the deposited sediment on the far bank.*

The tributary that runs adjacent to the dumpsite had a deep red colour, a somewhat cloudy appearance, and a bad smell, indicating that leachate had probably entered the system and could still be a contributing factor. The sediment that had been deposited by the quarry next to the river also exhibited red stains and patches of oil, possibly from the leachate as well.

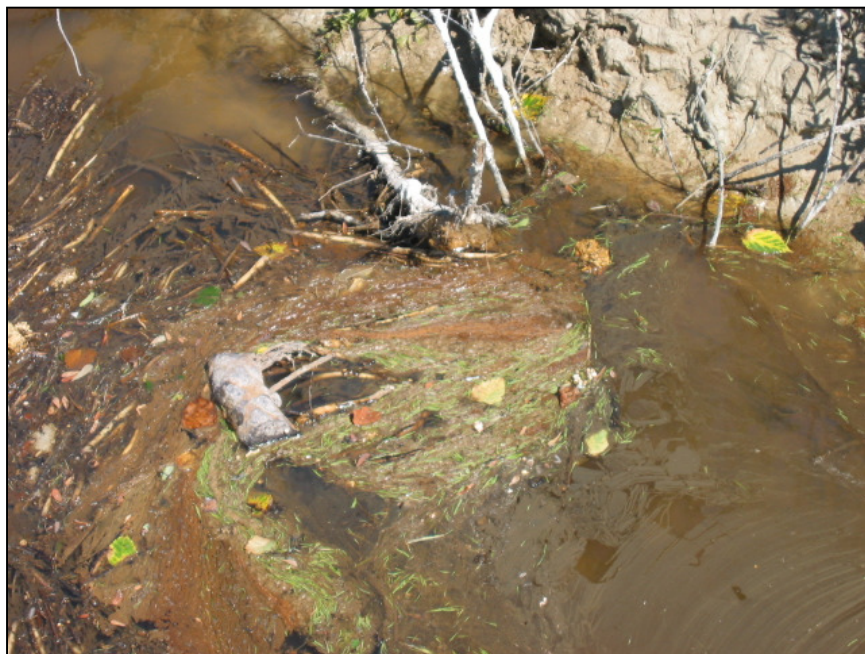
Photo 10: *Blockage of Site 3 after the channel was disturbed (sweep 3). Downstream is towards the left.*

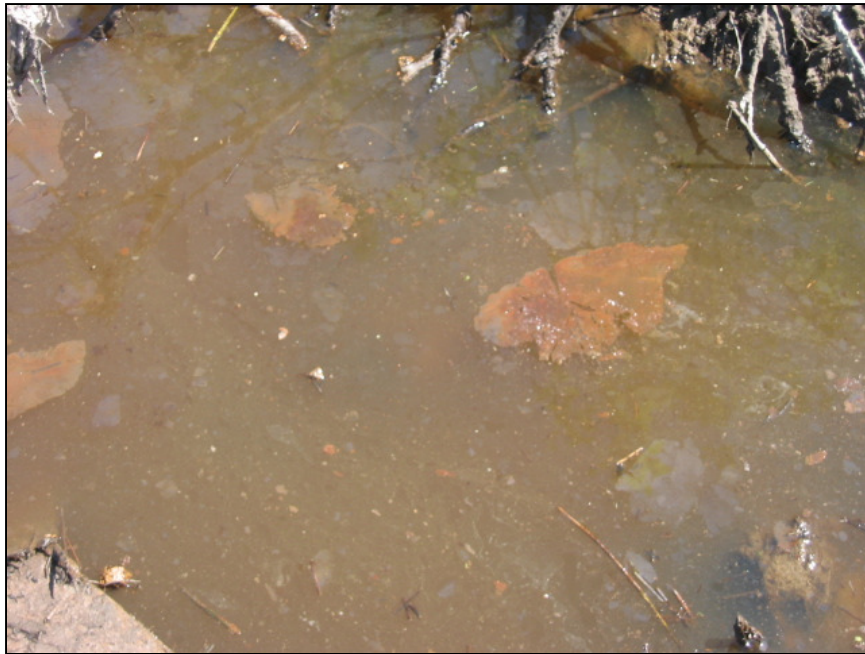
Photo 11: *Example of poor water quality in an affected part of Nut Brook (Site 3). Downstream is to the left.*

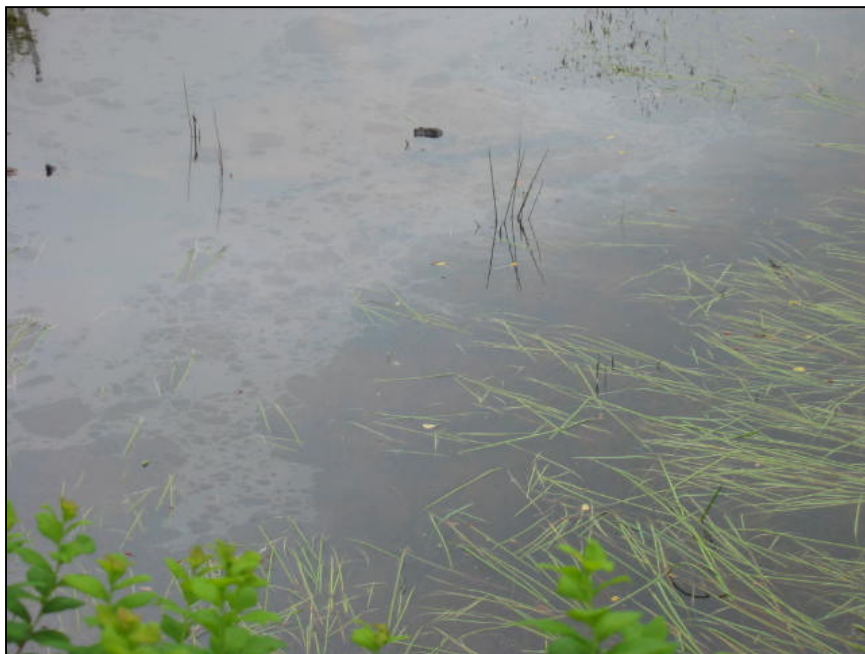
Photo 12: *Oil transported from its source downstream to Site 5. Facing upstream.*

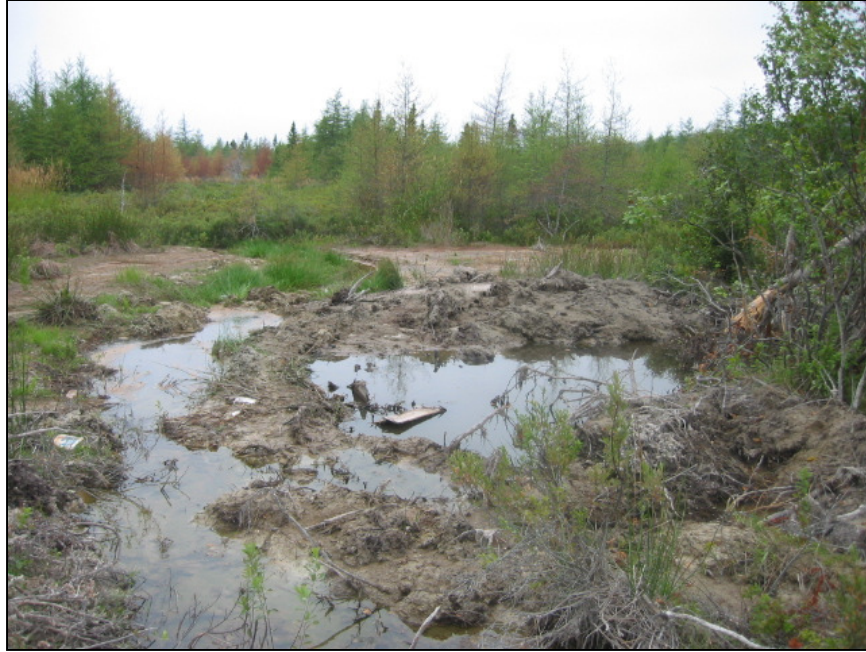
Photo 13: *View showing major destruction to the stream from an excavator. Facing downstream.*

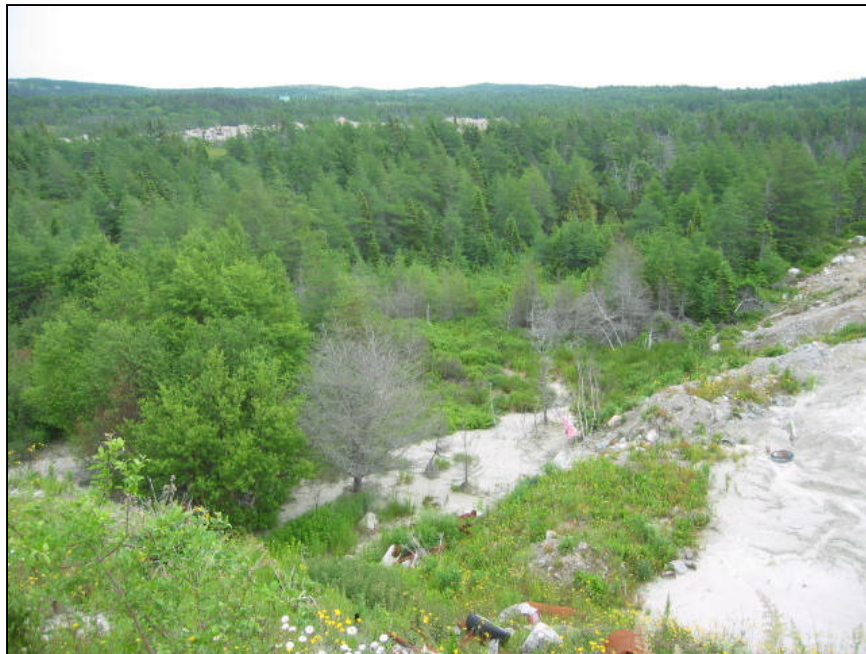
Photo 14: *View of sediment fanning over the edge of a hill before depositing into the tributary adjacent to Nut Brook to the left. The source quarry is away to the right.*

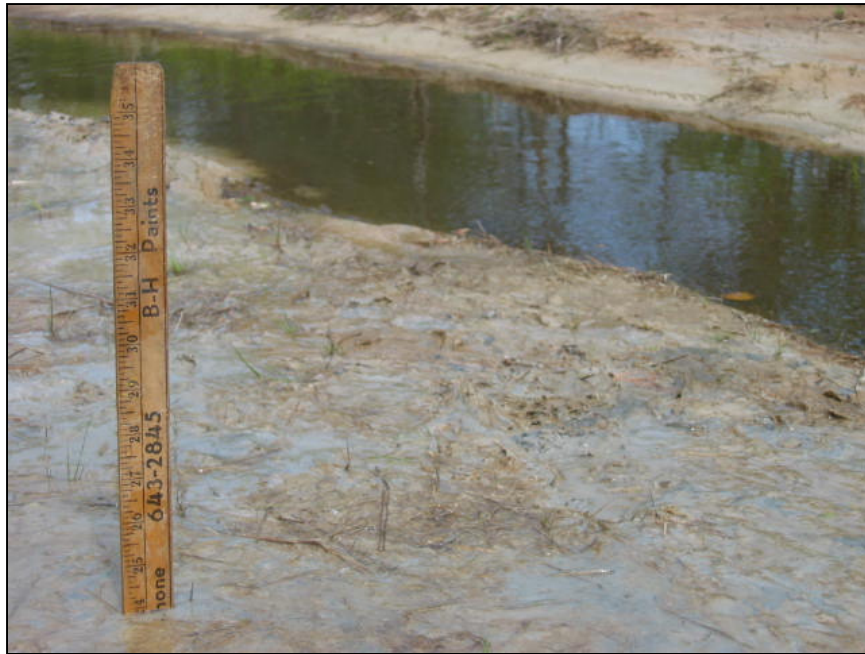
Photo 15: Yardstick buried 24 inches (Approximately 61cm) deep in sediment deposited in the flood zone of the stream bank (Site 3). Downstream is to the left.

the system that it had accumulated 50 – 70cm deep all the way downstream, and had also been deposited up to this depth on the stream's flood region about 5 – 8m on either side. This meant that not only had the stream's depth and flow been greatly reduced, the natural benthic environment had been completely choked, and vegetation, including trees, in the flood region were also being covered and suffocated. Since the natural organic matter of the streambed was replaced by quarry sediment, the chemistry of the water would also be expected to change. Dissolved oxygen, which is essential for aquatic ecosystems, would be the biggest factor expected to change with this regard.

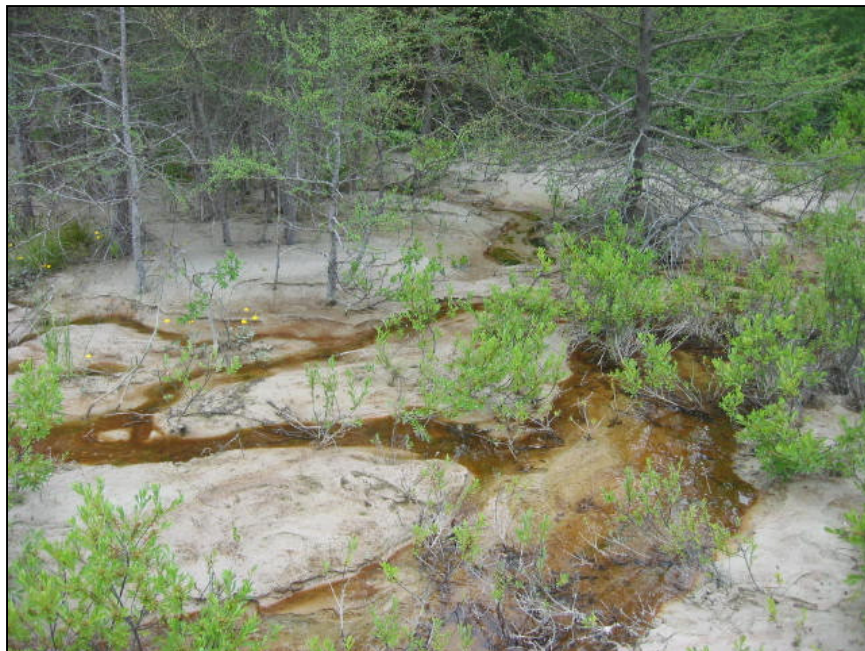
Photo 16: View of the adjacent tributary and buffer zone (downstream of site 3) choked with sediment and also red with leachate. Facing downstream.

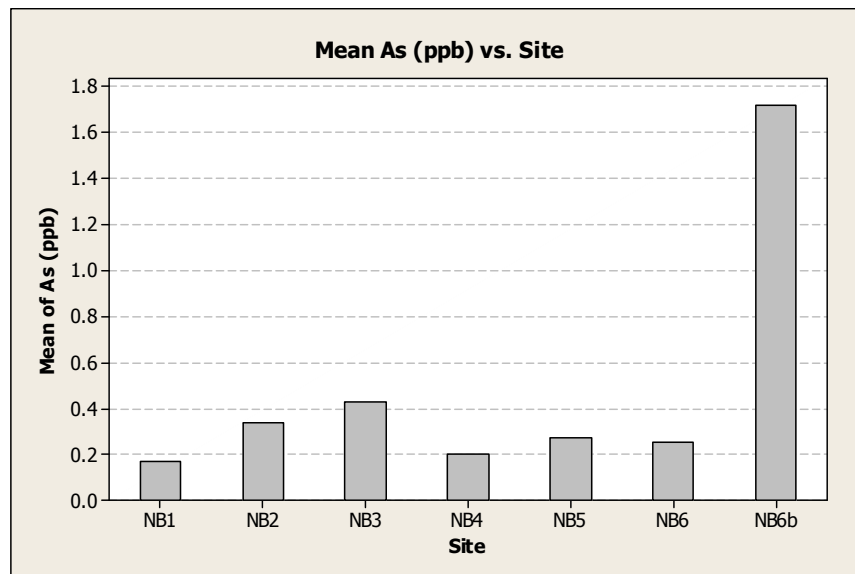
The CCME guideline regarding arsenic for the protection of aquatic life in freshwater is set at 5.0 ppb (2003), but none of the samples in Figure 12 had mean values even close to this limit. A slight spike in sites 2 and 3 at mean concentrations of 0.34 ppb and 0.43 ppb respectively was noted in comparison to site 1 at 0.17 ppb, however a TEV test in the statistical analysis gave a high p-value (>0.05) and thus showed there was no significant variance between the values of As at each site. It was likely for that reason that much of the element was naturally occurring. Any accurate interpretation was difficult to obtain because most of the raw values were below the detection limits of the method used to create the results (*Appendix A*). According to statistical advice received, it is occasionally feasible to divide the results in half because it can sometimes give an approximate estimate of what the actual values could be (M. Pippy, personal communication, October 19th, 2005), which was what was done here. It should be noted that site 6b had a notably higher concentration of arsenic than the other sites at 1.72 ppb (*Figure 12*).
