**Northeast Avalon ACAP's Wetland Survey Project
Final Report for the 2011-2012**

April 2012

**Northeast Avalon
Atlantic Coastal Action Program**

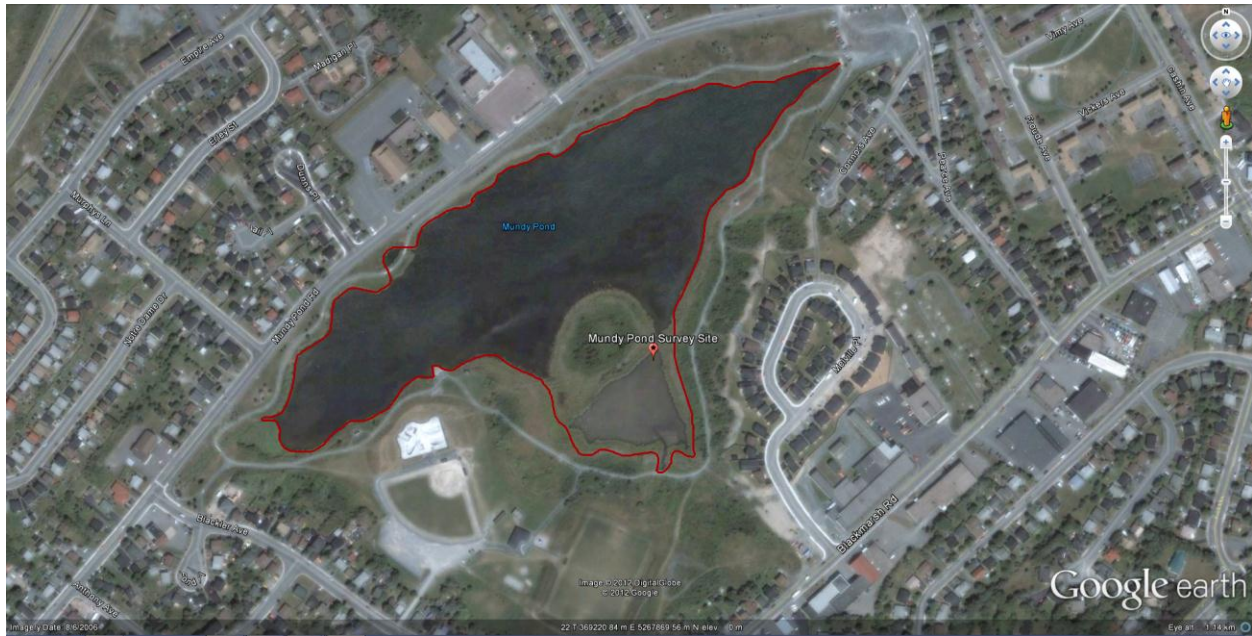
The Mundy Pond wetland study site was located on the southern side of Mundy Pond in St. John's. Water flows into the main pond through a culvert system that originates in a wetland area to the north of Empire Avenue. Water flows east from this wetland, through residential neighbourhoods and into Mundy Pond at the west end of the pond. The surveyed site and the pond were connected by a small channel of water. Due to both sites being hydrologically connected and in close proximity to each other, the wetland boundary was delineated to include Mundy Pond. Mundy Pond Road runs closely along the north shoreline of the site.

Figure 1: Mundy Pond wetland study site with the boundary indicated in red.
(St. John's. (2006, 6th August). 36_92 20.84E, 5 26_78 69.56N. Google Earth Image.
[Accessed 26 March 2012]. Available from: <http://www.google.com/earth/index.html>).

The wetland delineation found in Appendix B (Figure1) was used for the analysis of potential stressors in the stress evaluation rubric. Development on Mundy Pond Road was within 30 meters of the wetland boundary and was densely developed. A parking lot was located at the east corner of Mundy Pond that was within 15 meters of the wetland boundary. The pond outflow culvert runs under this parking lot. A residential neighbourhood, Connors Avenue, was located south of this parking lot, within 30 meters of the wetland boundary. Another residential neighbourhood, Melville Place, was located within 30 meters of the wetland boundary near the survey site. The park's skateboarding facilities were located within 30 meters of the wetland boundary. This site obtained a score of 33 in the stress evaluation rubric.

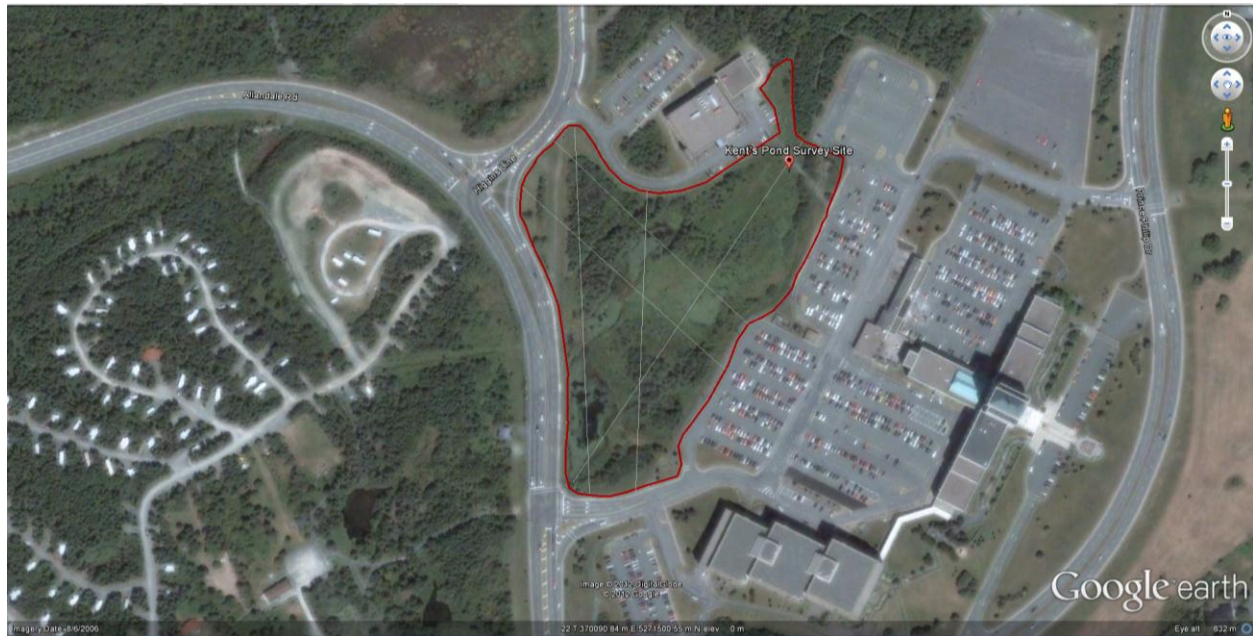
The Kent's Pond wetland study site was located to the east of Allandale Road, St. John's. The wetland site boundary was mostly defined by the development that is contiguous to the wetland. Higgin's Line, Allandale Road and the paved parking lots of the XWave building and the Confederation Building marked all but a small section of the wetland boundary. The boundary in the northeast corner was marked by the beginning of a forest stand that ended at the Kent's Pond shoreline.

Figure 2: Kent's Pond wetland study site with the boundary indicated in red. The thin grey lines are drawn from wetland boundary to areas of increased potential of impact from run off. (St. John's. (2006, 6th August). 37_00 90.84E, 5 27_15 00.55N. Google Earth Image. [Accessed 26 March 2012]. Available from: <http://www.google.com/earth/index.html>)

The wetland delineation found in Appendix B (Figure 2) was used for the analysis of potential stressors in the stress evaluation rubric. Higgin's Line, Allandale Road and the paved parking lots of the XWave building and the Confederation Building were all within 50 meters of the wetland boundary. The elevation of the land showed a slope toward the southeast meaning there is potential for a greater impact of runoff from the impervious surfaces of Higgin's Line and the Xwave parking lot. The Kent's Pond wetland study site obtained a total score of 48 in the stress evaluation rubric.

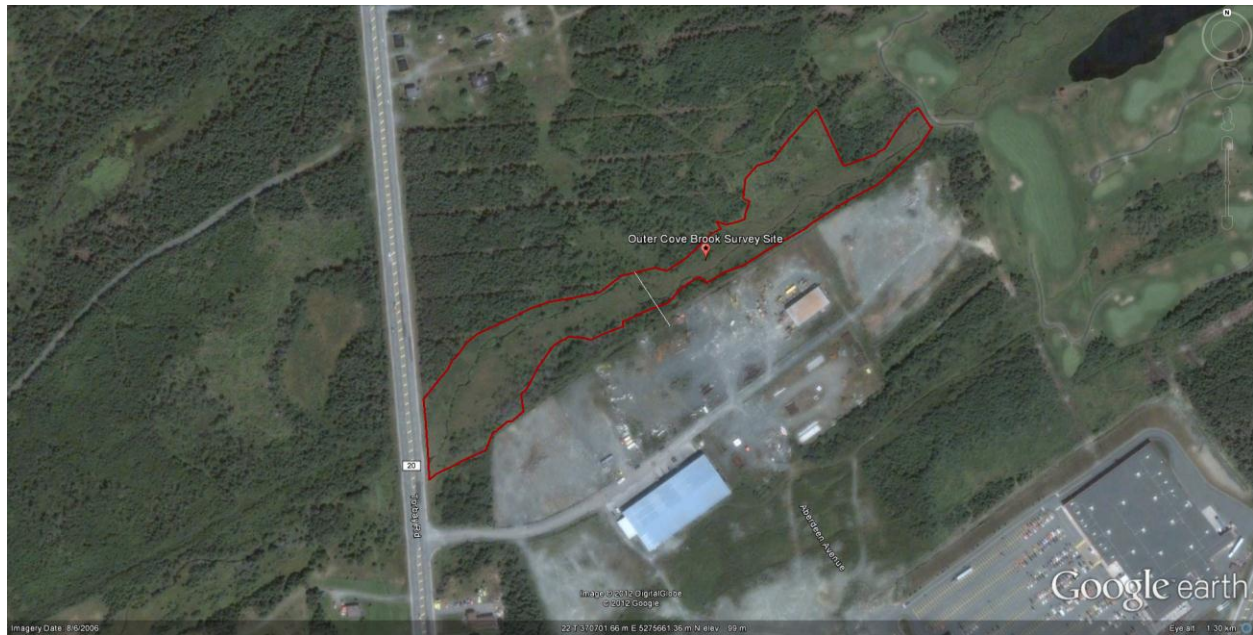
The Outer Cove Brook wetland study site was located east of Torbay Road and west of the Clovelly Golf Course in St. John's. It was adjacent to Outer Cove Brook. The wetland study site was delineated based on forest and developed borders. Torbay Road formed the western boundary and the golf course formed the eastern boundary. The southern boundary was a developed border, composed partially of the RONA Building Supplies property.

Figure 4: Outer Cove Brook Wetland study site with the boundary indicated in red. The thin grey lines are drawn from wetland boundary to areas of increased potential of impact from run off. (St. John's. (2006, 6th August). 37_07 01.66E, 5 27_56 61.36N. Google Earth Image. [Accessed 25 April 2012]. Available from: <http://www.google.com/earth/index.html>).

The wetland delineation found in Appendix B (Figure 4) was used for the analysis of potential stressors in the stress evaluation rubric. Torbay Road and the RONA property were contiguous to the wetland boundary. The RONA property was at an elevation above the wetland, which could increase the potential impact of run-off from this feature into the wetland site. Golf course features were not included in the stress evaluation rubric. The golf course to the east of the Outer Cove Brook wetland was located downstream from the wetland site at an elevation that is not likely to cause a significant impact from run-off into the wetland site. The stress from this feature was thought to be negligible. The Outer Cove Brook wetland received a value of 27 in the stress evaluation rubric.

There are some potential threats or stressors to the wetland ecosystem that were not included in the stress evaluation rubric that should be noted. The aerial images used to delineate the wetland and assess the potential stressors for this site did not reflect recent construction and development, including the Stavanger Drive/ Aberdeen Avenue commercial area that is expanding towards Outer Cove Brook. Also, the airport is located upstream of the wetland site and there is potential for contaminants from there to be transferred to the wetland. Likewise, any development along the river upstream of the wetland would have the potential to impact the wetland as the river could transport contaminants.

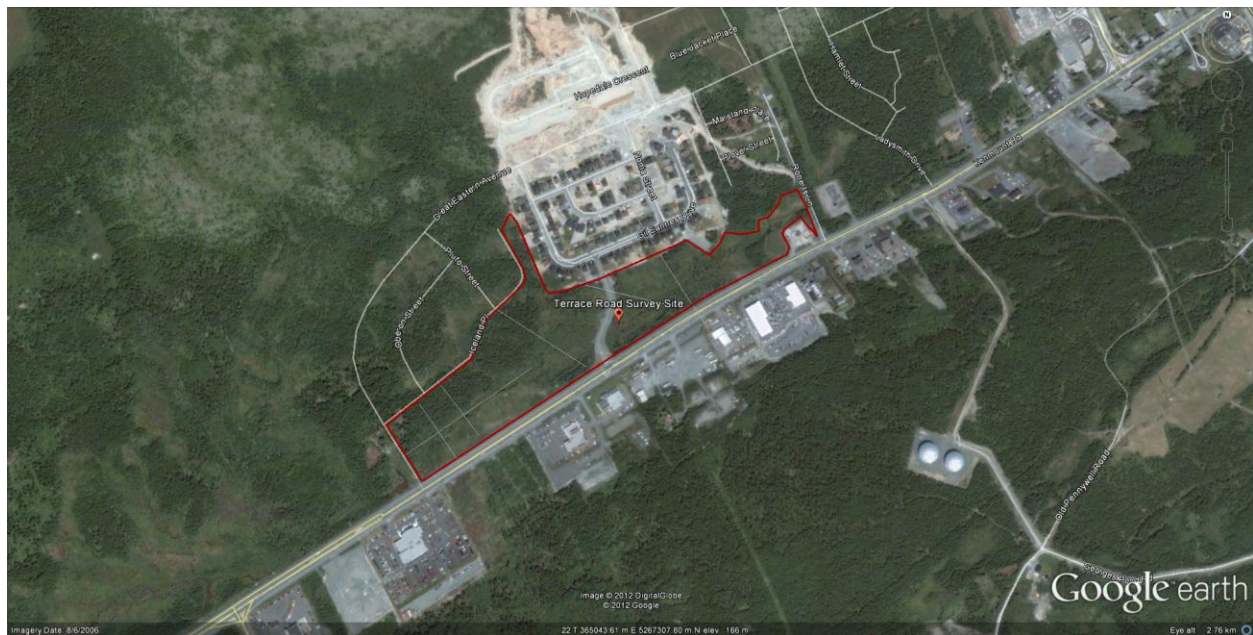
The Terrace Road wetland study site was located on the north side of Kenmount Road, St. John's. Terrace Road itself was indicated on the aerial images used to delineate the wetland site but did not exist as a road used for vehicles at the time of the wetland survey. It had been decommissioned, the asphalt removed and the land had been in a state of plant regrowth at the time of the site visit in 2011. Many roadways were indicated on the aerial images as an overlain layer and were not represented in the satellite image. The Terrace Road wetland study site was delineated based on developed and forest borders. Great Eastern Avenue, Iceland Place and the residential development on the south side of Gil Eannes Drive, Roberts Lane, and Kenmount Road formed the developed borders of the site.

Figure 6: Terrace Road Wetland study site with the boundary indicated in red. (St. John's. (2006, 6th August). 36_49 03.20E, 5 26_72 94.97N. Google Earth Image. [Accessed 10 April 2012]. Available from: <http://www.google.com/earth/index.html>).

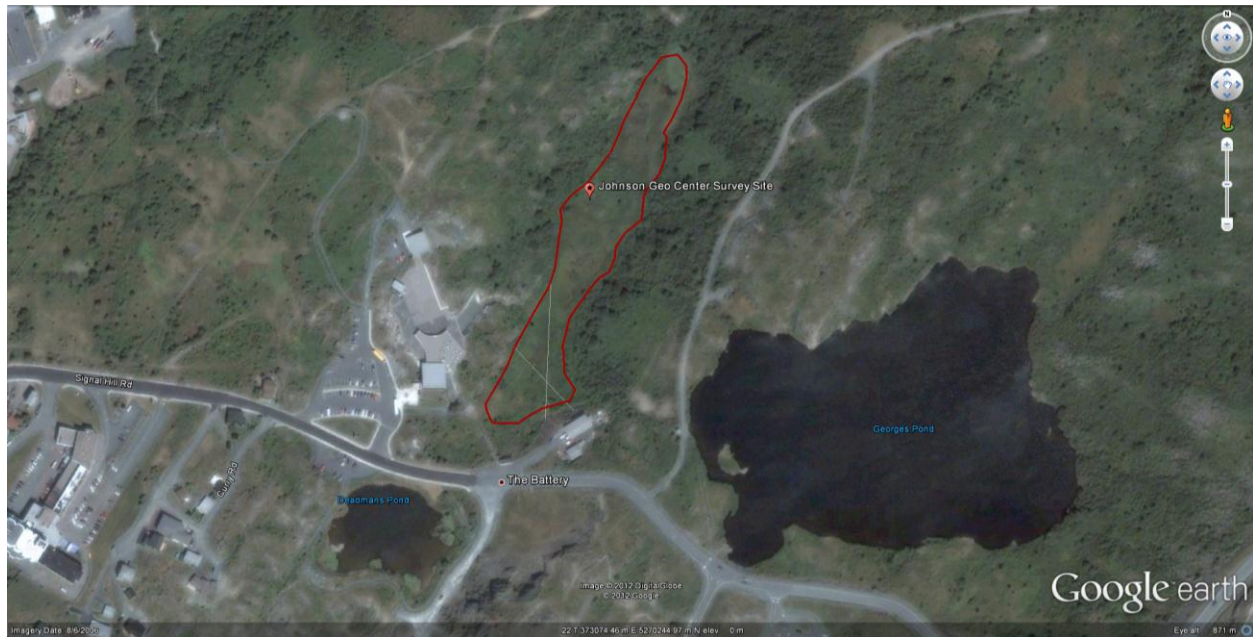
The Geo Centre wetland study site was located adjacent to the Johnson Geo Centre on Signal Hill Road in St. John's. This wetland occupied a depression in the land, with steep slopes on three sides, so the boundaries of this site were defined by topographic borders.

Figure 9: Johnson GEO CENTRE wetland study site with the boundary indicated in red. The thin grey lines are drawn from wetland boundary to areas of increased potential of impact from run off. (St. John's. (2006, 6th August). 37_30 74.46E, 5 27_02 44.97N. Google Earth Image. [Accessed 26 March 2012]. Available from: <http://www.google.com/earth/index.html>).

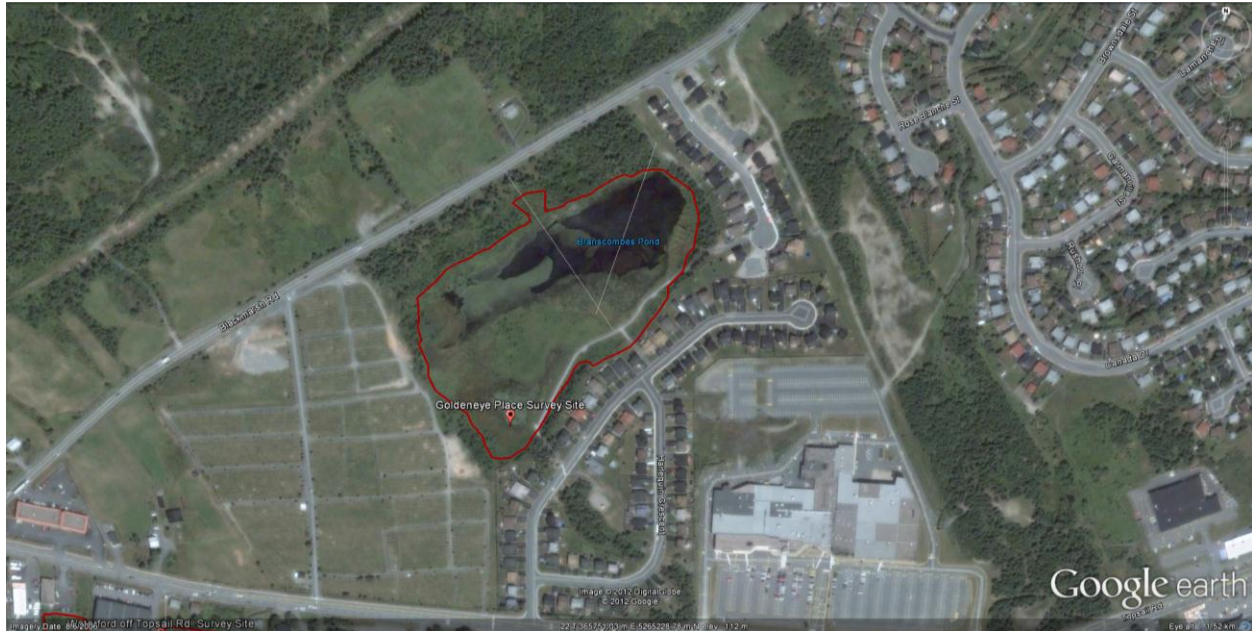
The Goldeneye Place wetland study site was located at Branscombes Pond in Mount Pearl. This pond was located east of the intersection of Blackmarsh Road and Topsail Road. The wetland study site was delineated using forest and developed borders. The residential development located on the north side of Goldeneye Place formed the developed border of the site.

Figure 11: Goldeneye Place Wetland study site with the boundary indicated in red. (Mount Pearl. (2006, 6th August). 36_57 51.03E, 5 26_52 28.78N. Google Earth Image. [Accessed 25 April 2012]. Available from: <http://www.google.com/earth/index.html>).

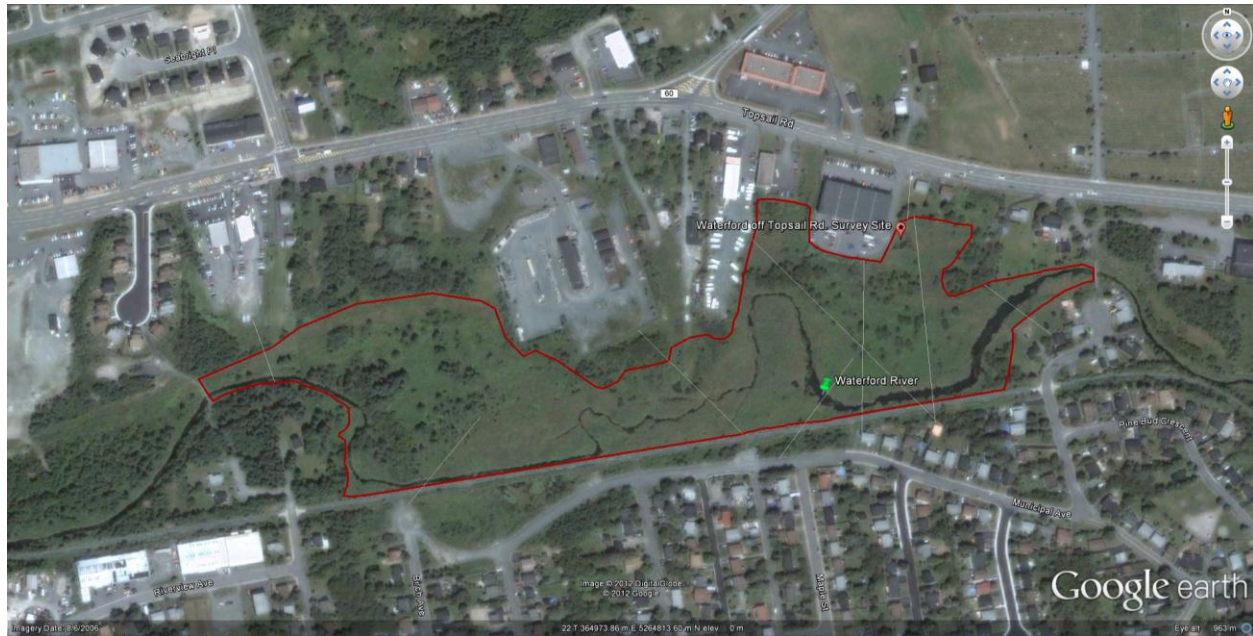
The Waterford River system covers a large area with many wetland type areas along its length. One wetland site visited for this project was located along the Waterford River behind Krown Automotive on Topsail Road. The Waterford River at Krown wetland study site was delineated based on development borders. The boundary of the surveyed wetland was marked by bridges that cross the Waterford River at the east and west ends of the site. There were commercial developments to the north of the wetland site, along Topsail Road.

Figure 12: Waterford River at Krown wetland study site with the boundary indicated in red. The thin grey lines are drawn from wetland boundary to areas of increased potential of impact from run off. (Mount Pearl. (2006, 6th August). 36_49 73.86E, 5 26_48 13.60N. Google Earth Image. [Accessed 26 March 2012]. Available from: <http://www.google.com/earth/index.html>).

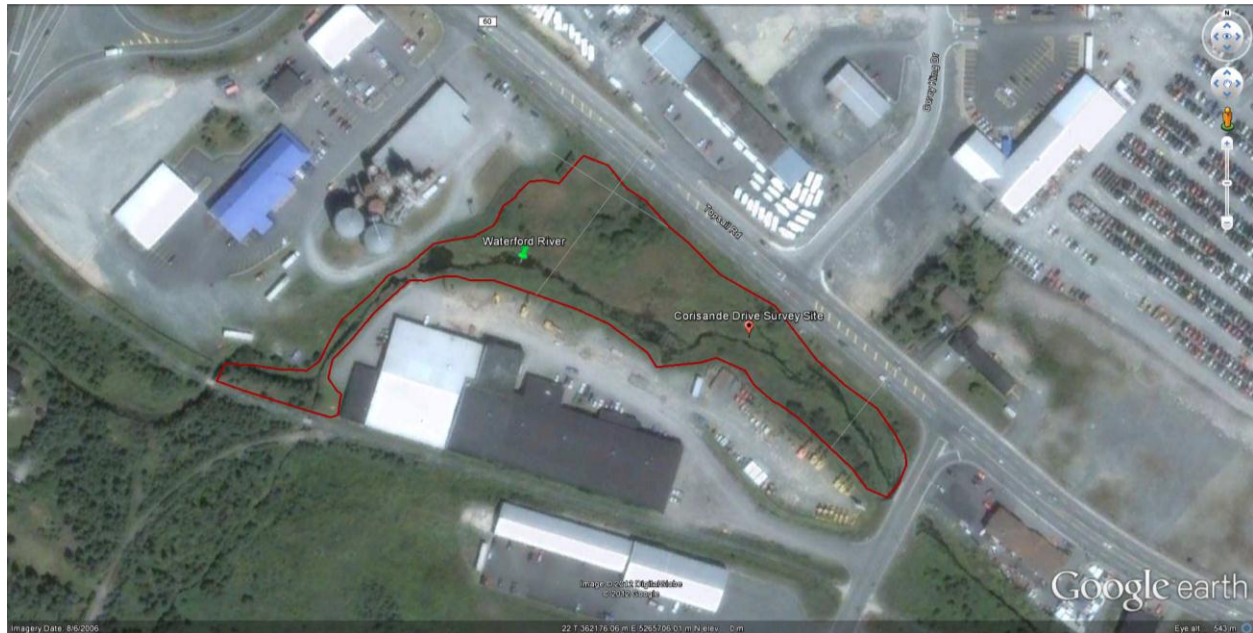
The Corisande Drive wetland site was located adjacent to the Waterford River at the corner of Topsail Road and Corisande Drive in Mount Pearl. This wetland site was delineated based on topographic and developed borders. The south boundary of the site was bordered by a large developed lot; the western side of the site is also bordered by a large development.

Figure 13: Corisande Drive wetland study site with the boundary indicated in red. The thin grey lines are drawn from wetland boundary to areas of increased potential of impact from runoff. (Mount Pearl. (2006, 6th August). 36_21 76.06E, 5 26_57 06.01N. Google Earth Image. [Accessed 26 March 2012]. Available from: <http://www.google.com/earth/index.html>).

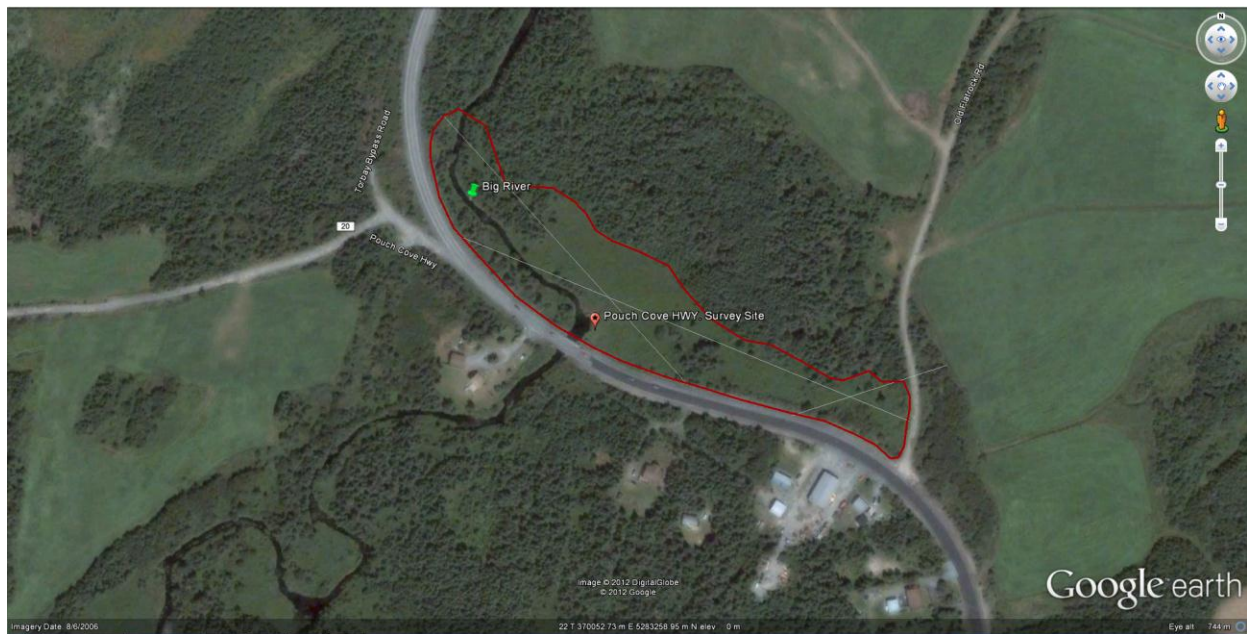
The Pouch Cove Highway site was located in Flatrock, north of Pouch Cove Highway and west of Old Flatrock Road. It was located to the east of Big River, which flows in a south to north. The Pouch Cove Highway wetland study site was delineated in Google Earth based on tree line and contiguous development. An area of dense trees marked the northern wetland boundary. The southern and eastern boundaries were marked by Pouch Cove Highway, a paved two lane road. Old Flatrock Road, a dirt or unmaintained roadway, formed the western boundary

Figure 14: Pouch Cove Highway wetland study site with the boundary indicated in red. The thin grey lines are drawn from wetland boundary to areas of increased potential of impact from run off. (Flatrock. (2006, 6th August). 37_00 52.73E, 5 28_32 58.95N. Google Earth Image. [Accessed 26 March 2012]. Available from: <http://www.google.com/earth/index.html>).

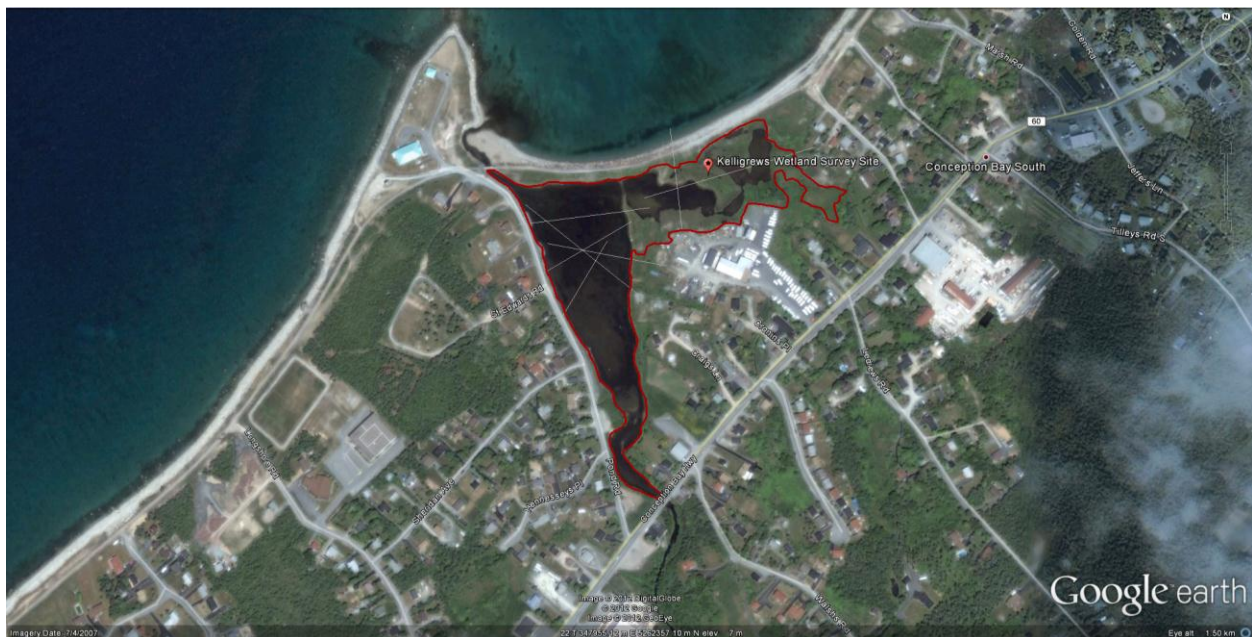
The Kelligrews wetland study site was located in Kelligrews, Conception Bay South near the coastline and adjacent to Kelligrews Pond. The Kelligrews wetland site was delineated based on developed borders, deep water pond borders, and visual clues of wetland boundary. Kelligrews Pond was included in the wetland boundary as it is hydrologically connected with the wetland. The southern border of the wetland was contiguous with a commercial lot. The western boundary was a deep water pond border. Northern and eastern boundaries were delineated based on the appearance of the land and vegetation. Conception Bay Highway formed a border where the Kelligrews River flowed under the Conception Bay Highway.

Figure 16: Kelligrews Wetland study site with the boundary indicated in red. (Conception Bay South. (2006, 6th August). 34_79 55.12E, 5 26_23 57.10N. Google Earth Image. [Accessed 25 April 2012]. Available from: <http://www.google.com/earth/index.html>).

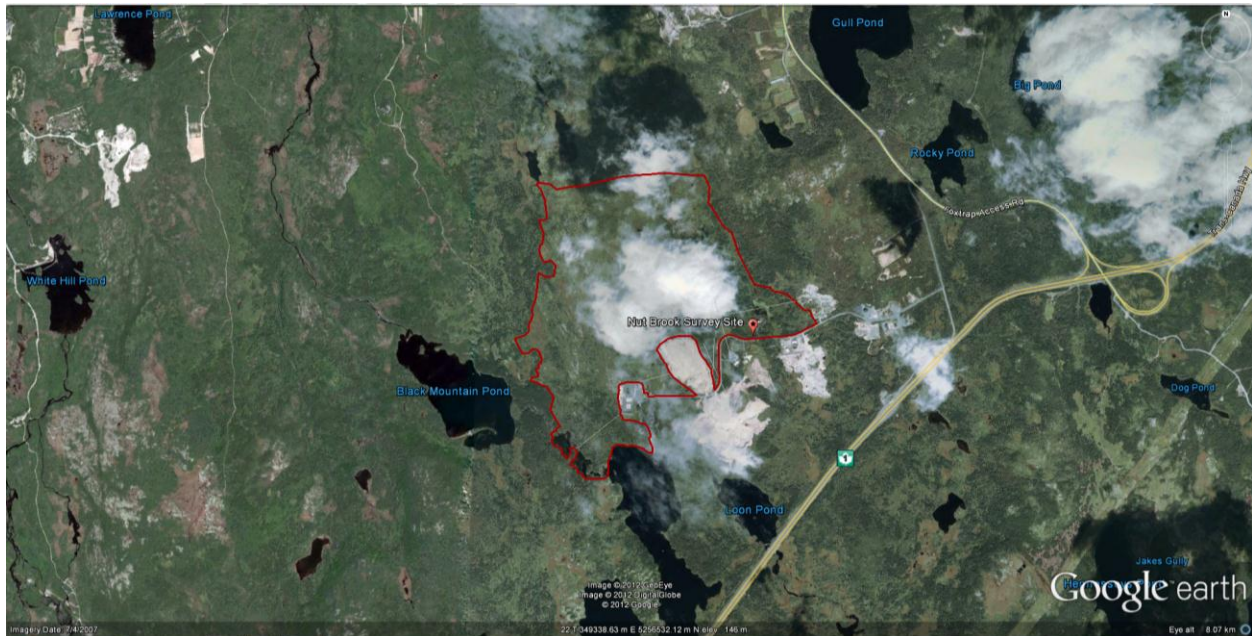
The Nut Brook wetland study site was located off Incinerator Road, St. John's. Due to limitations in the images used for site delineation because of cloud cover, the site was delineated based on forest, developed and deep water pond borders. It was recognized however, that Nut Brook, and associated wetland areas, extended beyond the study site boundaries. The southern border of the delineated site was mainly a developed border. Incinerator Road, and the industrial and commercial developments along this roadway, were contiguous to the wetland. A deep water pond border comprised a small portion of the southwest boundary. The remaining study site was delineated by a forest border.

Figure 20: Nut Brook Wetland study site with the border indicated in red. (St. John's. (2006, 6th August). (St. John's. (2006, 6th August). 34_93 38.63E, 5 25_65 32.12N. Google Earth Image. [Accessed 25 April 2012]. Available from: <http://www.google.com/earth/index.html>).

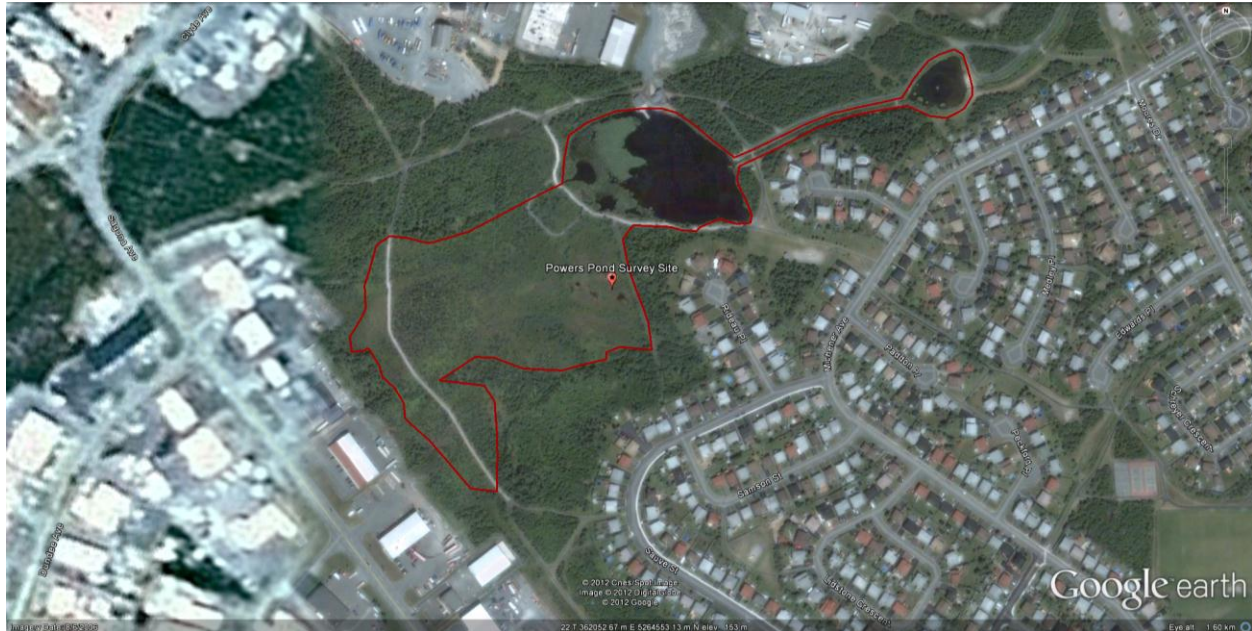
The Powers Pond wetland study site was located adjacent to Powers Pond, south of the Donovan's Industrial Park development in Mount Pearl. Water flows from Powers Pond to the northeast into the Waterford River. The site was delineated to include two bodies of water that are hydrologically connected to the wetland site. Forest borders were used to delineate the western boundary of the site.

Figure 21: Powers Pond Wetland study site with the boundary indicated in red. (Mount Pearl. (2006, 6th August). 36_20 52.67E, 5 26_45 53.13N. Google Earth Image. [Accessed 25 April 2012]. Available from: <http://www.google.com/earth/index.html>).
