# **An Examination of the Barachois Pond Ecosystems on the Northeast Avalon Peninsula of Newfoundland and Labrador**

**March 2013**

**Phoebe Metcalfe (BSc., ADWQ)**  
*NAACAP Environmental Technologist*

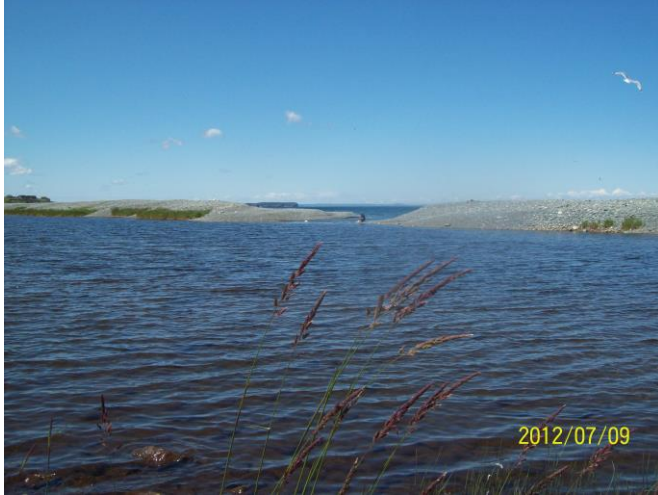
Figure A1. Looking towards the barrier and the breach in the barrier from the northeast shore of Topsail Bight.

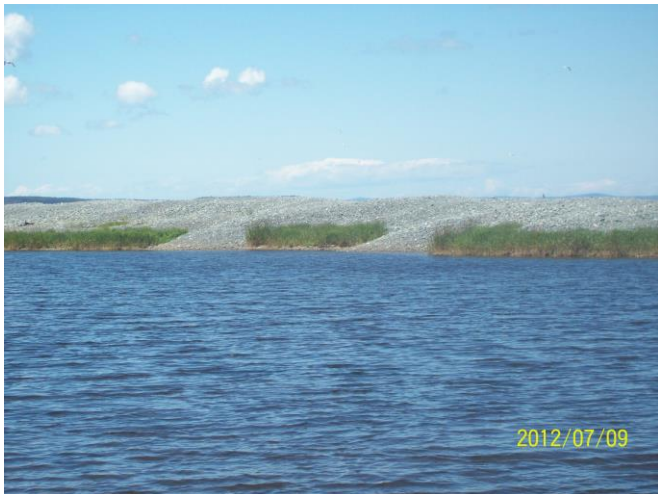
Figure A2. View of the barrier to the west of the breach site taken from the northeastern shore of Topsail Bight. There is a belt of vegetation towards the bottom of the barrier, with breaks in it that could demonstrate past barrier over wash events

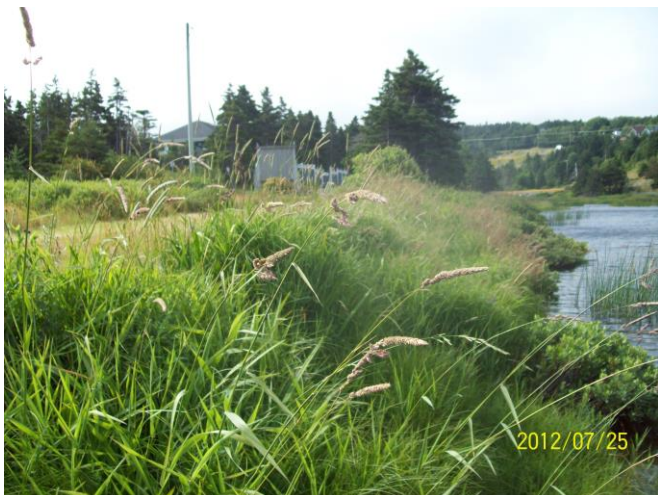
Figure A3. Shoreline vegetation along the eastern shore, looking south from northeastward. Trees, shrubs, grasses and other herbaceous plant types present.

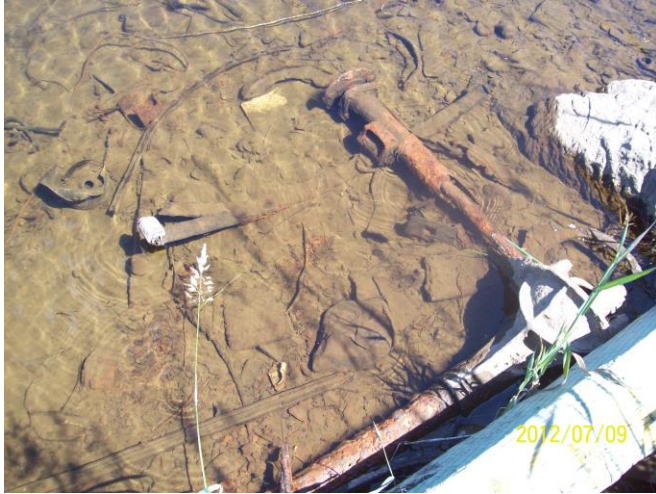
Figure A4. Some of the debris found in the northwest corner of Topsail Bight.

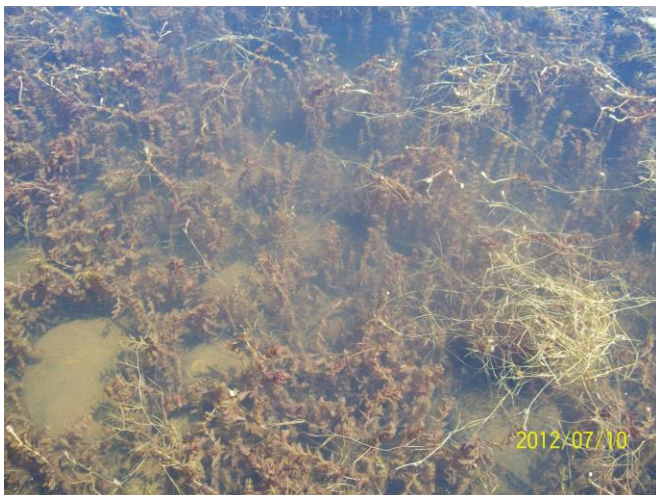
Figure A6. Dense growth of pondweed, taken from the northeast corner of Chamberlains Pond.

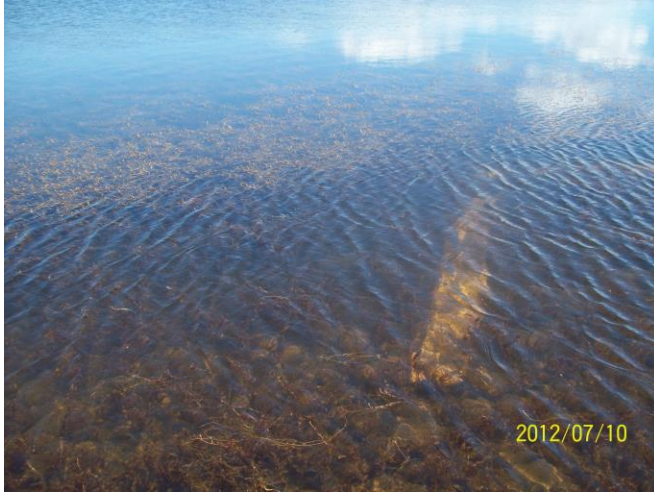
Figure A7. An example of debris, in this case vinyl siding, found in the water along the western shoreline of Chamberlains Pond.

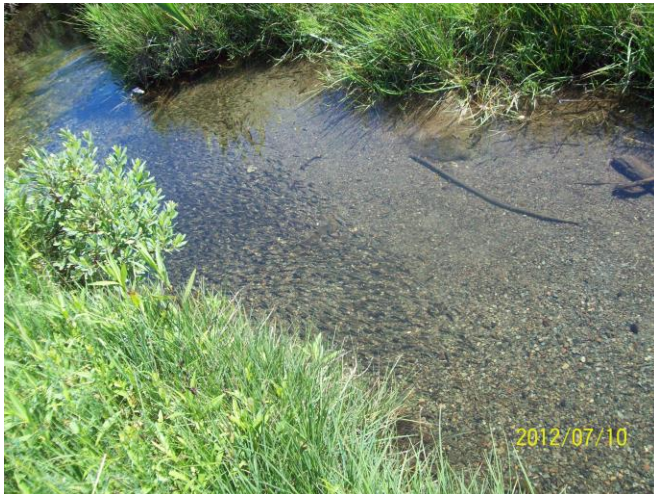
Figure A8. Photo taken of a school of fish at the mouth of Fowlers River where it enters Chamberlains Pond.

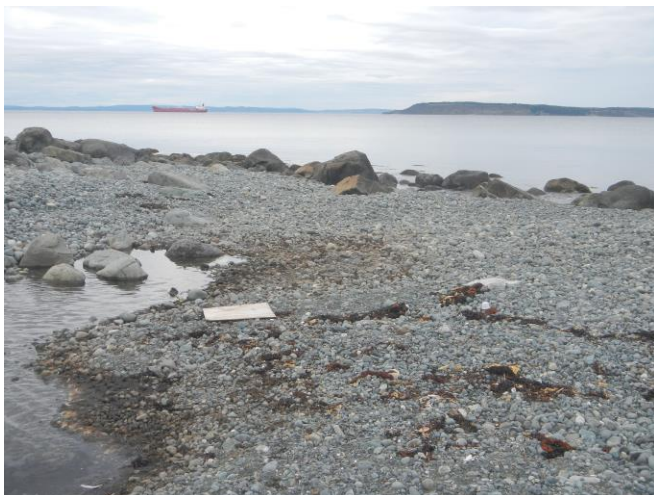
Figure A9. Photo taken of the area of the barrier breach at Bubble Pond. There was flow from the lagoon into the bay early in the summer, but later in the summer, as illustrated in the photo, the flow was cut off before reaching the bay.

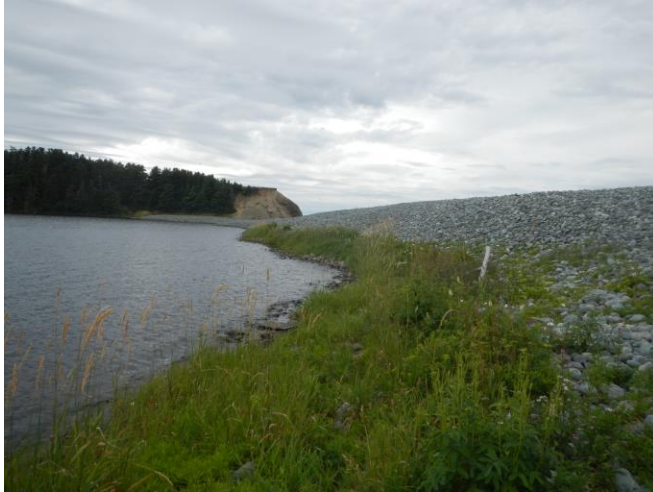
Figure A10. Looking west across the lagoonal side of the barrier at Bubble Pond from the eastern most end of the barrier. Note the continuous patch of vegetation near the water.

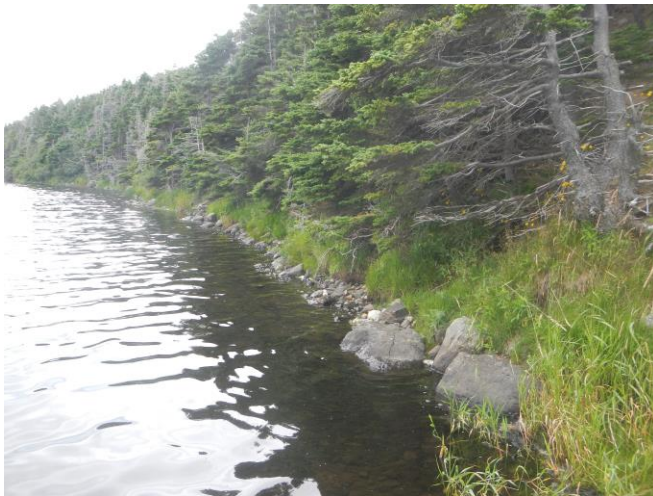
Figure A11. Looking southward along the western shoreline of Bubble Pond. Shoreline vegetation included coniferous trees and herbaceous plants

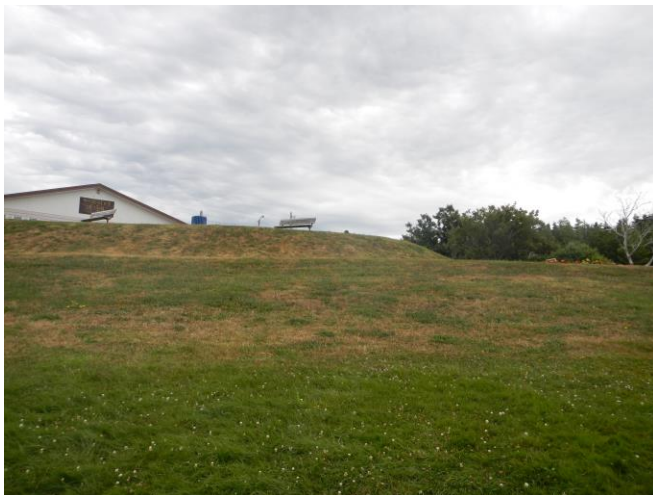
Figure A12. Worsely Park as viewed from the water's edge on the eastern shore of Bubble Pond.

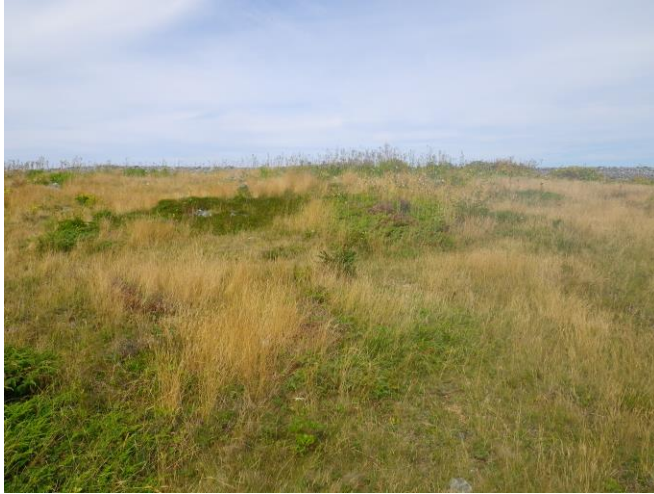
Figure A13. Vegetation located on the lagoonal side of the barrier at Long Pond, just to the west of Burnt Island.

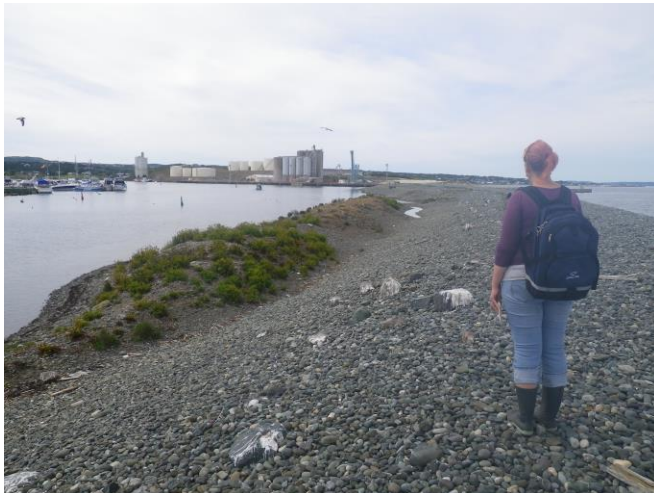
Figure A14. Hummock- like area located towards the western end of the barrier at Long Pond. The hummock area was vegetated more densely than the rest of the barrier adjacent to it was.

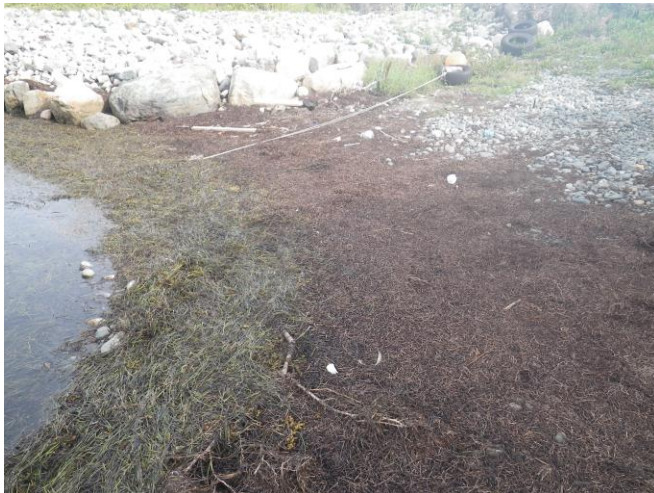
Figure A15. Photo taken from the northeast corner of Long Pond, at the end of Atkins Road. The large amounts of eel grass washed up on the shoreline were evidence that it grows in the pond, although none was located while doing nearshore aquatic vegetation surveys.

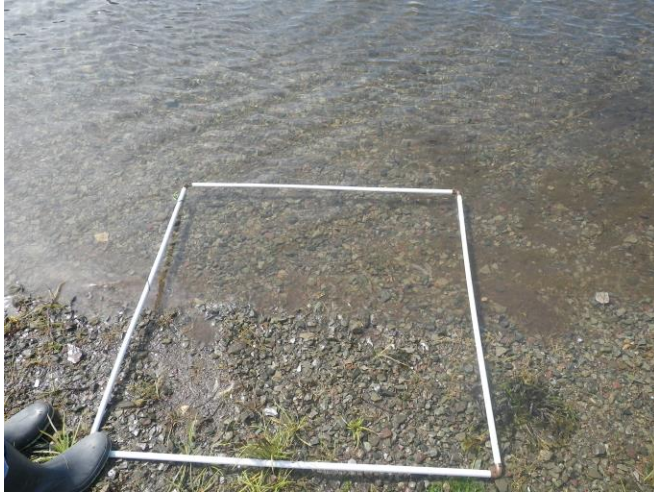
Figure A16. Quadrat placed at the water's edge for aquatic plant sampling in Long Pond, at the end of Perrins Road. This photo illustrates the rapid change in water levels. The shore edge of the one meter quadrat was placed at the water's edge, in seconds the water level had receded approximately half a meter.

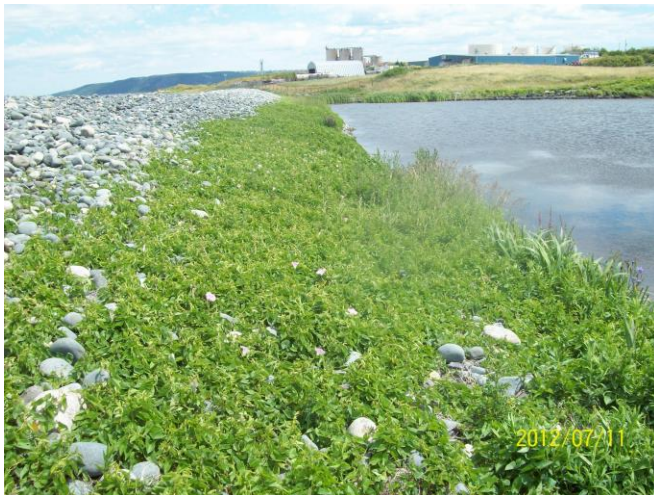
Figure A17. Barrier vegetation at Paddys Pond, looking from the western corner towards the east. Vegetation consisted mainly of morning glory.

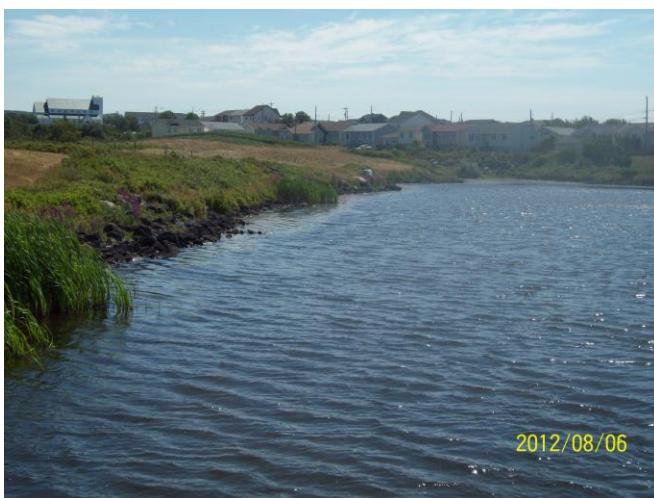
Figure A18. Looking southward along the eastern shore of Paddys Pond from the northeast corner. The eastern shore was bordered by agricultural areas, and there were houses to the southwest.

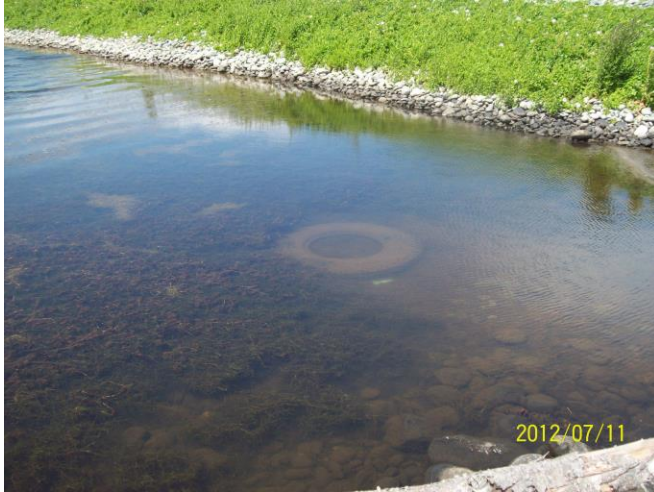
Figure A19. Photo taken of the northeast corner of Paddys Pond. Tire located in the water. In the background is the barrier and it's vegetation.

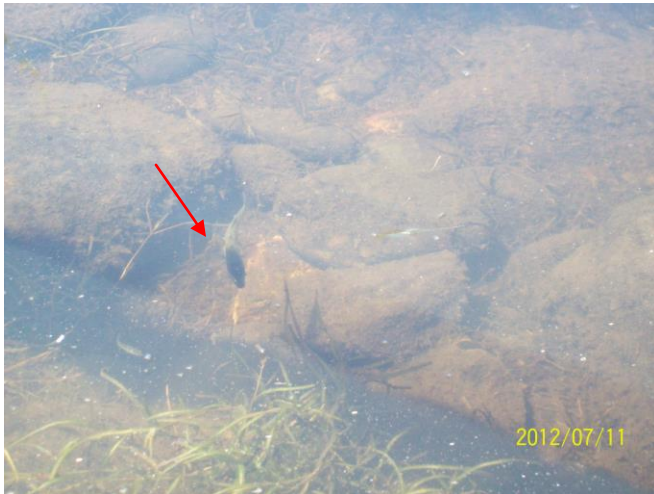
Figure A20. Fish observed in the northeast corner of Paddys Pond. An arrow has been drawn to a fish in this photo to make it's location more visible.

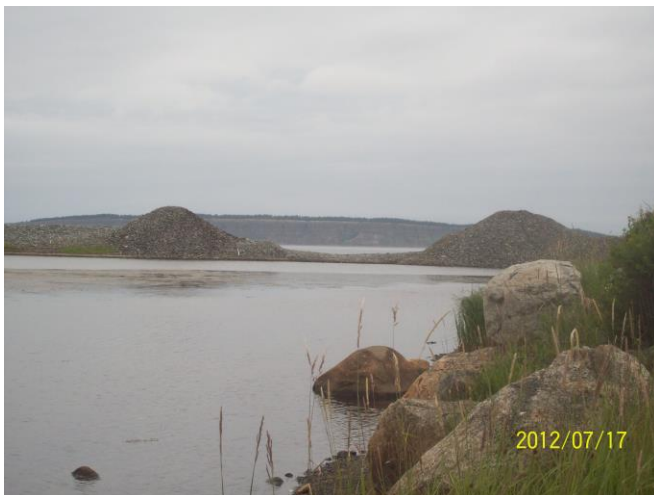
Figure A21. Photo taken from the eastern shore of Butlers Pond, looking at the location on the barrier where there likely was a past man made breach, as evidenced by the mounds of gravel.

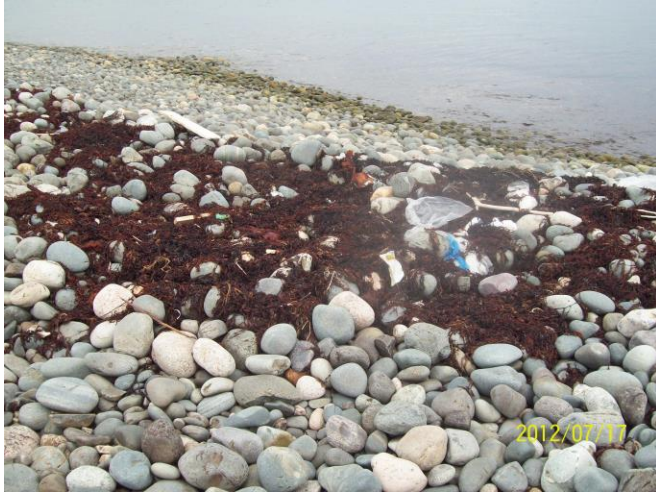
Figure A22. Debris and seaweed washed up on the barrier at the location of the past artificial breach at Butlers Pond. This photo was taken standing at the edge of the water in the lagoon facing the bay.

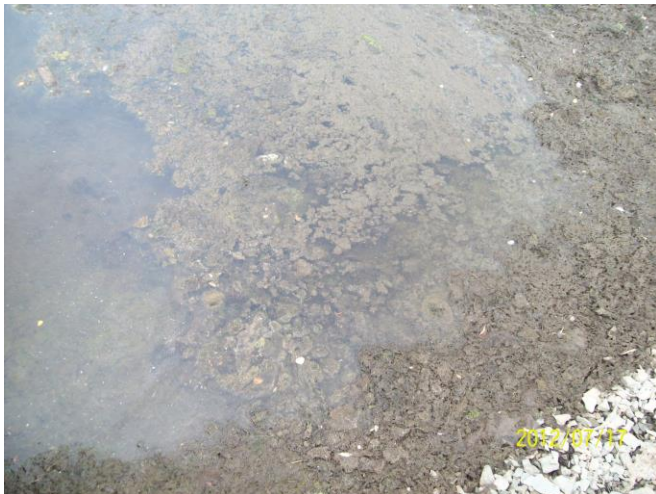
Figure A23. Brown scum- like material that was found throughout Butlers Pond. This photo was taken in the northeast corner of Butlers Pond.

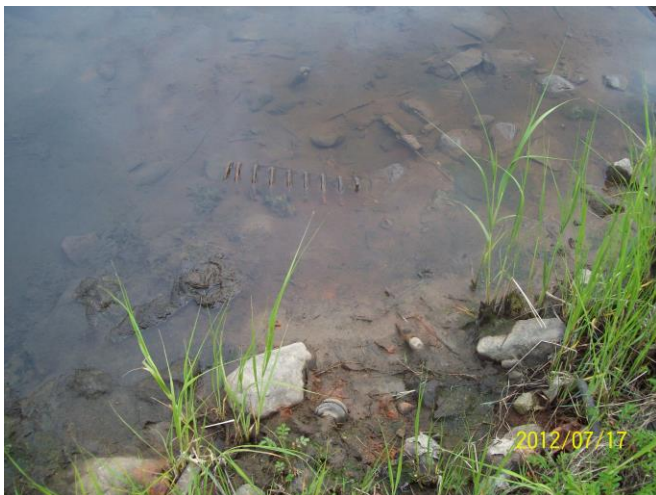
Figure A24. Metal debris located in the northwest corner of Butlers Pond.

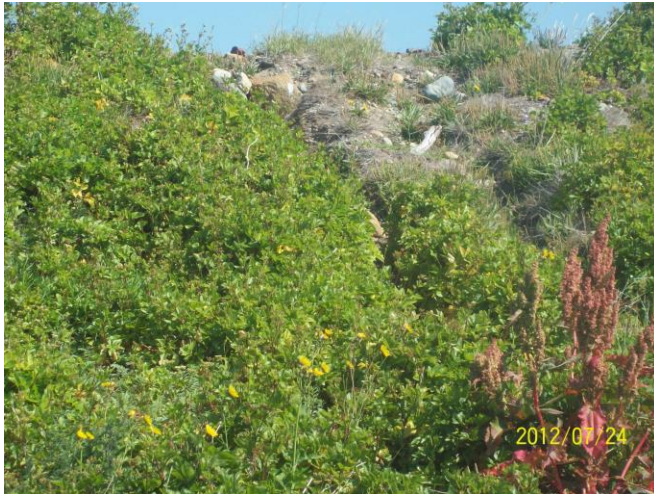
Figure A25. Erosion along the lagoonal side of the barrier at Kelligrews Pond. The old railway track is located at the top of the barrier in this photo.

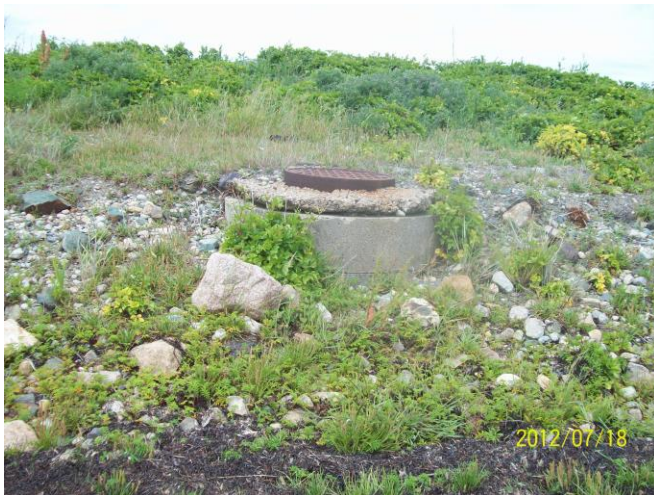
Figure A26. Manhole located on the lagoonal side of the barrier at Kelligrews Pond, evidence of the sewer main passing along there.

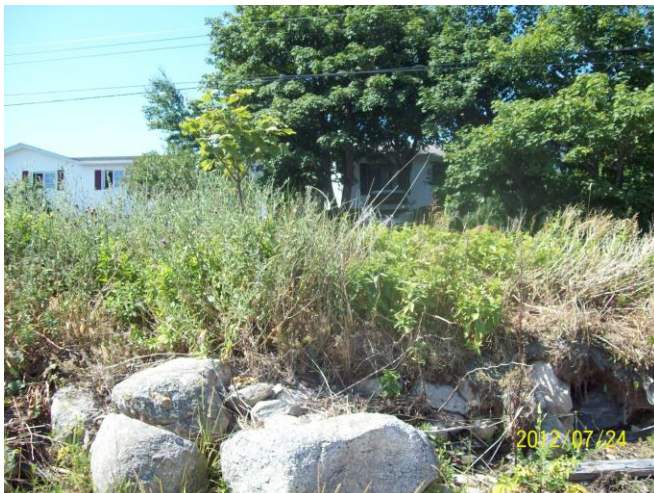
Figure A27. Shoreline erosion along the western shore of Kelligrews Pond. At the top of the bank is Pond Road.

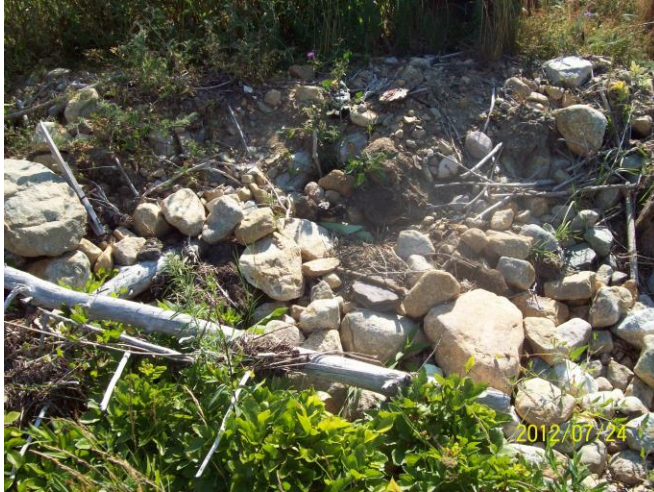
Figure A28. Erosion along the eastern shoreline of Kelligrews Pond.

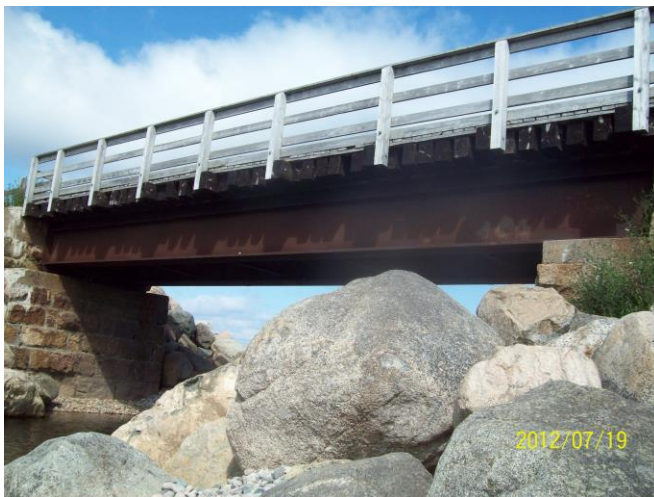
Figure A29. The railway trestle that runs over the barrier breach at Lower Gully Pond, viewed from the lagoon side.

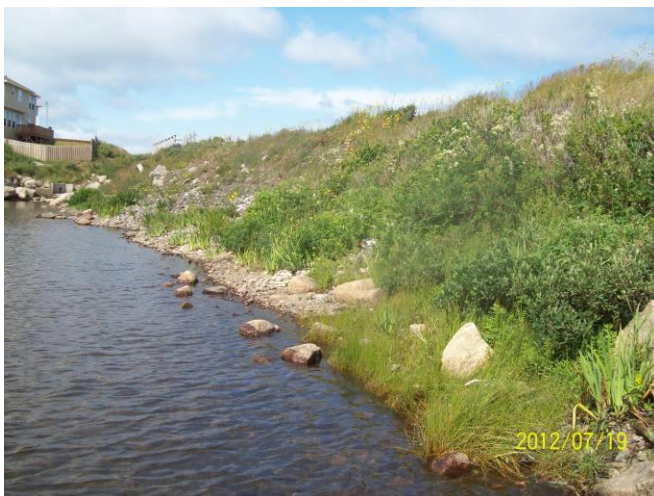
Figure A30. Looking west along the lagoonal side of the barrier at Lower Gully Pond from the east. The barrier vegetation was similar to the shoreline vegetation elsewhere around the lagoon.

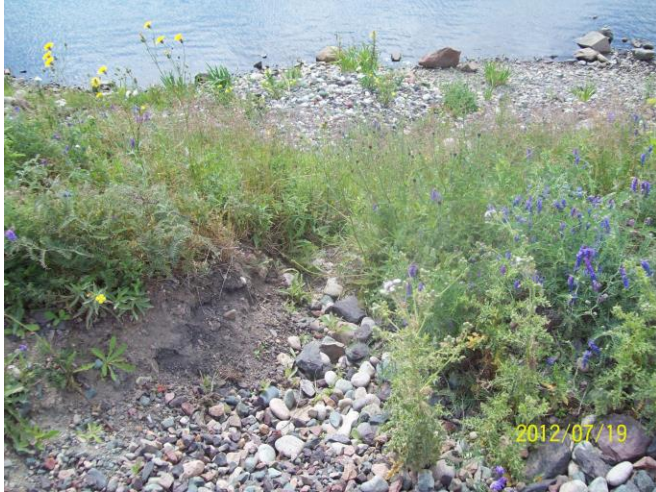
Figure A31. Erosion on the lagoonal side of the barrier at Lower Gully Pond. Photo taken from the old railway track at the top of the barrier.

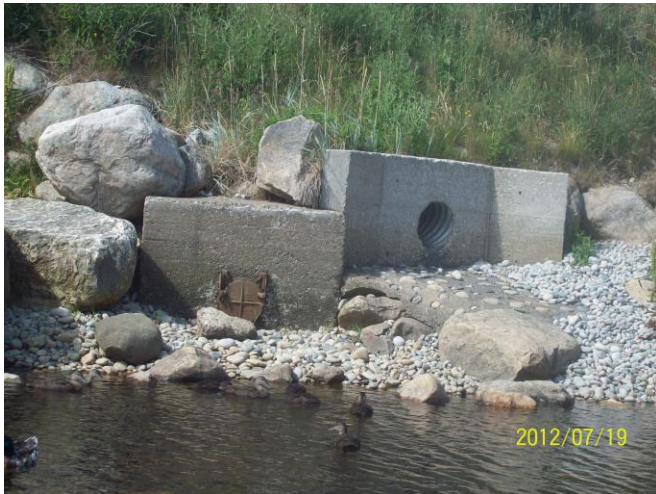
Figure A32. Lift station overflow and storm water outflows located on the northwest shore of Lower Gully Pond.

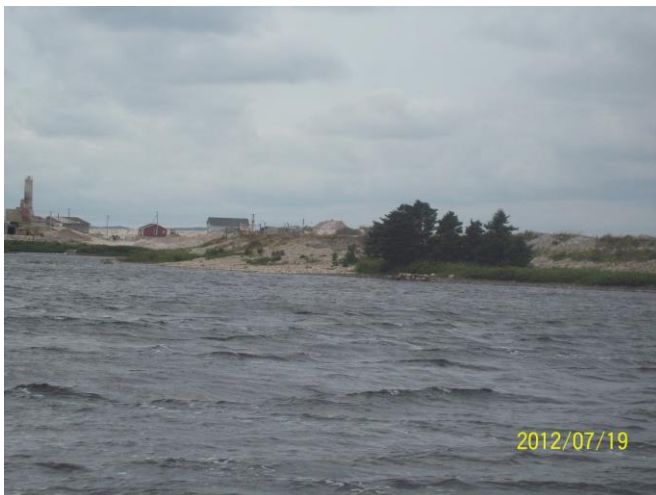
Figure A33. Photo looking northwestward towards the lagoonal side of the barrier at Lance Cove Pond, taken from the eastern shore. Barrier vegetation included coniferous trees and herbaceous plant types.

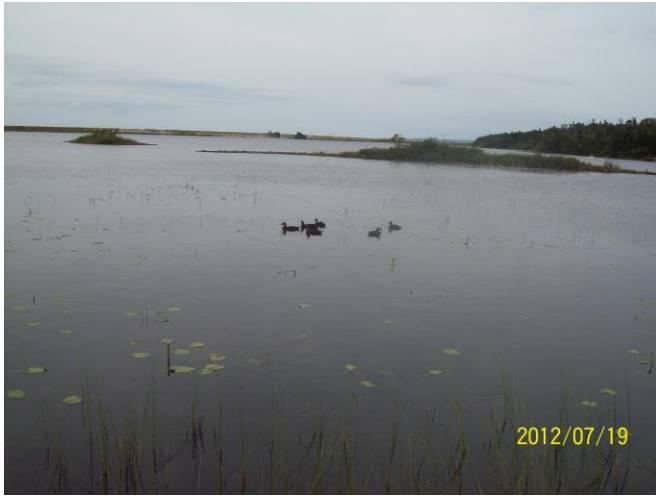
Figure A34. Photo, taken from the southern end of Lance Cove Pond, looking north. Lily pads were present in the water at the southern end of the pond.

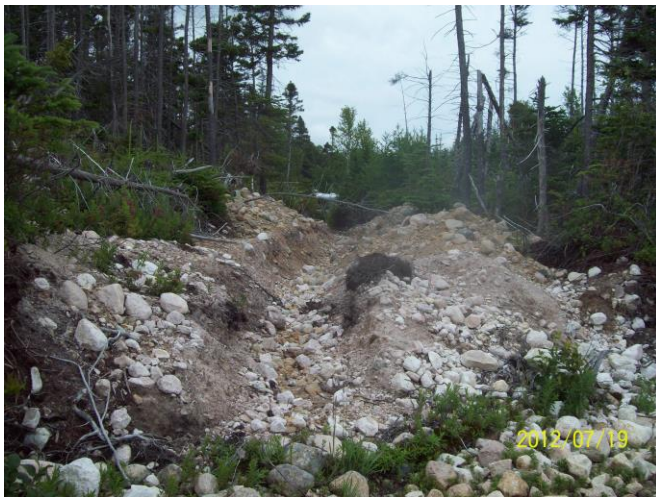
Figure A35. Disturbed area, possibly for drainage, located on the eastern shore of Lance Cove Pond

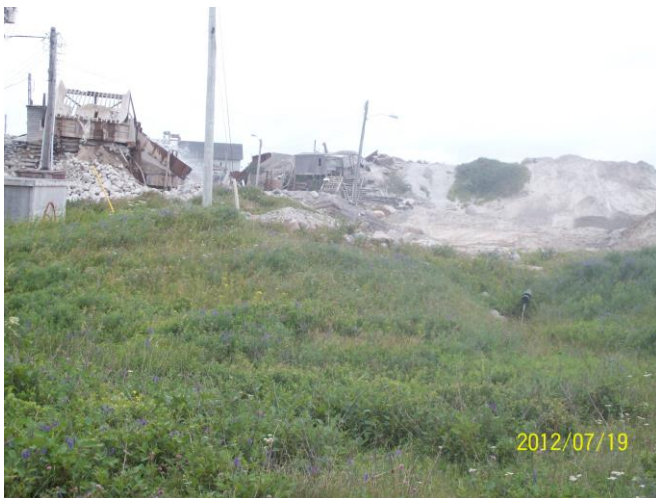
Figure A36. Photo, taken from the northwest corner of Lance Cove Pond, of the quarry located at the end of Lance Cove Road. The screen at the left of the photo had water running over it, likely for dust control. The water ran off the screen and to the right, where it was directed to the pipe with water flowing out of it, located to the middle right of the photo

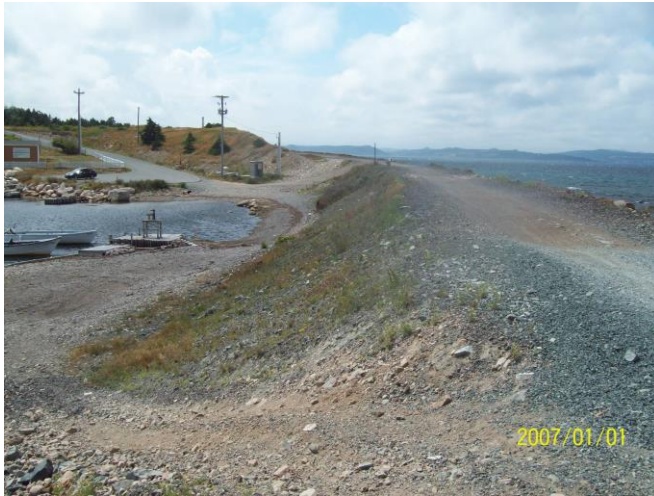
Figure A37. Looking southward along the barrier at Seal Cove Pond. The old railway track runs along the top of the barrier, and the slope on the lagoonal side is steep, with a flattening before the water's edge. The barrier breach and the trestle are behind the photographer.

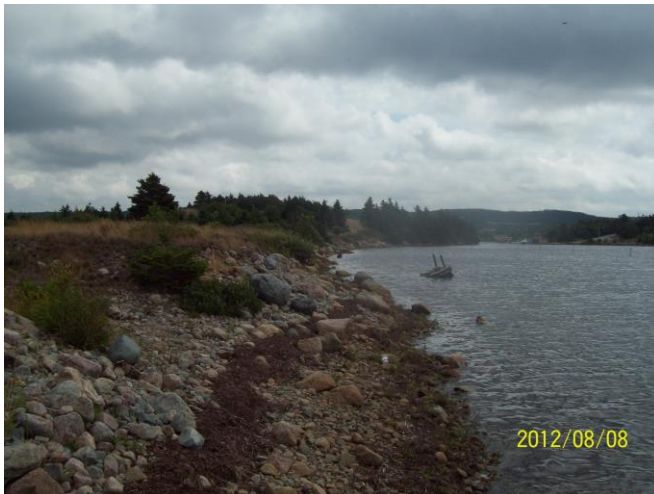
Figure A38. Section of the northern shoreline at Seal Cove Pond, looking east. The area in the foreground contained less shoreline vegetation

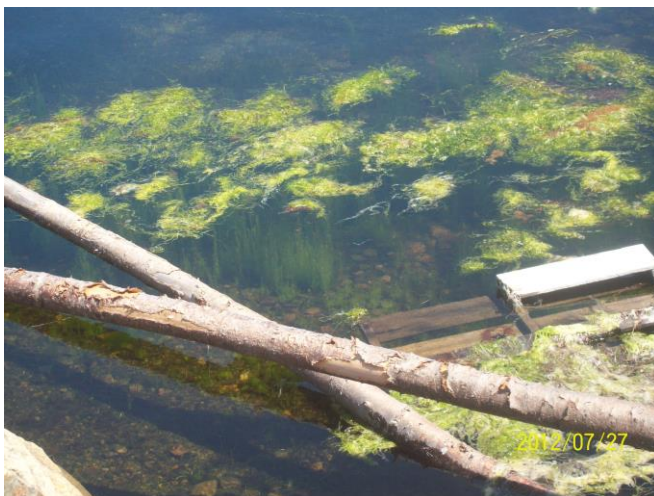
Figure A39. *Ulva intestinalis* observed in the southwest portion of Seal Cove Pond.

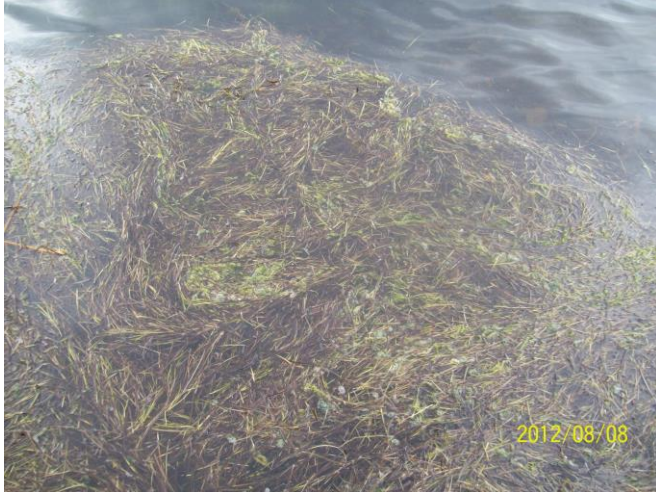
Figure A40. Eel grass washed up near the northern shore of Seal Cove Pond

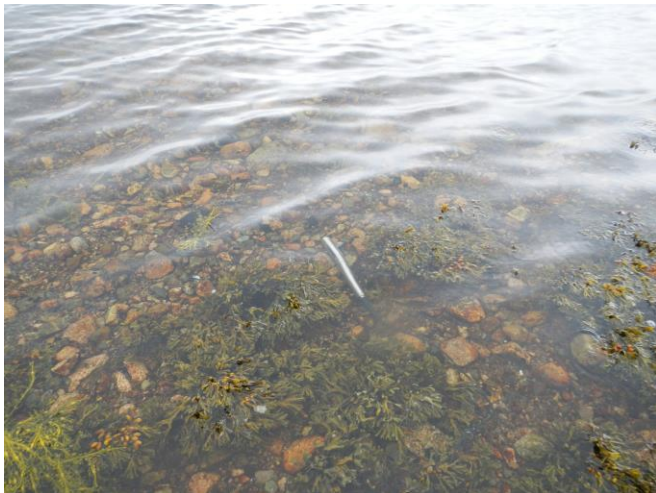
Figure A41. Rockweed and knotted wrack located along the eastern shore of Indian Pond

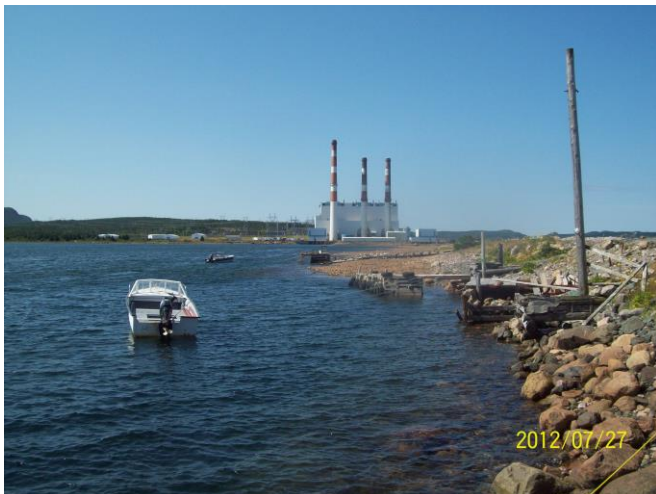
Figure A42. Looking southwest from near the northeast corner of Indian Pond. The hydro generating plant is located in the background. The shoreline in the left of the photo is the barrier. Also, small wharves and boats located in the area are shown in the photo.

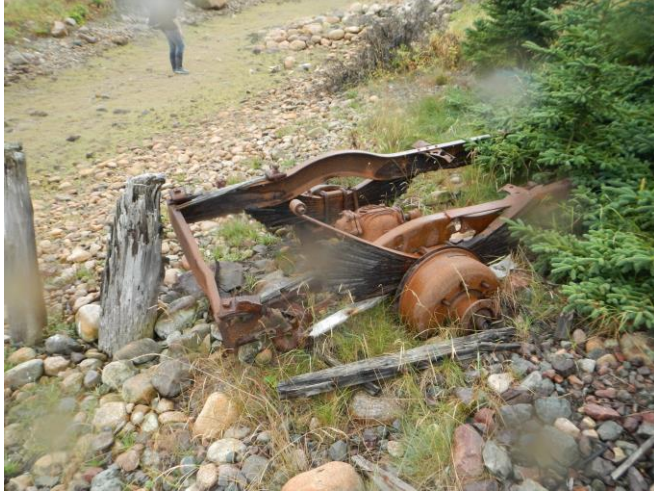
Figure A43. Debris, possibly a relic of the old railway, located along the barrier at Indian Pond.

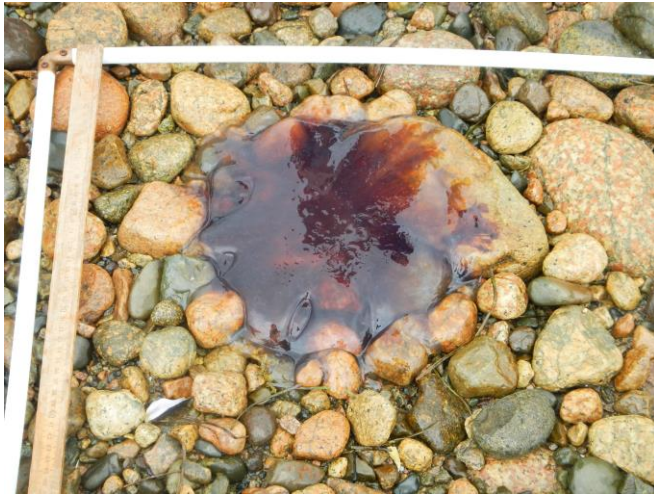
Figure A44. Large jellyfish washed up along the barrier at Indian Pond.

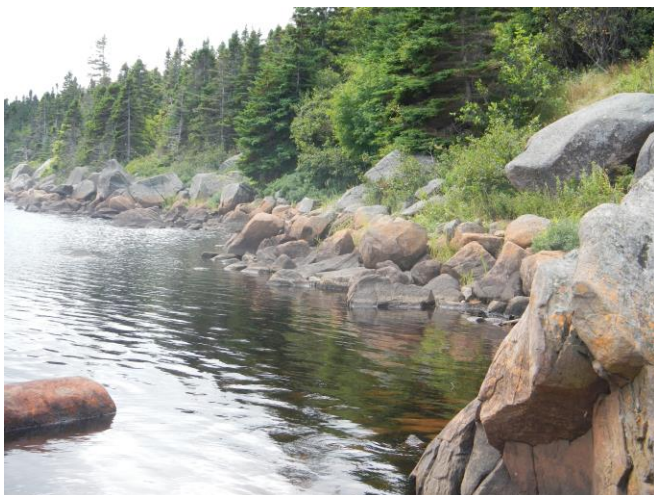
Figure A45. Western shore of Freshwater Bay Pond as seen from the northwest corner. Shoreline vegetation included coniferous trees and shrubs. The color variations on the rocks along the water's edge are indicators of low waters during the summer of 2012.

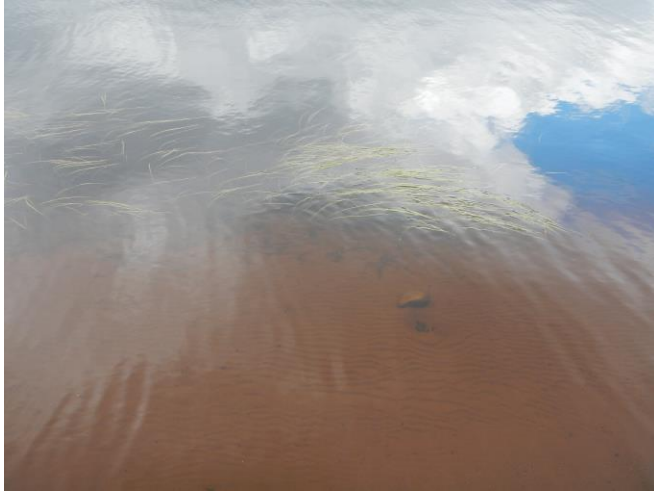
Figure A46. Aquatic vegetation observed in Freshwater Bay Pond midway along the barrier.

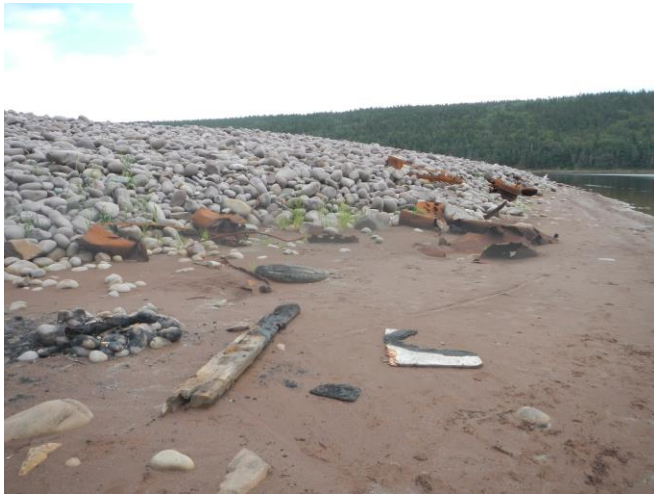
Figure A47. Metal debris and campfire remnants found in the northwestern corner of Freshwater Bay Pond.

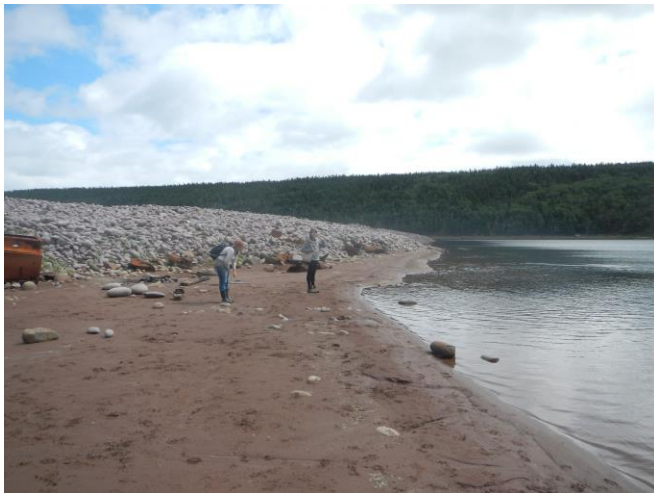
Figure A48. Looking east from the northwest corner of Freshwater Bay Pond. The sandy shoreline on the lagoonal side of the barrier would likely be underwater if summer weather included more precipitation.

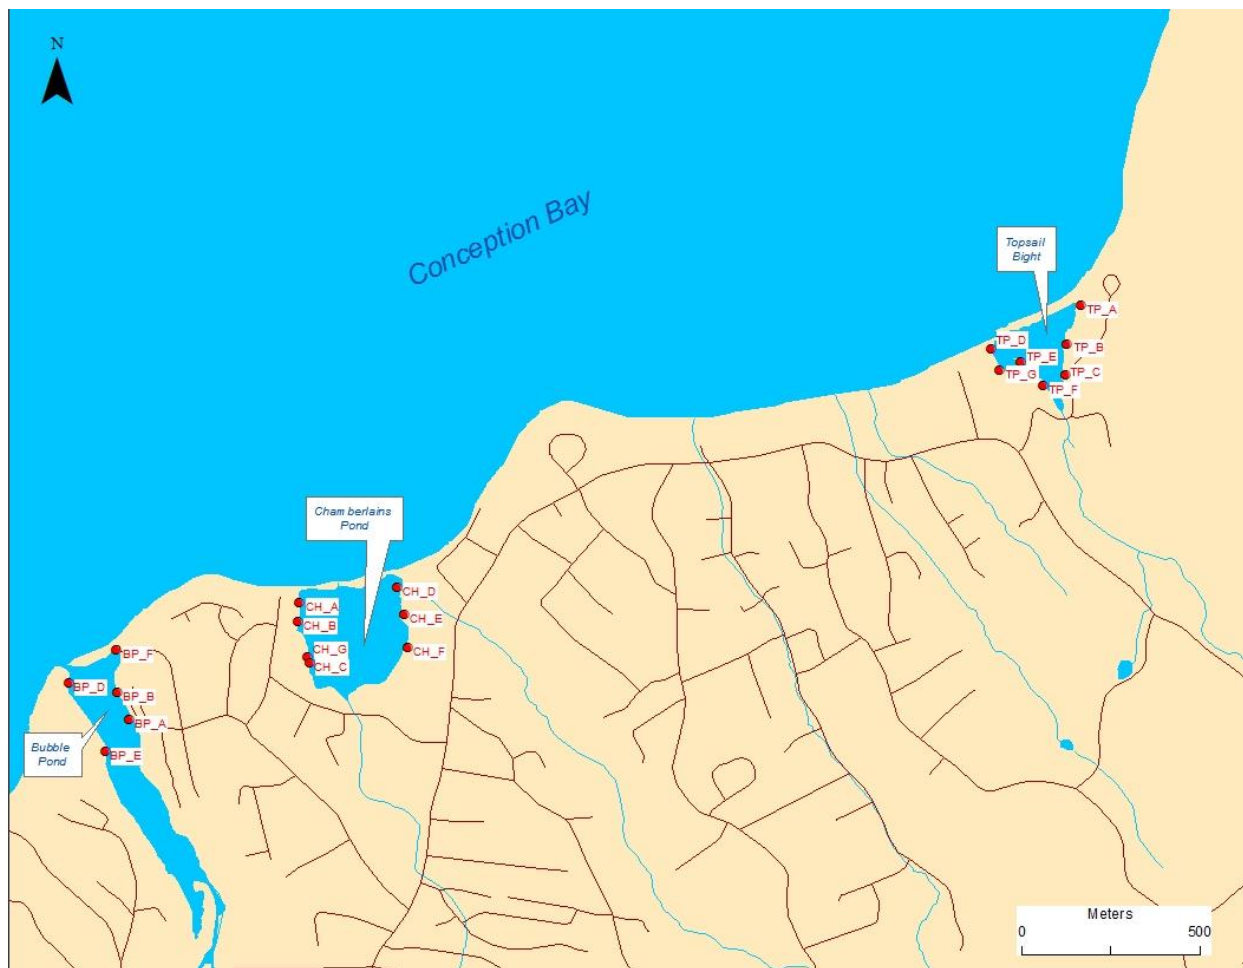
Figure B1. Sample locations in Topsail Bight, Chamberlains Pond, and Bubble Pond.

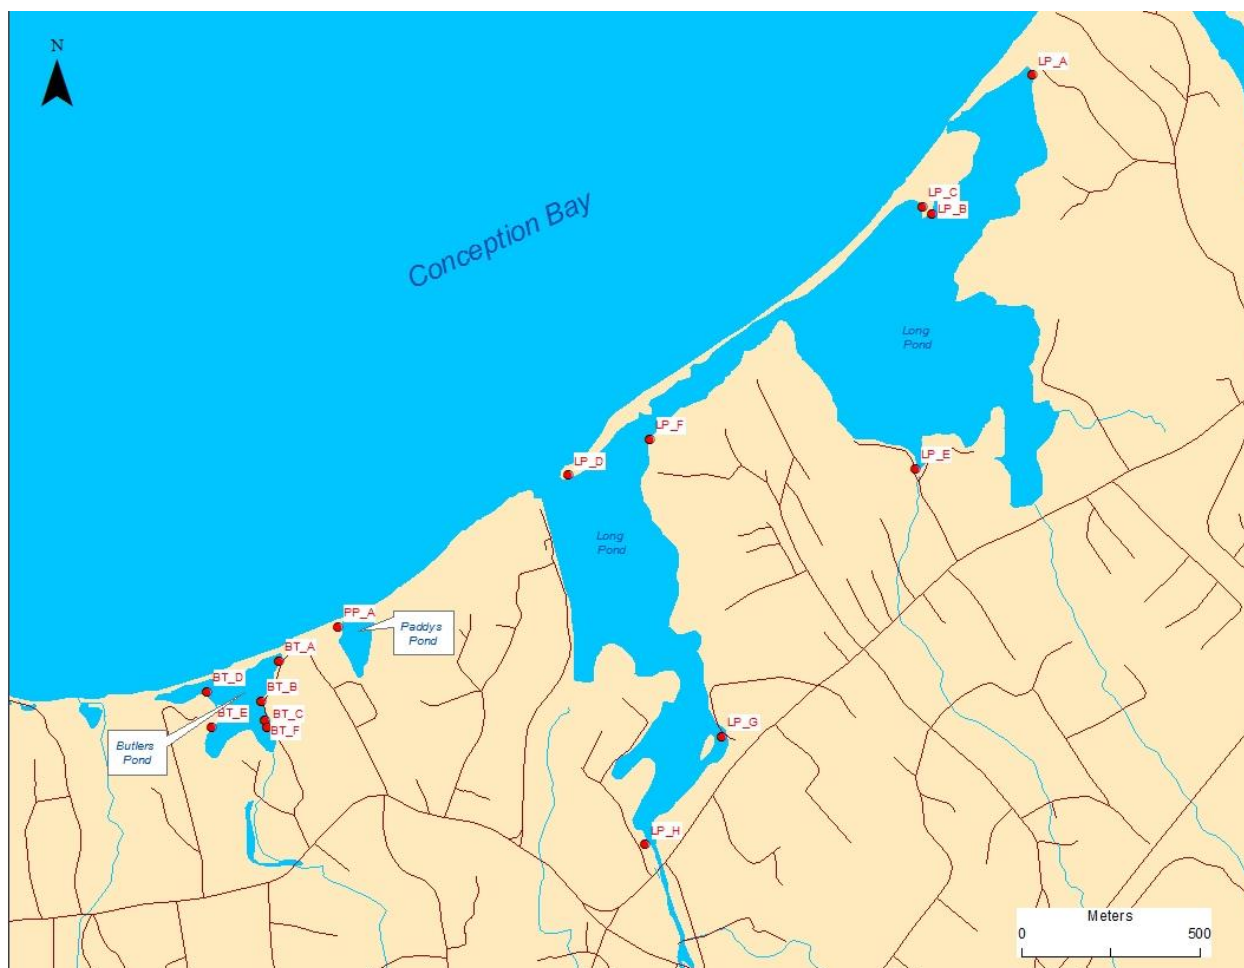
Figure B2. Sample Site locations for Long Pond, Paddys Pond, and Butlers Pond.

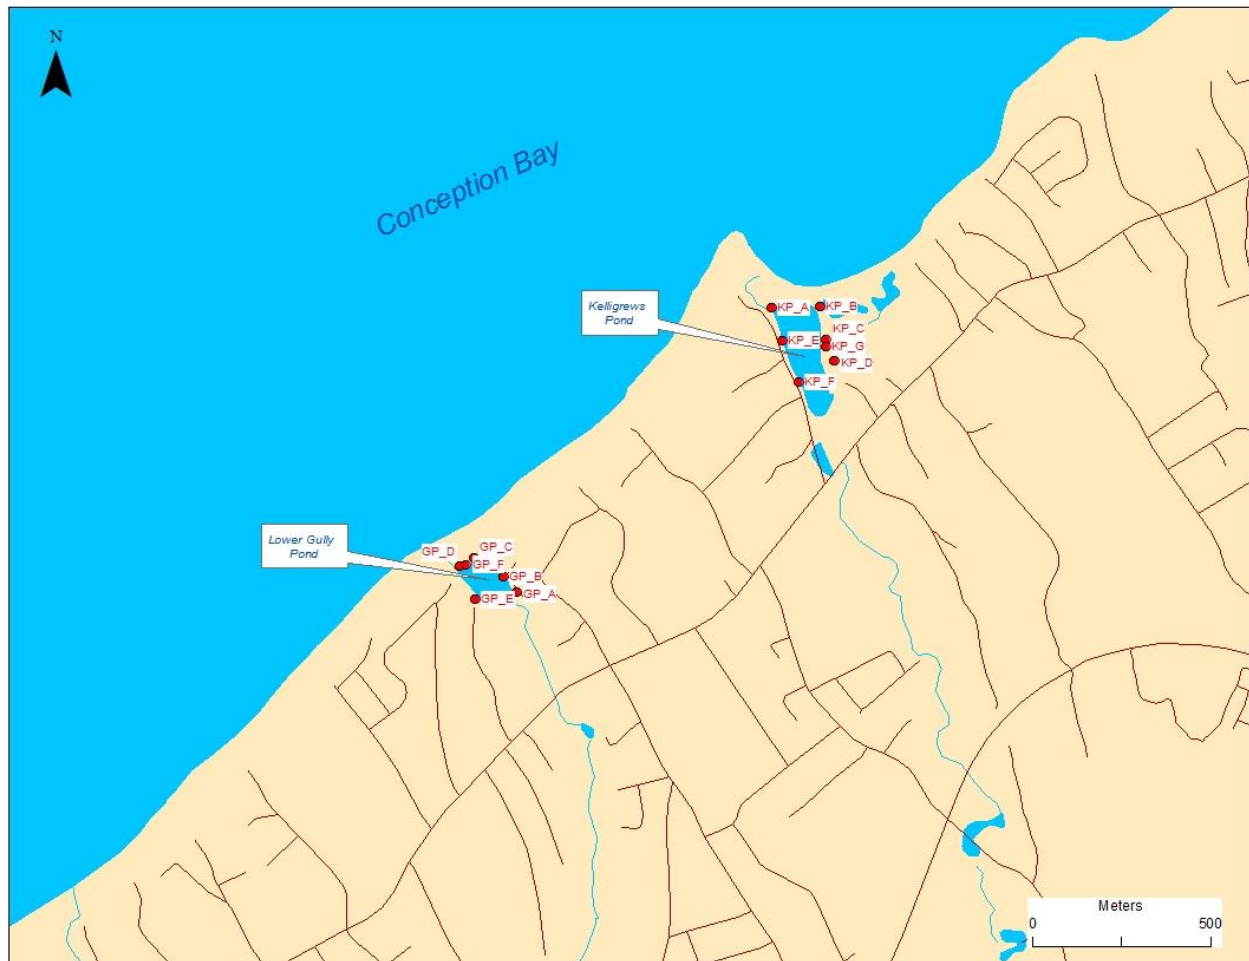
Figure B3. Sample site locations for Kelligrews Pond and Lower Gully Pond.

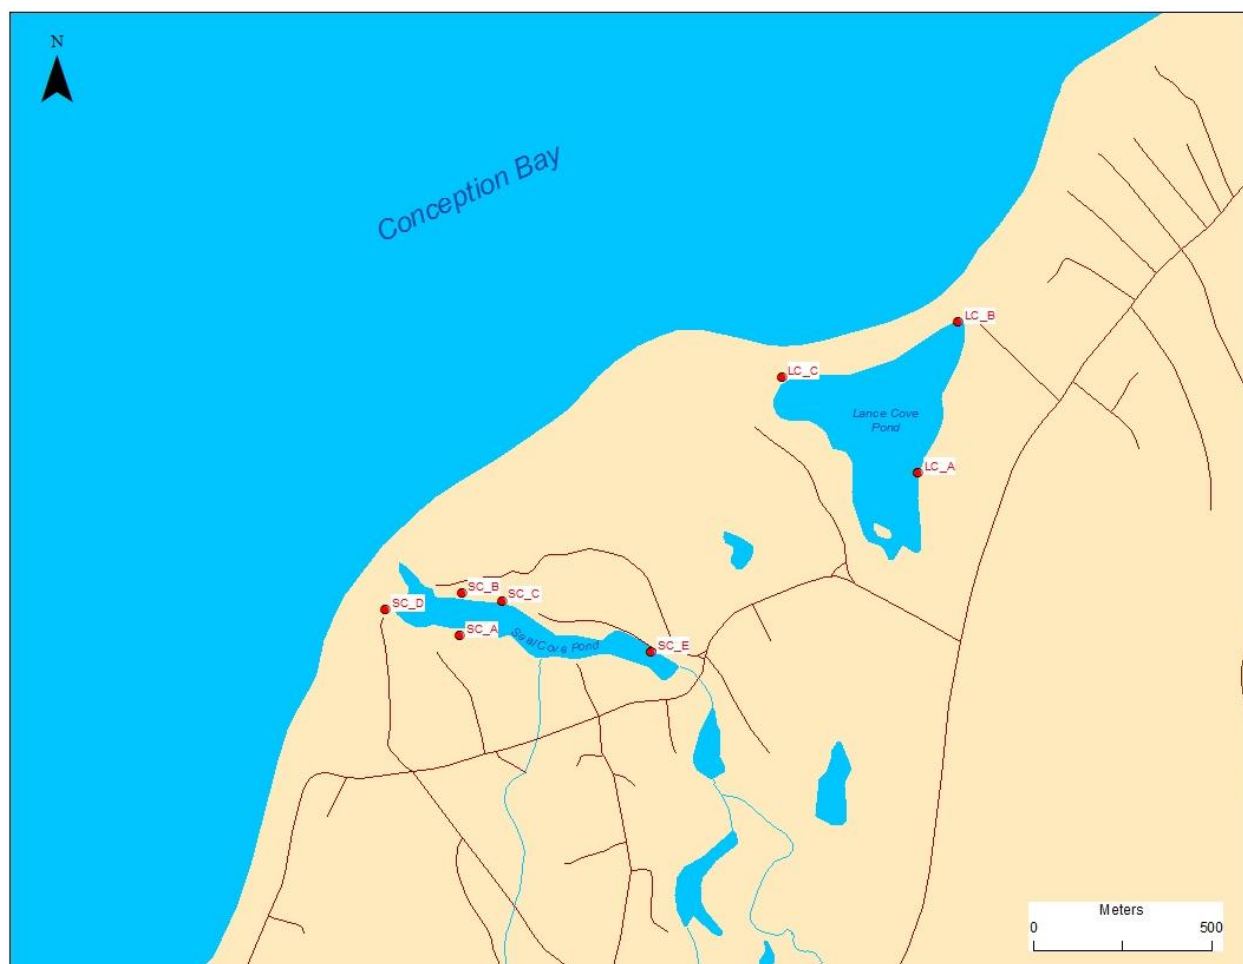
Figure B4. Sample site locations for Lance Cove Pond and Seal Cove Pond.
