# **An Examination of the Barachois Pond Ecosystems on the Northeast Avalon Peninsula of Newfoundland and Labrador**

**March 2013**

**Phoebe Metcalfe (BSc., ADWQ)**  
*NAACAP Environmental Technologist*

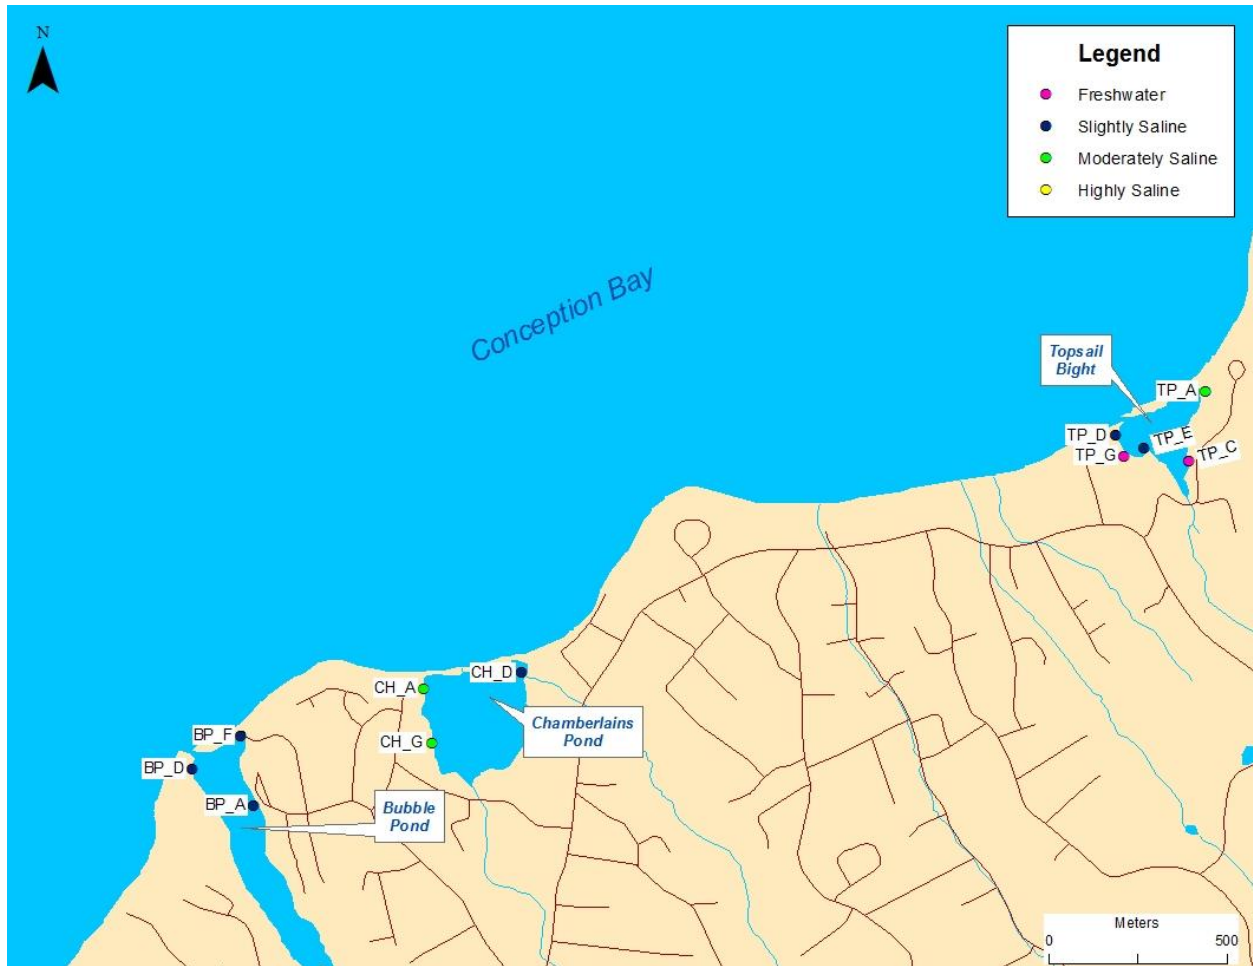
Figure C1. Water quality sample locations for Topsail Bight, Chamberlains Pond, and Bubble Pond, colored based on which classification their salinity reading fell into.

Many of the sample sites exceeded the recommended ranges in freshwater for conductivity and total dissolved solids (TDS) of 0.050 – 1.5 mS/cm and 0-1g/L respectively (Province of British Columbia, 1998). These higher values of conductivity and TDS can be related to the salinity values recorded for these sites, as generally salt water has a higher conductivity and TDS than fresh water. All of the sites with conductivity and TDS values higher than those recommended for freshwater had salinity values that fell within the classification ranges other than that of freshwater (Bergman, 2001). For the purposes of this study, the classifications can be combined so that the classifications of slightly saline, moderately saline and highly saline are representative of brackish water. With this generalization, Topsail Bight, Chamberlains Pond, Bubble Pond, Long Pond, Paddys Pond, Butlers Pond, Kelligrews Pond, Seal Cove Pond and Indian Pond contain brackish water. Lower Gully Pond, Lance Cove Pond, and Freshwater Bay Pond contain fresh water. The highest salinity, TDS and conductivity values were found in Long Pond, Butlers Pond, Kelligrews Pond, Seal Cove Pond and Indian Pond. The distribution of salinity classifications for each lagoon can be found in Appendix B.

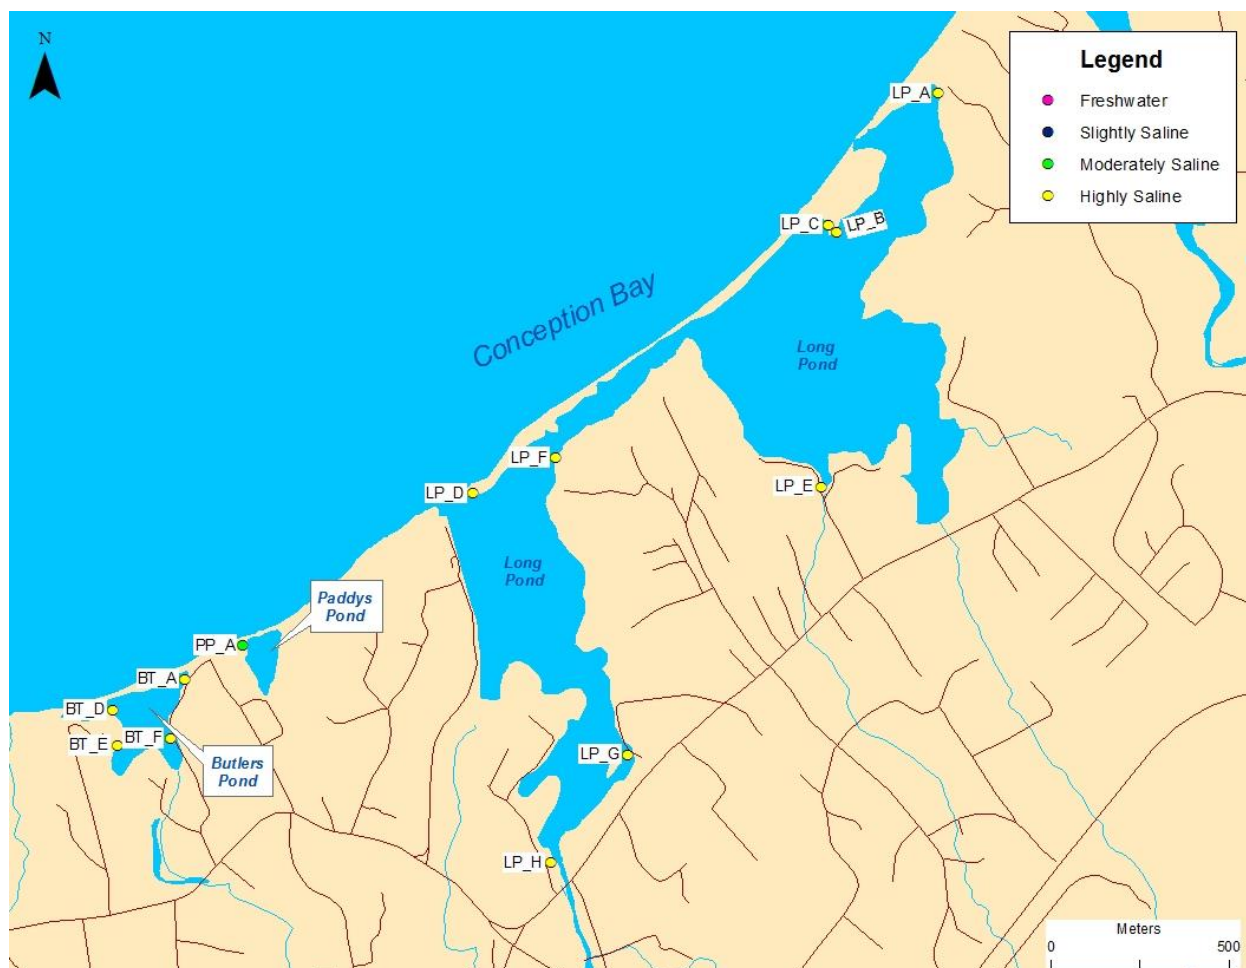
Figure C2. Water quality sample locations for Long Pond, Paddys Pond and Butlers Pond, colored based on which classification their salinity reading fell into.

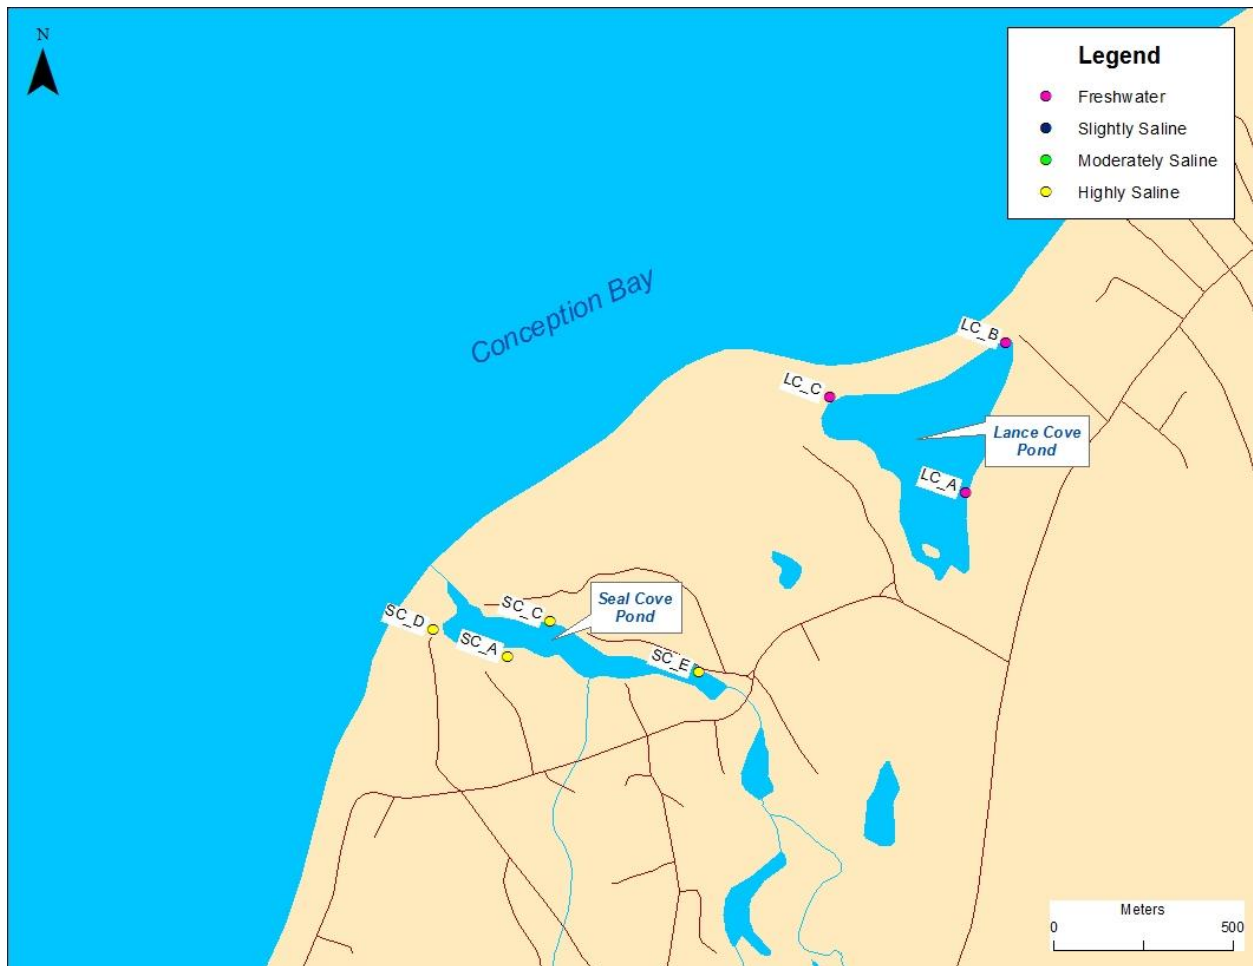
Figure C4. Water quality sample locations for Lance Cove Pond and Seal Cove Pond, colored based on which classification their salinity reading fell into.
