At the headwaters of the South Brook Watershed

Northeast Avalon ACAP
Box 8732, St. John's, NL, A1B 3T1
709-726-9673
info@naacap.ca

A Preliminary Vulnerability Assessment of a Watershed within the Proposed 2500 Acre Galway Development

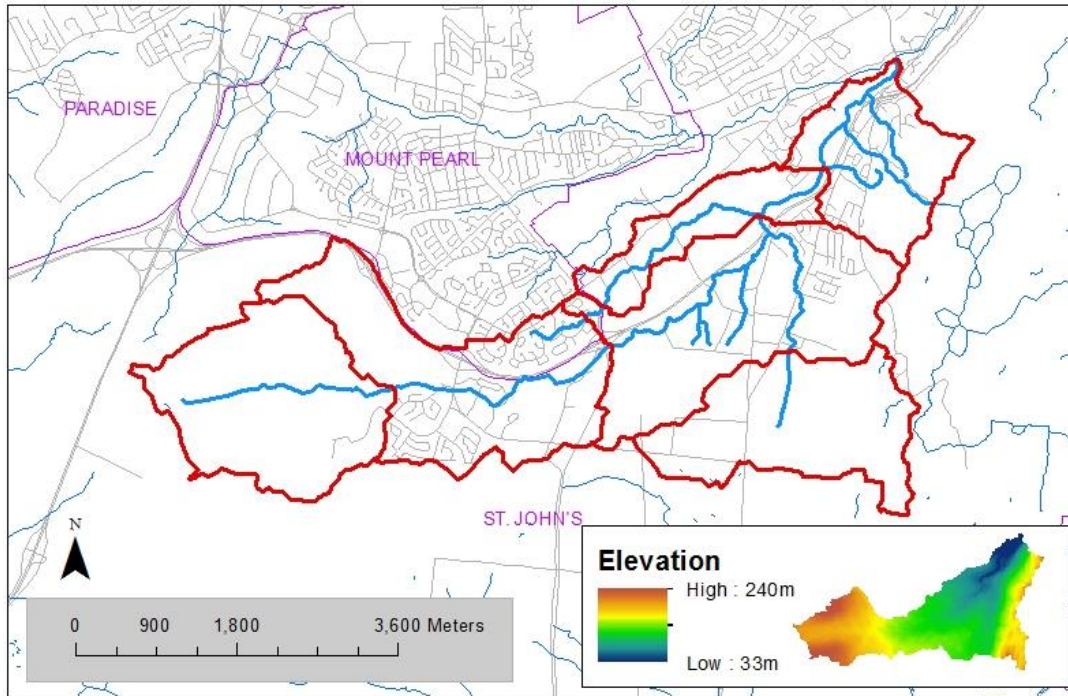
Figure 1 - The South Brook Watershed delineated in red with Digital Elevation Model (DEM) inset.

The South Brook Watershed is located predominately in St. John's, directly south of the municipal boundary of Mount Pearl (Figure 1). The watershed spans an area of approximately 30 km². South Brook is the largest tributary to the Waterford River, at a length of approximately 10.8 km. Its headwaters are found in natural wetlands. South Brook flows through natural, residential and agricultural areas, as well as Bowring Park before it eventually meets the main channel of the Waterford at the eastern end of Bowring Park.

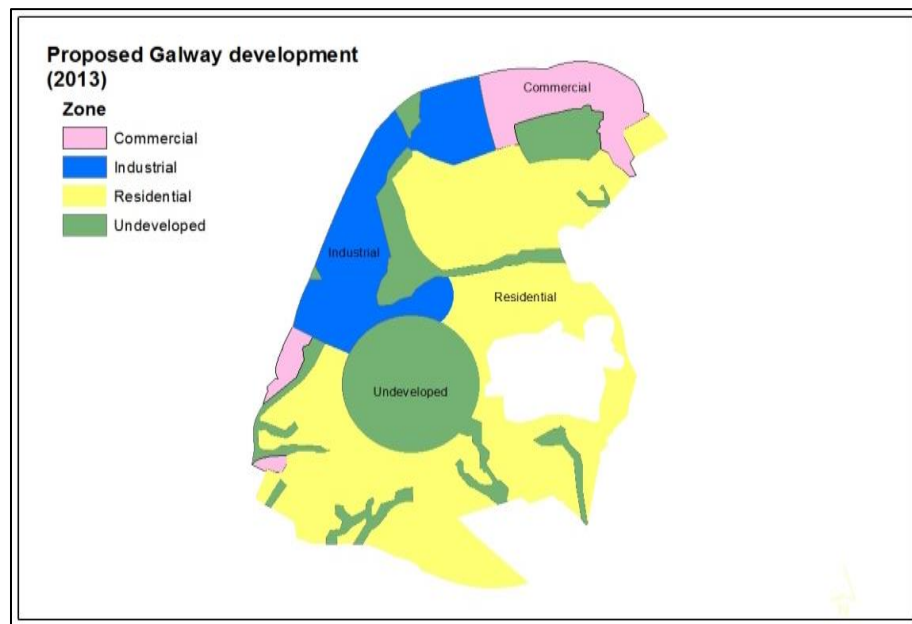
Figure 2 - The proposed Galway development concept plan, released as part of St. John's City Council meeting minutes, May 6th, 2013. There is a golf course in the mid-right area of the development proposal (white), since this golf course already exists and will not change, it has been left out of the analysis for clarity regarding what is proposed.

A preliminary concept plan for the Galway development was released in May, 2013 (Figure 2). This concept plan contains four different zones: Commercial (pink), Industrial (blue), Residential (yellow) and 'Undeveloped' (green). The land use zonings used in this preliminary concept plan were used to determine the land cover change that will occur under the proposed development. Completion of the entire development, however, is slated to take many years, and detailed concept plans for the development were not released to the City during this project.

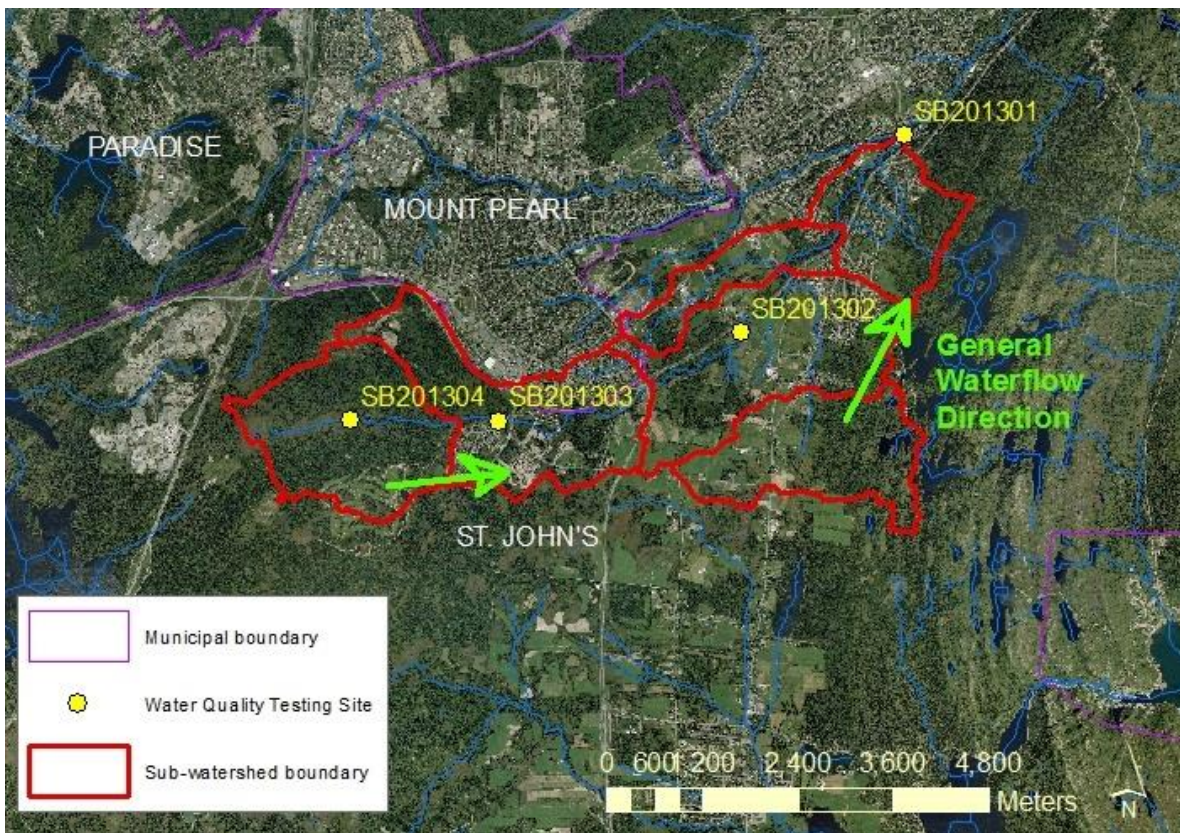
Figure 3 - Locations of NAACAP water quality testing and sub-watershed boundaries in South Brook watershed, Northeast Avalon Peninsula (NL).

Water quality data were collected from South Brook during the summer of 2013. Two of the sites visited are sampled quarterly by the Provincial Department of Environment and Conservation, Water Resources Management Division as part of their Water Quality Management Agreement with Environment Canada. One of these sites, known as NF02ZM0185 by the Province, is located at Treetop Drive, while the other, known as NF02ZM0176 by the Province, is located at the mouth of South Brook in Bowring Park. These two sites were named SB201303 and SB201301 respectively, and two additional sites were added for a total of four sample sites to capture the full distribution of South Brook for this project (Figure 3). One site (SB201304) was further upstream in the headwaters of South Brook where the proposed development is scheduled, and the other site (SB201302) was upstream of Pearltown Road, which is located between the two sites sampled regularly by the Province. Large scale maps of all four sample locations are contained in Appendix A.

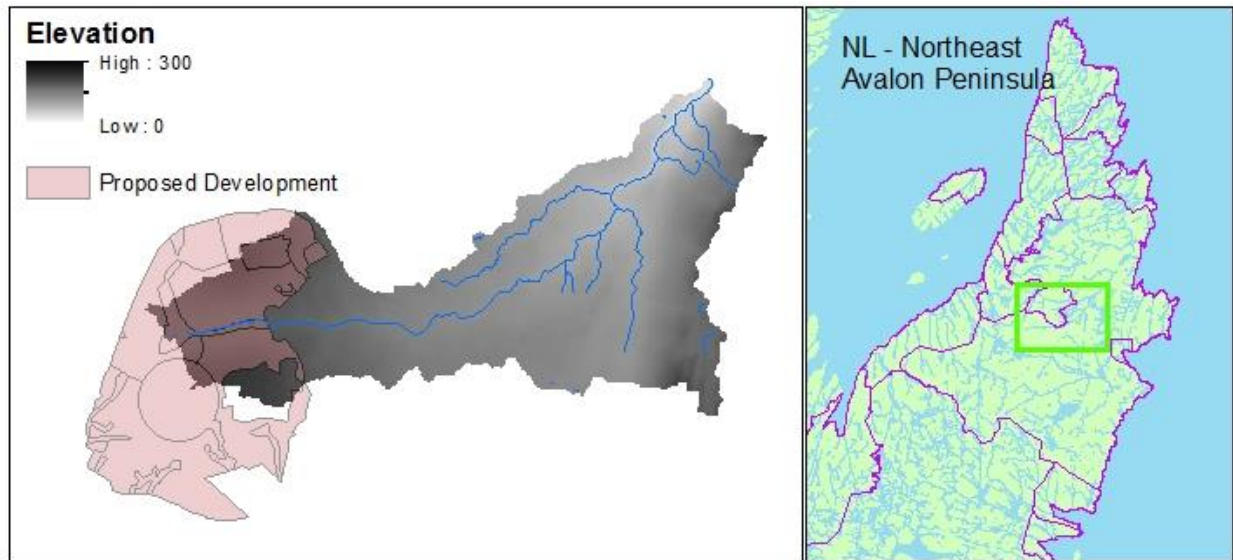
Figure 4 - The South Brook Watershed (grey), the proposed development known as Galway (rose), and the area of overlap between the two – the study area. South Brook and tributaries are marked in blue.

ArcGIS was used to determine the area of land common to both the proposed development and the South Brook Watershed. The common land area is the northeast section of the Galway development, sitting over the higher elevation western section of the South Brook Watershed, and will be referred to as the study area (Figure 4).

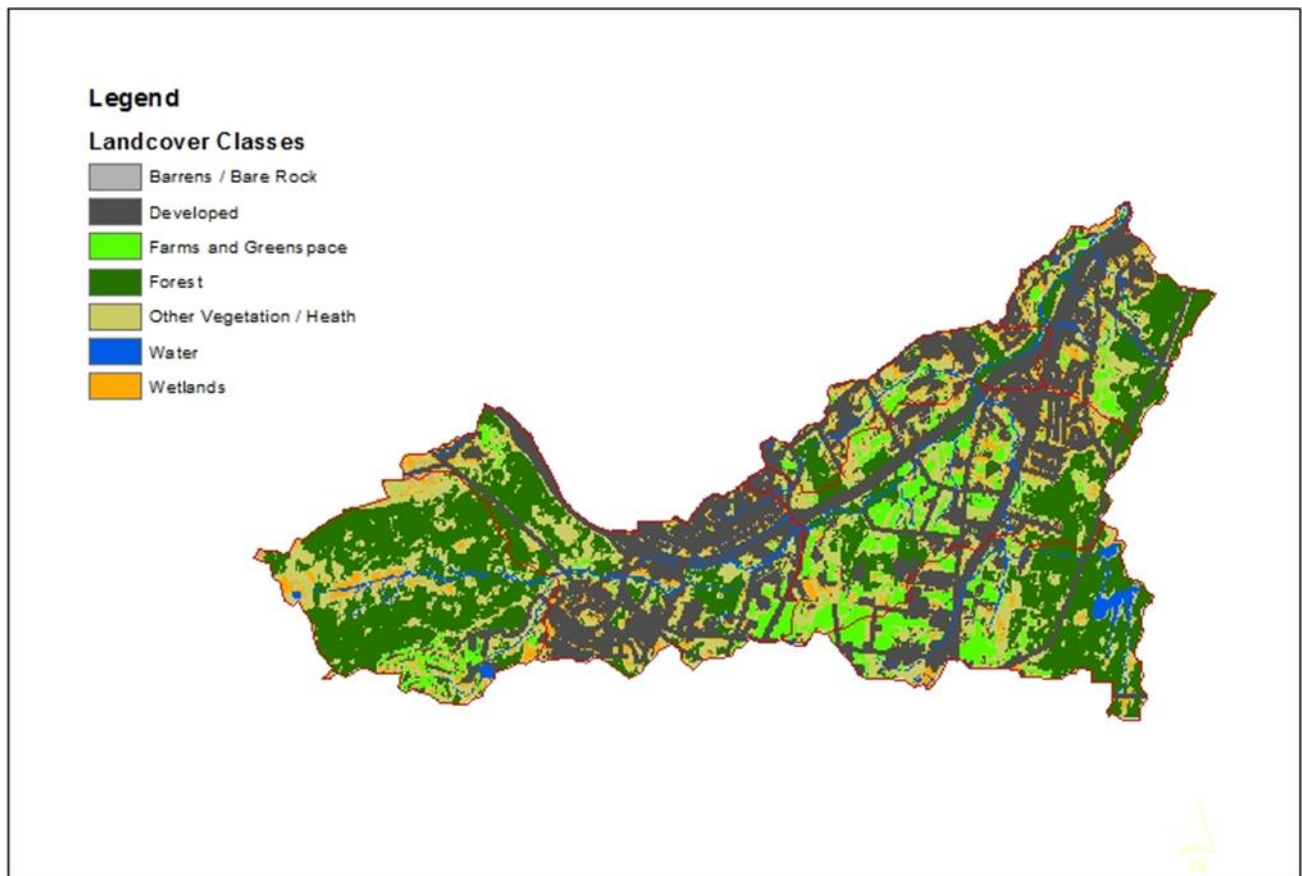
Figure 5 - Land cover classifications for the land area within the delineated South Brook watershed, Northeast Avalon Peninsula, NL.

During subsequent analysis, the results of the South Brook Watershed delineation were used in combination with the land cover results. ArcGIS ArcToolbox clip function using the watershed boundary imposed over the land cover results produced the South Brook Watershed with land cover classifications necessary for further analysis (Figure 5).

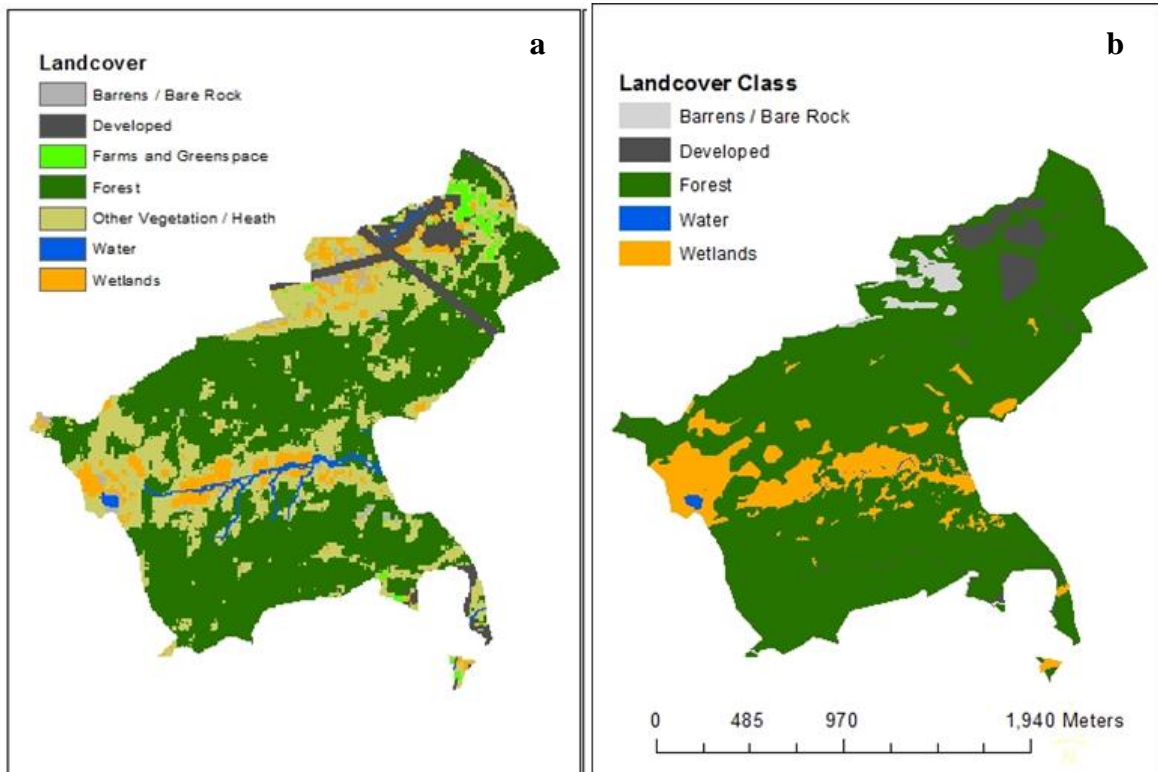
Figure 6 - ArcGIS land cover classifications (a) and manual land cover classifications (b) for the study area

identified land cover type. Of the seven land use classes identified using GIS (Figure 6a), only five classes were verified through manual inspection (Figure 6b).

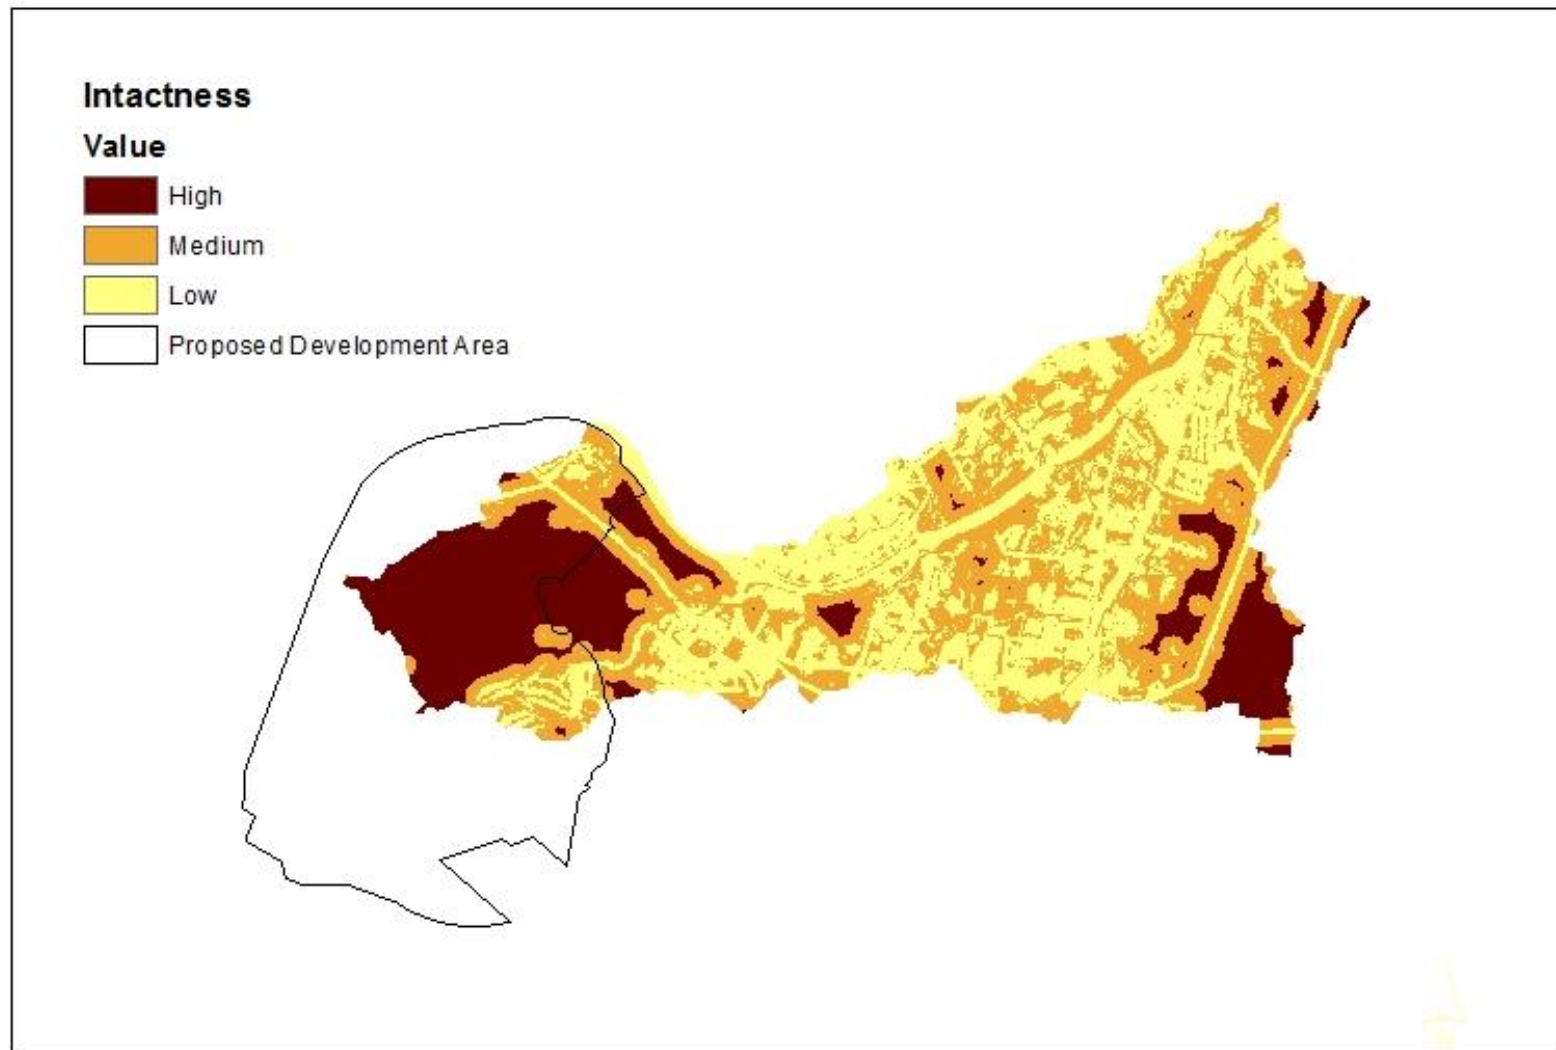
Figure 7 – Visual representation of intactness classification for the South Brook Watershed. A large area of high intactness is clearly visible at the western extent, within the boundary for the Galway concept plan outlined in black.

Land cover classes were thus assessed based on the simple 3-tier rating in order to visualise the intactness of the South Brook watershed. The map is created by substituting a single visual representation (a colour for each of low, medium or high intactness level) for each land cover class within ArcGIS. The resulting South Brook watershed intactness map based on 2010 aerial imagery is shown (Figure 7). From this GIS representation it is evident that the development area encompasses the largest continuous area with the highest level of intactness within the South Brook Watershed.

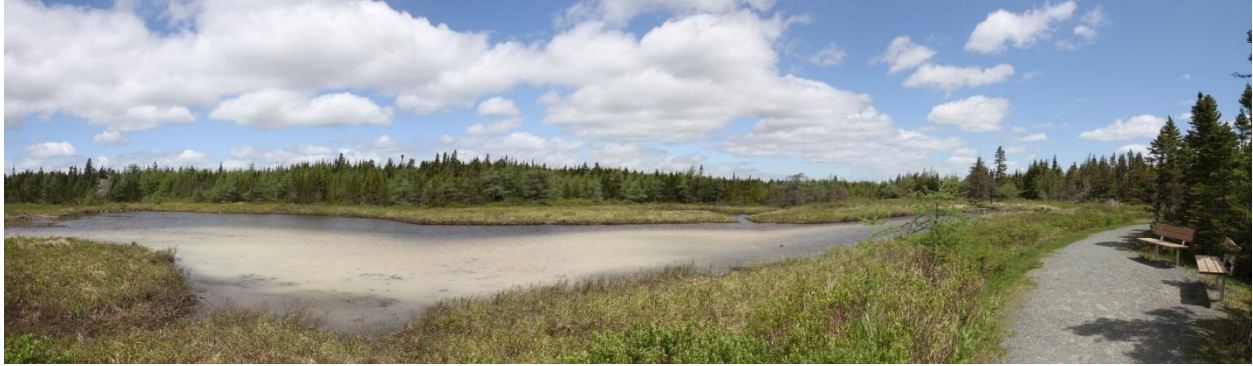
Figure 8 - Siltation of South Brook (St. John's, Newfoundland and Labrador), June 6, 2013 located in the area of Cyprus Street and Southlands Boulevard. A small tributary that enters South Brook via a culvert appeared to be the source of the siltation. (Photo courtesy of Nick White).

new housing being built in the Kilbride and Southlands areas. One visual sign of this increasing influence on water quality is recent siltation of South Brook. These events were noted at various times throughout this project year, including on June 6, 2013 at the corner of Cypress Street and Southlands Boulevard (Figure 8), and November 21, 2013 when a tributary which enters South Brook in the vicinity of Old Bay Bulls Road became sediment laden (Figure 9), and caused both South Brook and the downstream portions of the Waterford River to become turbid.

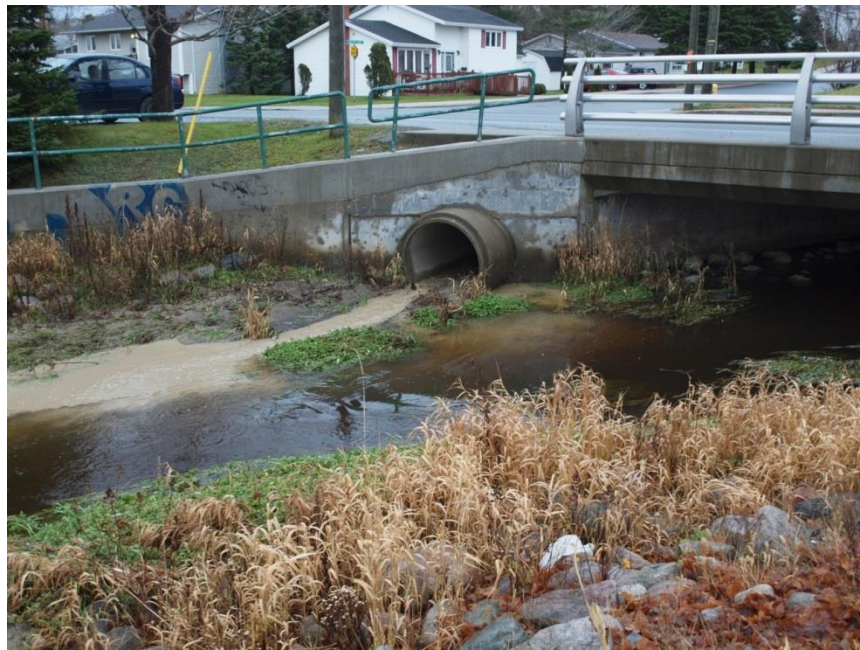
Figure 9- Sediment laden water enters a tributary to South Brook (St. John's, Newfoundland and Labrador), downstream of Bay Bulls Road November 22, 2013. (Photo courtesy of Diana Baird).

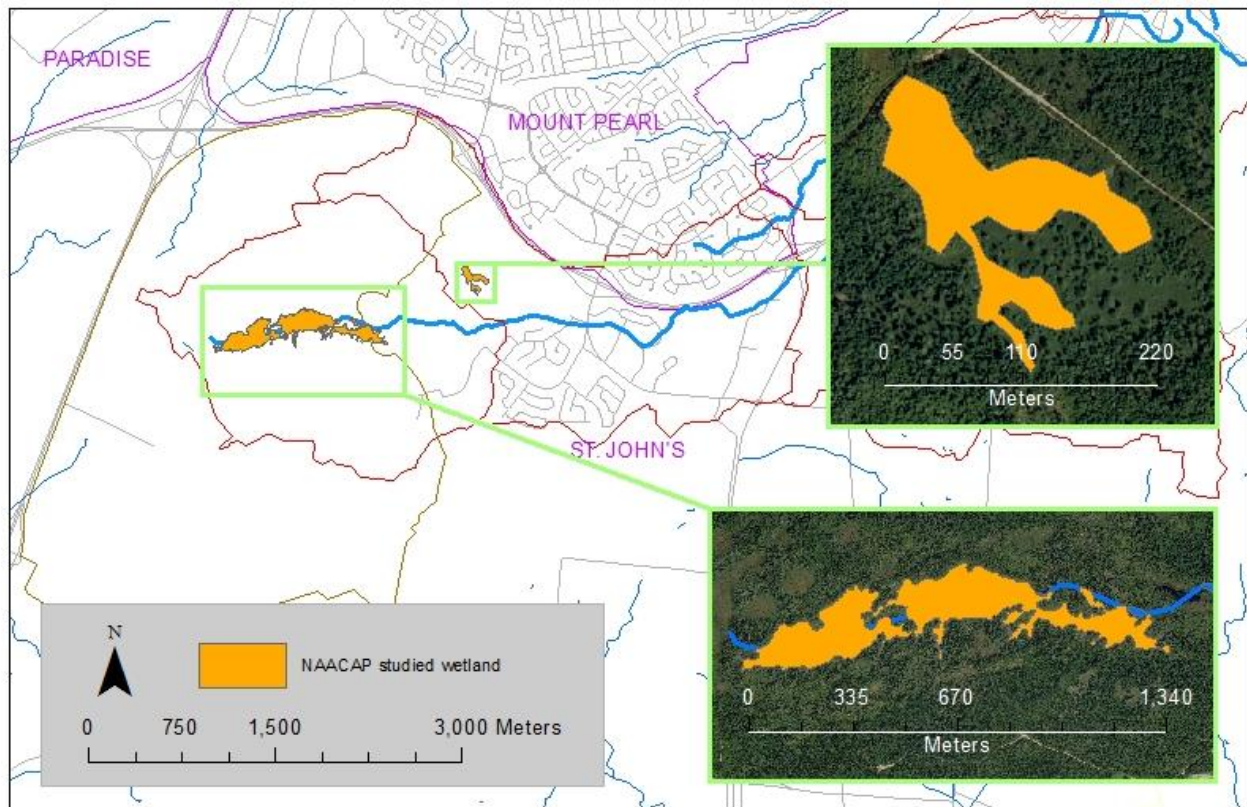
Figure 10 - Wetland sites visited by NAACAP's Green Team in summer 2013. Inset area Southlands Site 1 (upper right) and Southlands Site 2 (lower right).

Two wetlands inside the study area were sampled to obtain basic biological data from the wetland ecosystem (Figure 10). These wetlands were named Southlands Site 1 and Southlands Site 2 by the Conservation Corps NAACAP Green Team.

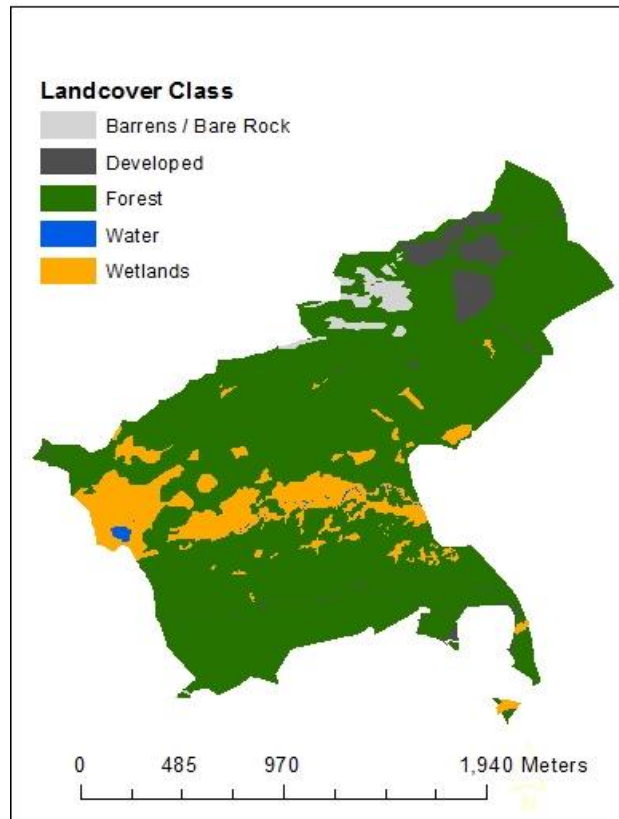
Figure 11 – Manual land cover classifications for the study area before the Galway development.

Figure 11 shows the manual land cover classifications for the study area, determined prior to the Galway development. The large wetland complex in Figure 11 contains the headwaters of South Brook, and the upper reaches of the river flow through the centre of these wetlands. Part of this wetland complex was visited during 2013 by NAACAP field staff, as described above (Southlands Site 2 in Section 3.2).

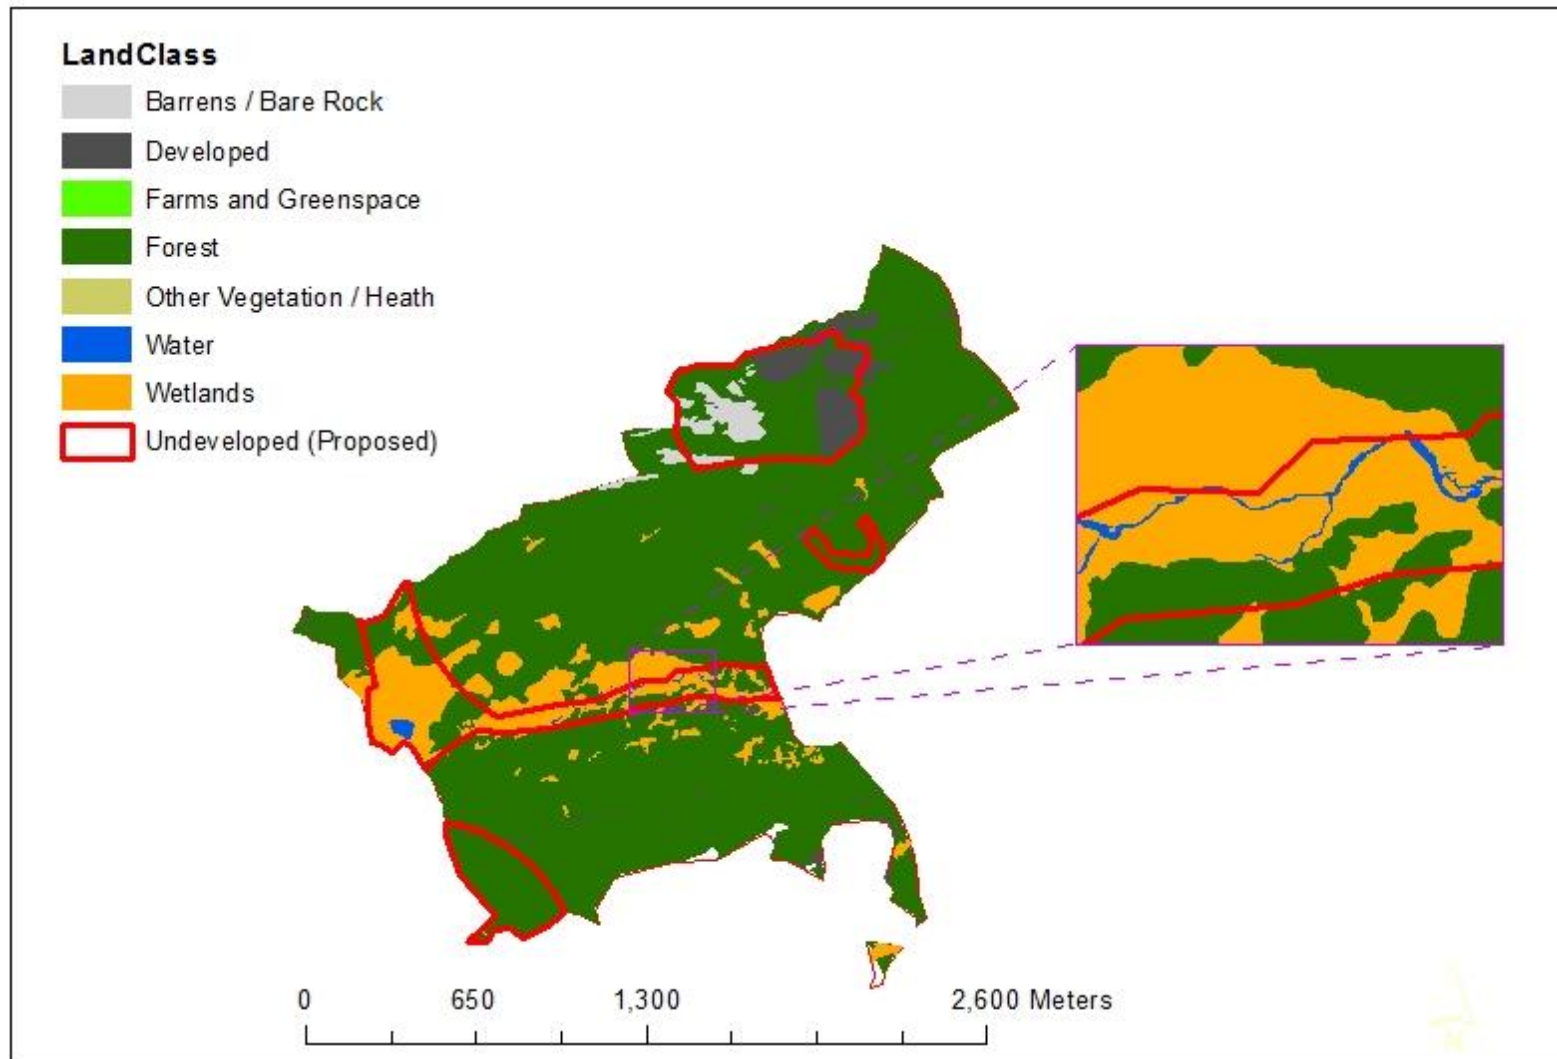
Figure 11 - The manual land cover classifications with the undeveloped sections of the proposed Galway development plan outlined in red. A corridor of proposed undeveloped area runs west to east along the center of the study area.

Part of this large wetland falls within a proposed corridor of undeveloped land on the preliminary Galway development plan. Figure 12 shows the manual land cover classifications with the proposed undeveloped areas. This illustrates the limited amount of wetlands that will be conserved based on the preliminary development plan, assuming that areas that are zoned residential, industrial or commercial will not contain conservation areas. It can be seen that the boundaries of the proposed undeveloped corridor located in the center of the study area (Figure 12) will run through the wetlands and along South Brook, and does not appear to follow the natural wetland boundaries. This undeveloped corridor measured in GIS software ranged from approximately 58 meters at the narrowest point to 134 meters at the widest point. To sustain the wetland, there should also be a section of forest included around the wetland area to act as a buffer. The exact extent of the undeveloped area needed to sustain the wetland depends on several parameters including surrounding vegetation, slope, soil type, rainfall etc. These parameters need to be considered when determining buffer width. Table 6 shows a breakdown of the land cover classifications within the undeveloped zone surrounding South Brook in the center

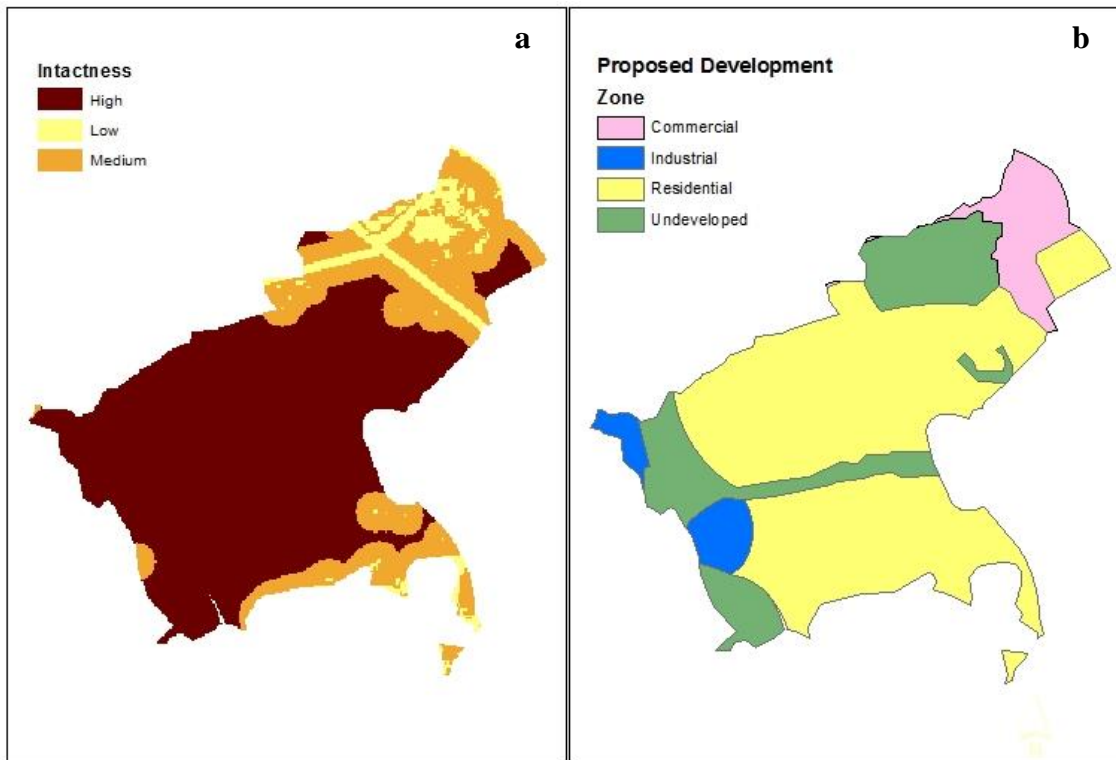
Figure 13 – Pre-development intactness (a) and proposed Galway development zones (b) for the study area.

Prior to Galway, the study area was largely undeveloped and thus mostly highly intact (Figure 13a). This area will be developed into a large residential area with smaller industrial areas (Figure 13b).

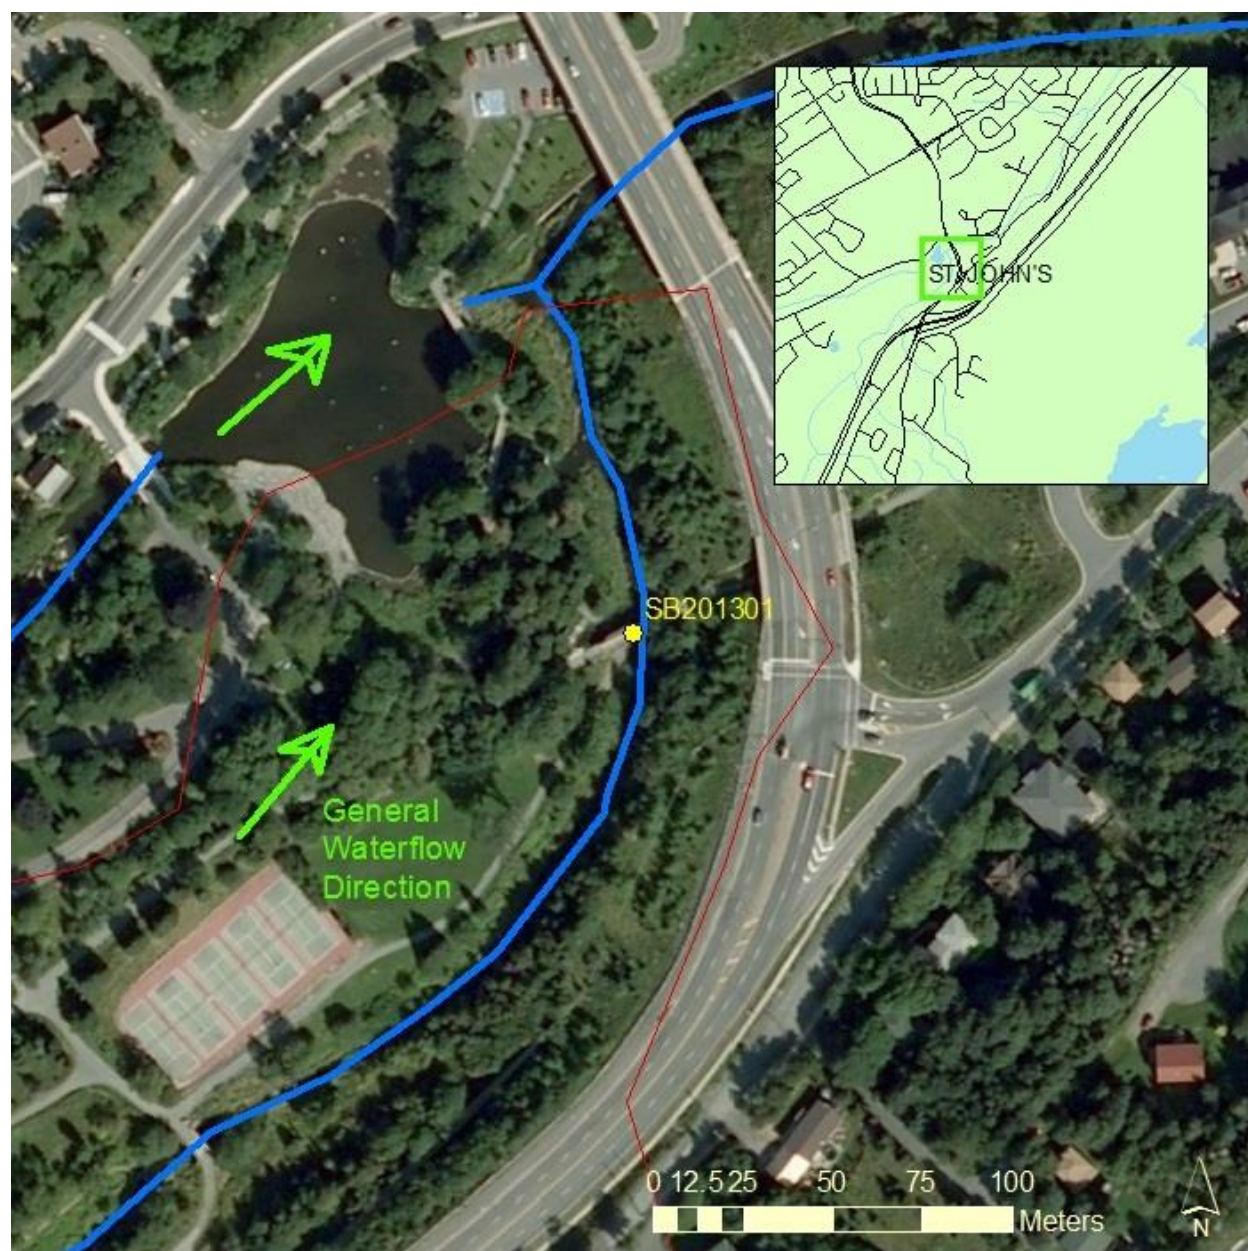
Figure A1. Location of sample site SB201301 the furthest downstream water quality sample site in St. John's, Newfoundland and Labrador. Sampling occurred upstream of the railway crossing in Bowring Park. The red line indicates the boundary of the South Brook watershed, which is bounded on the east by Columbus Drive. To the north of site SB201301, South Brook enters the Waterford River, which flows eastward out of Bowring Park.

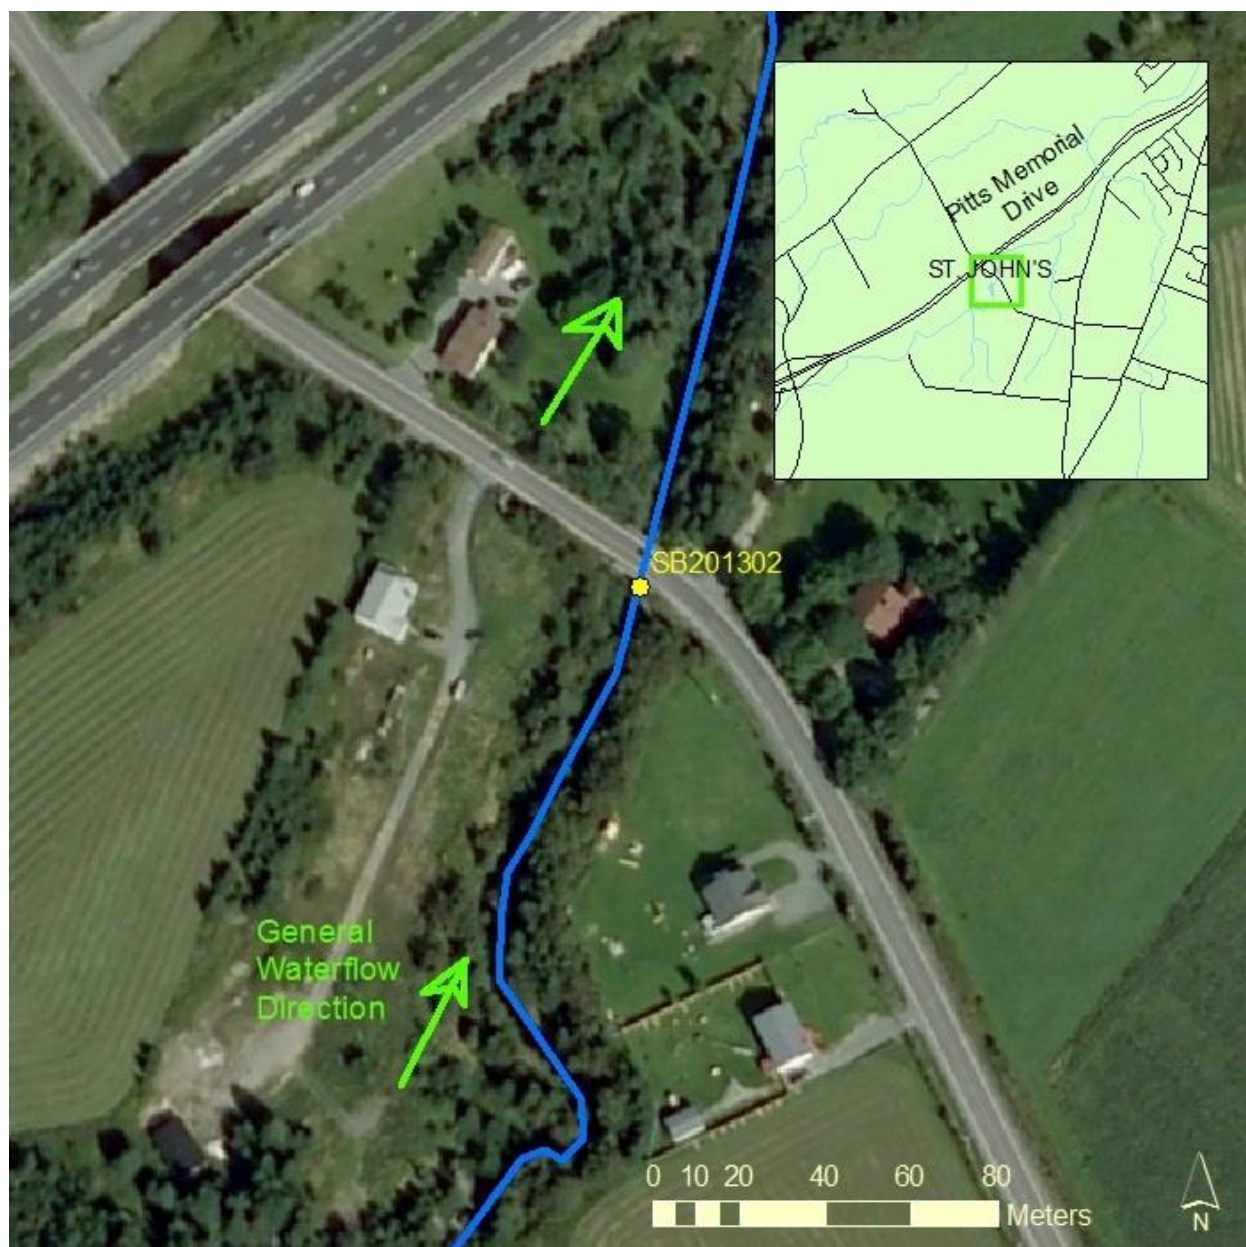
Figure A2. Location of water quality sample site SB201302, located upstream of Pearl Town Road. The dominant land use in the area is agricultural. The divided highway located in the northwest corner of this image is Pitts Memorial Drive.

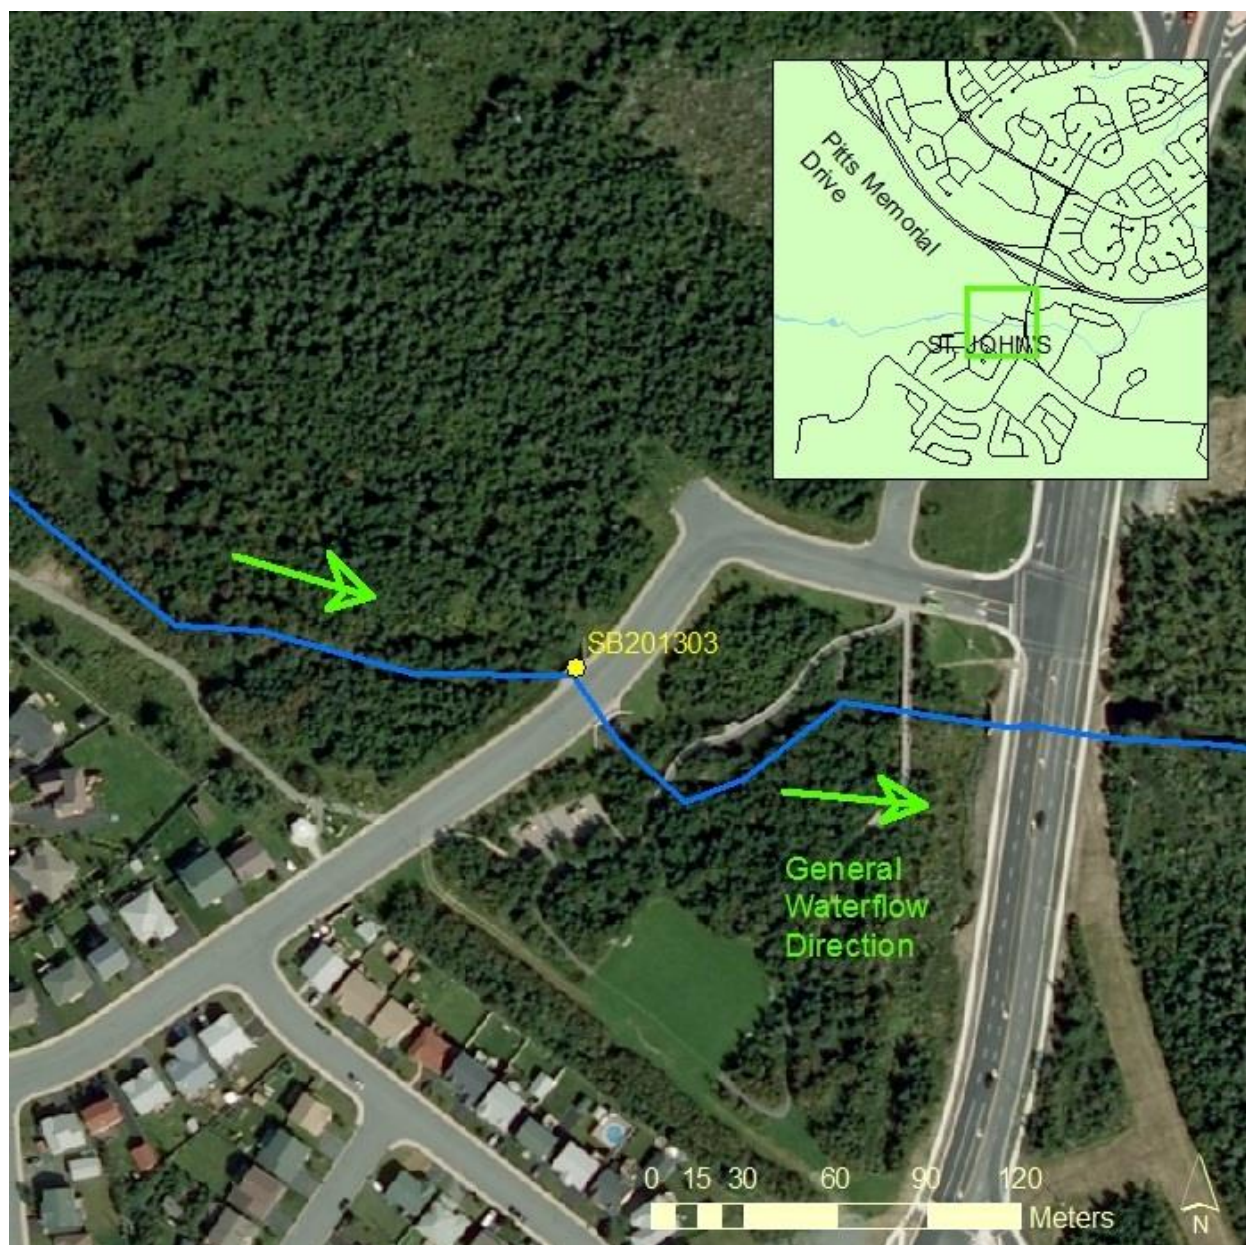
Figure A3. Location of water quality sample site SB201303, located upstream of Treetop Drive in the Southlands development. The double highway to the east is Southlands Boulevard. Note: the blue line representing South Brook is a generalisation of the flow

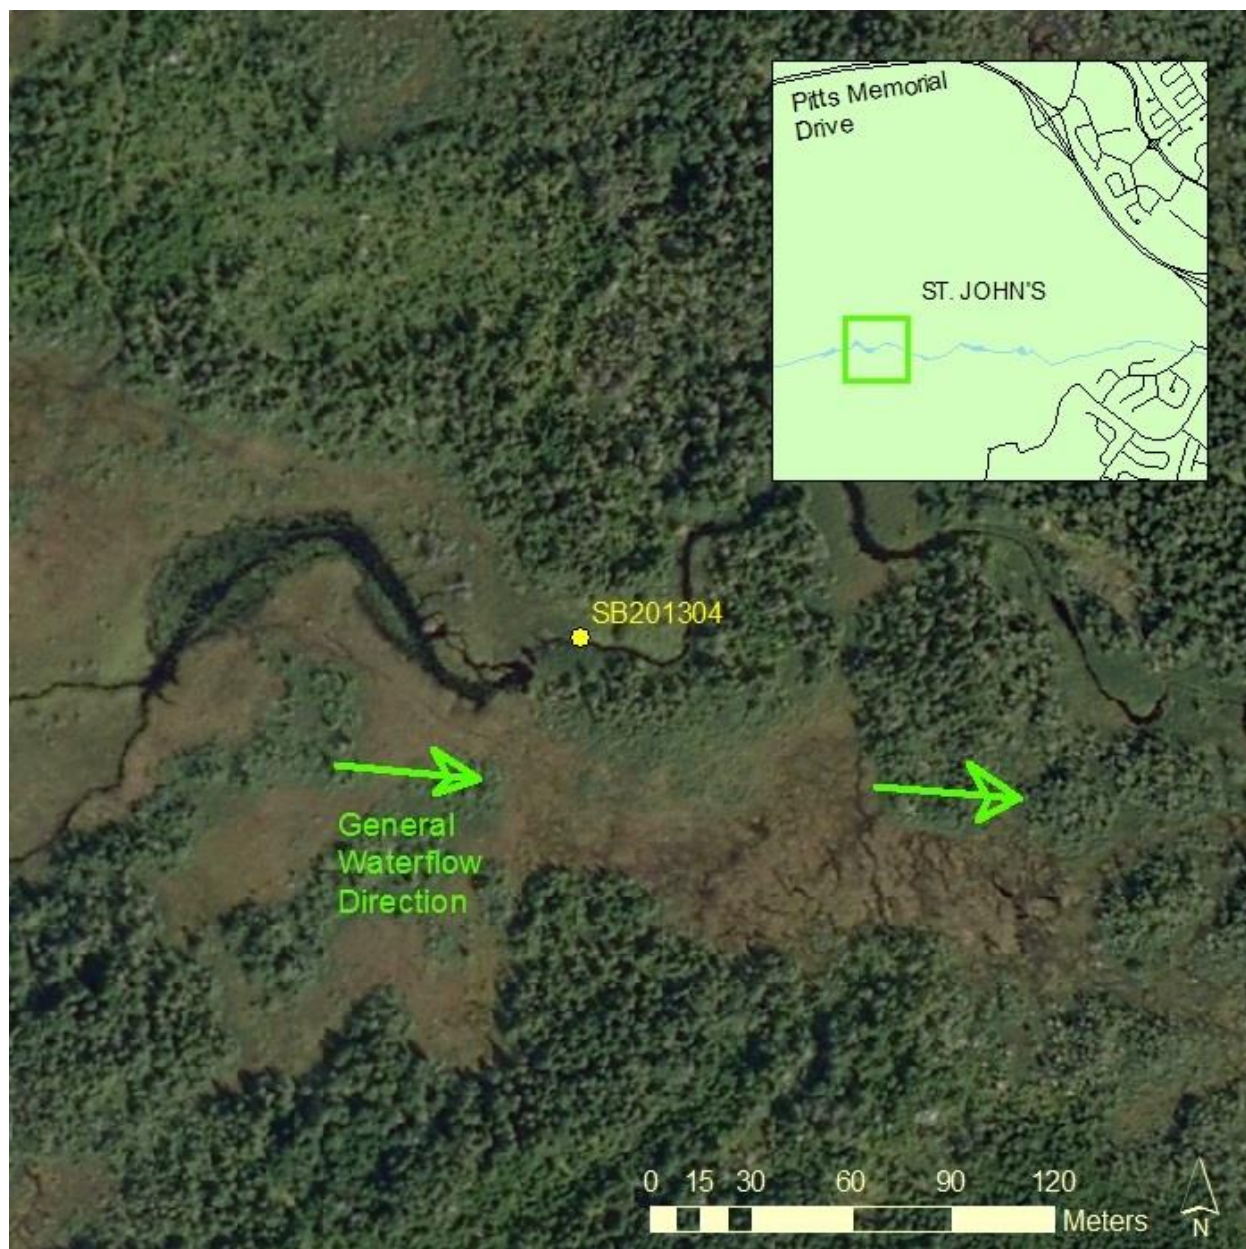
Figure A4. Location of water quality sample site SB201304, located in the headwaters of South Brook, where the river originates and flows out of a wetland area. This site is located within the boundaries of the proposed Galway development
