RENNIE'S RIVER WATERSHED

RIPARIAN ASSESSMENT

INTRODUCTION

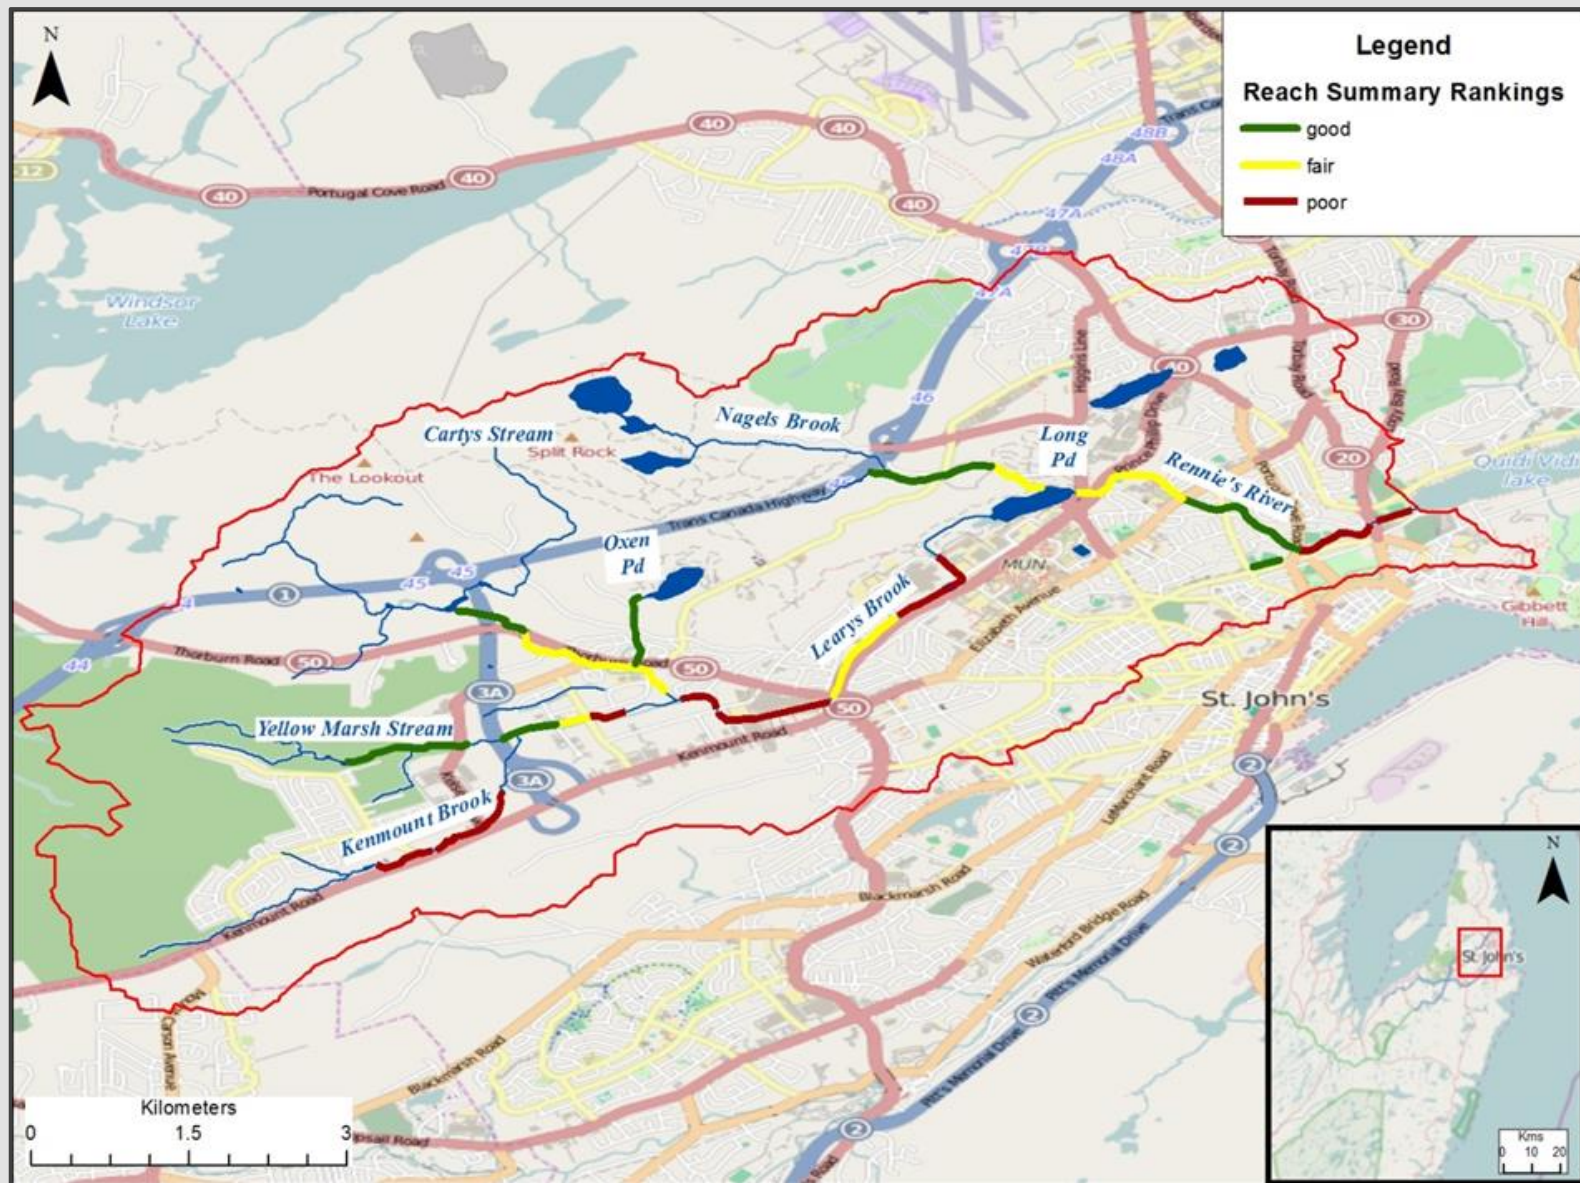
Figure 2. Color coded reach rankings for the Rennie's River / Learys Brook watershed, based on applying Visual Assessment Protocol methodology during Summer 2014.

Geographically, the reaches ranked as good were found towards the headwaters sections, where there was generally a lesser degree of

human influence (Figure 2). The exceptions to this were the reaches along Rennie's River between Portugal Cove Road and Elizabeth

Avenue (Reach 3 and Reach 4), including the daylighted section of Kelly's Brook (Reach 2A). Although surrounded by residential areas, Reaches 3 and 4 appeared to have healthy riparian vegetation, buffer zones between development intact and minimal amounts of channelization. The overall score of Reach 3 was negatively impacted mainly by a lack of canopy cover, while the overall score of Reach 4 was negatively impacted by a lack of pooling, as defined in the methodology. Although only a small section of an otherwise buried stream, Reach 2A scored as good as there was abundant riparian vegetation and the channel appeared to be in good condition.

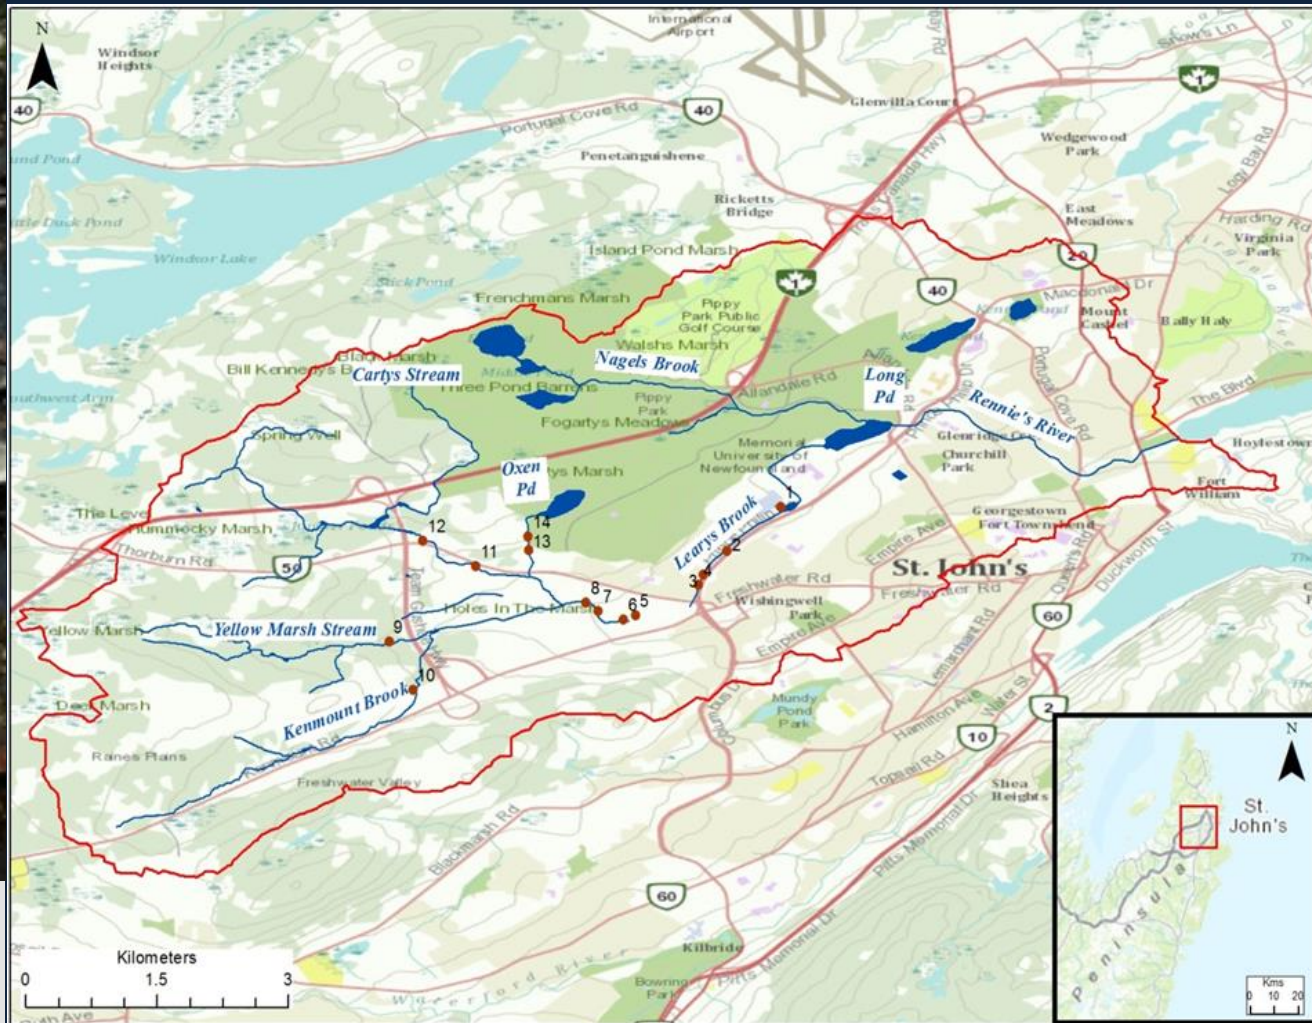
metal pieces were also found (Figure 8), with excessive amounts in the upper portions of Leary's Brook, upstream and downstream of Thorburn Road. Figure 11 illustrates that large debris was only documented upstream of Long Pond, while no such debris was found downstream along Rennie's River. This is likely because there is a walking trail that borders the river. It is possible that in the past large debris that existed there was removed to improve aesthetics of the walking trail. It is also less likely that residential areas would act as a source for large debris and metal scrap such as shopping carts and car parts; these types of debris are more likely entering the river from commercial and industrial areas.

Figure 11. Map showing locations of large debris noted during assessment in 2014. Descriptions of each sighting are found in Table 3.

Number Assigned for mapping	Description
1	Shopping carts within pond next to Health Sciences Centre
2	Shopping carts and accumulating debris of a variety of types
3	Tire, street sign, other debris build up by Provincial real time monitoring station
4	Shopping cart in river
5	Shopping cart in fish ladder by mall parking lot, pallet in pooling area, accumulation of a variety of debris
6	Shopping cart in river by mall parking lot
7	Shopping cart well buried by substrate deposition
8	Metal debris scattered throughout this area of river
9	Large amount of fallen trees, catches other debris and garbage Just downstream of Kelsey Drive stream crossing
10	Shopping carts/large amounts of garbage found on hill behind Mark's Work Warehouse and Canadian Tire.
11	Rusted out car and parts littered around river, located on left bank touching the river flow
12	Private driveway has fallen into the river on the upstream side, causing rocks and debris to fall into opening of the culvert

13	Large piece of metal, about 10ft long located at the mouth of the culvert downstream of Seaborn Street
14	Old rusted cars and parts up a hill about 15ft away from the river

Table 2. Descriptions of debris found at locations throughout the Rennie's River / Leary's Brook watershed, as illustrated in Figure 11.

Removal of large debris. The removal of larger debris can be slightly more difficult than the removal of garbage, because of the size of the debris, and because it was often located in the water, requiring greater attention to safety during the removal. One area with a large number of shopping carts was behind Marks Work Wearhouse, where the carts were found mainly along the side of the river, but over a steep bank from the parking lot, making access more difficult. The area behind the Avalon Mall where shopping carts were also found has steep banks and will have to be accessed with caution.

Businesses taking ownership of their nearby stream. The reach between Thorburn Road and Critchs Path where various car parts and metal were found should be cleaned up. However, this area is also difficult to access. Ideally, the cooperation of some property owners in the area would facilitate the cleanup. Upstream of this reach there were numerous old car frames found along the river bank which appeared to be on private land and would also require the property owner's cooperation for removal.

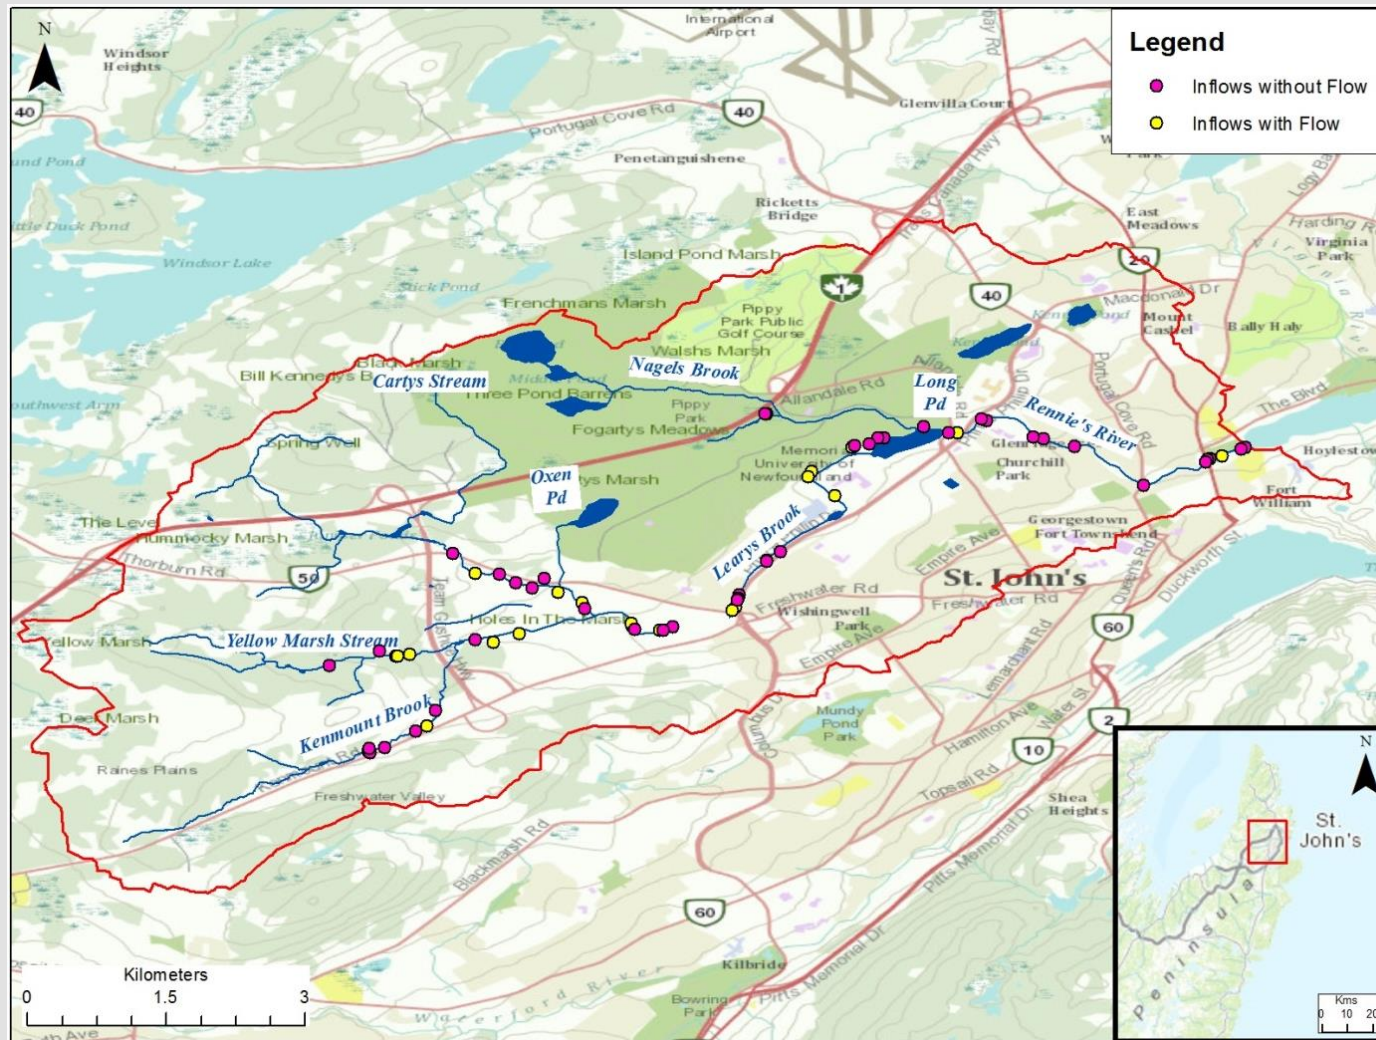
Although not one of the nine assessment criteria for the assessment, information was also collected on the location of inflows to the main stream paths. These locations could be useful for future assessments, specifically to track pollution sources. Figure 15 shows inflows with

either water flowing from them or no water flowing from them at the time of assessment. As shown in Figure 15, there appears to be more inflows without flow than with flow. As assessment was conducted during summer, which is generally dry, it is likely that many of the inflows are storm sewer outlets.

Figure 15. Recorded locations of inflows to the main streams, both with water flow and without water flow at the time of assessment.
